Experiences of mine closure cover with geosynthetics in Peru

Abstract. Peru is internationally recognized as one of the countries with significant mining reserves. According to the Department of Energy and Mines (MINEM), as of December 2021, a total of 672 mining concession holders were registered and declared in the Monthly Statistical Declaration (ESTAMIN). Likewise, 44 mining concessions are in the closure stage (progressive, post-closure and final). In addition, Peru has 7956 Mining Environmental Liabilities (MEL) as of 2020, according to the inventory approved by the Department of Energy and Mines, which need to be remediated as they constitute a permanent and potential risk to the health of the population, the surrounding ecosystem and property. As part of the closure of these MEL and closure of some mining components, the use of geosynthetics has increased in Peru, and we speak specifically of the closure cover in slopes, platforms, sidewalks and others, which has become relevant as an alternative solution for soils selected as part of a traditional closure, the objective of this work is to present a series of experiences of the application of geosynthetics in mine closure

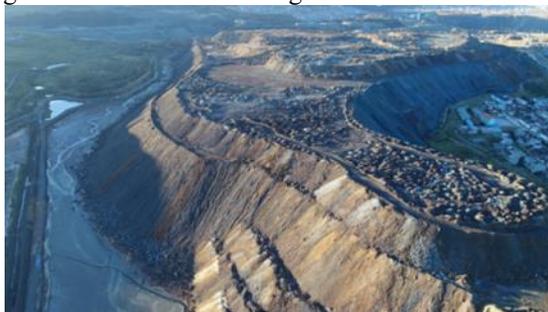
Fig. 1. Initial stage before closing.

The Excélsior Closure Plan is the largest environmental liability in the history of Peru, located in Cerro de Pasco, with 69 hectares and 55 million tons of mining waste accumulated from 1956 to 2000. Figure 1 shows the initial stage of the closure of the Excélsior mine.

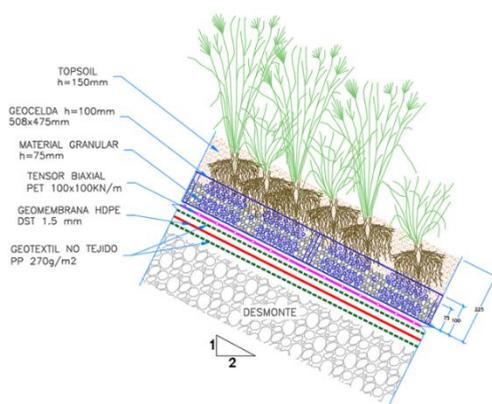
Fig. 2. Type I cover.

This type of cover was installed on the slope of the dump, in order to fulfil the function of waterproofing the clearing, the slopes were 2H:1V.

Granular material (0.075m thick): It had the function of filter and drainage of the waters that could cross the topsoil by means of a catchment system, the waters were derived from the waterproofed waste water tank.

Topsoil or topsoil (0.15m thick): Its function was to support the native grass species planted for revegetation.

Geomembrane: This geosynthetic made of 1.5mm double textured HDPE (high density polyethylene) was used to encapsulate the reservoir and contain the flow. Based on PNN (net neutralization potential) analyses, this reservoir had a potential to generate acid drainage, making it necessary to reduce the infiltration levels of non-contact water with the acid-generating material. The geomembrane used follows an international standard specification GM13 of the GSI (Geosynthetics Institute) that guarantees good mechanical performance, due to its high resistance to chemical and biological degradation, as well as its high resistance to UV rays.

Nonwoven geotextile: This material made of PP (polypropylene) with a grammage of 270g/m² was placed under and over the geomembrane for puncture protection purposes. The profiled slopes could present puncture zones that could damage the geomembrane during the process of installing the geosynthetics and filling the cover materials.

Geocell: The geocell, made of HDPE (high density polyethylene), followed the GSI GS15 standard specification, with dimensions of 100mm in height and 508x475mm in opening. The purpose of the geocell was to improve the short- and long-term stability conditions of the cover on the 2H:1V slope. This cover was made up of 75mm of granular material for drainage of precipitation infiltration and 150mm of topsoil for vegetative growth with native species. The geocell contributes in generating a macrocorrugation along the slope, the geocell walls increase the stability influence of the cover beyond 100mm thickness, which made it unnecessary to confine the cover in its total height. The geocell type considerations were a function of slope steepness, geotechnical parametric of the cover material and final total thickness of the closure cover.

Biaxial tensor: This tensor made of high-strength PET (polyester) was used to support the geocell filled with cover material on the slope. It was anchored in trenches built on each slope sidewalk, in which the entire set of geosynthetics was anchored, i.e., the geomembrane, geotextile and tensor. PET is a material that shows low deformation over time when subjected to a constant load, making it an ideal material for a structure whose closure life is projected to be hundreds of years.

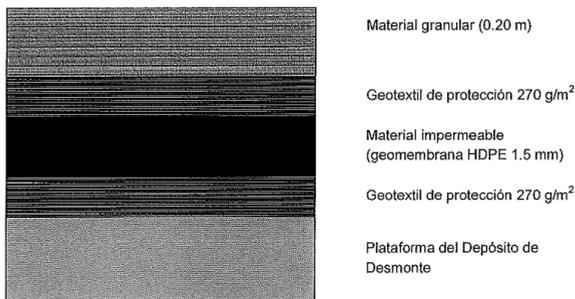
Fig. 3. Type II cover.

This type of cover was installed on the surface of the platforms and sidewalks of the reservoir.

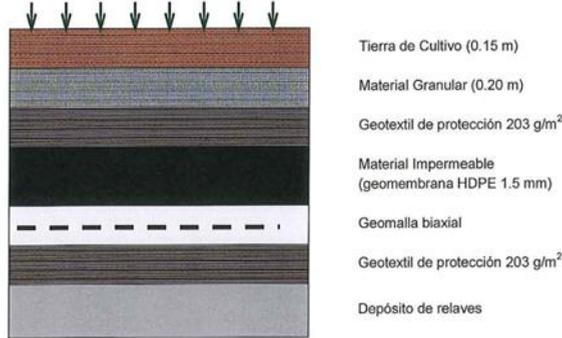
Fig. 4. Type III cover.

This type of cover was installed on the surface that limits the slope of the Excélsior dump and the Quiulacochoa tailings storage, it fulfilled the function of waterproofing and stabilizing the tailings surface.

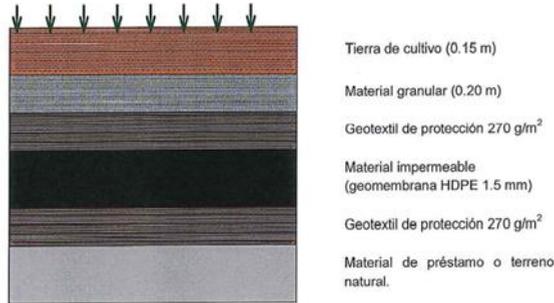
Fig. 5. Type IV cover.

This type of cover was installed on the natural ground surface or on fill with borrow material, at the foot of the waste dump.

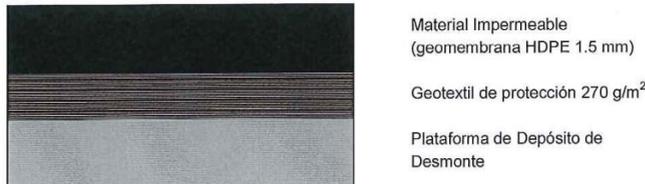
Fig. 6. Type V cover.

This type of cover was installed over the water pools located on the dump platform.

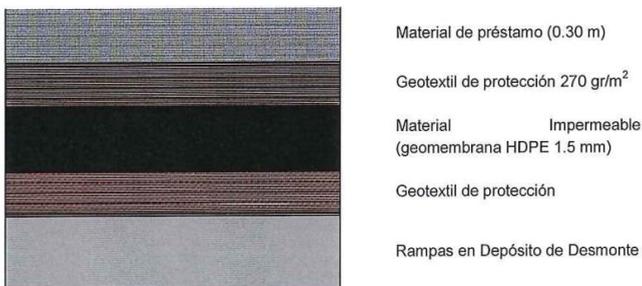
Fig. 7. Type VI cover.

This type of covering was installed on the surface designed for sloped accesses.

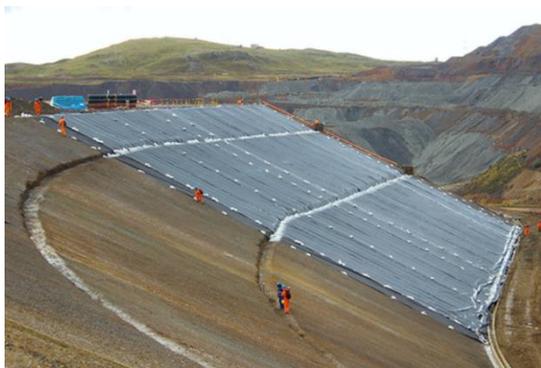
Fig. 8: Geomembrane and geotextile installation.

Once the slopes of the reservoir were shaped and profiled to achieve physical stability, the geotextile and geomembrane were installed.

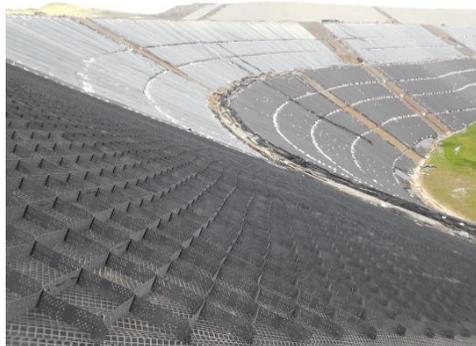
Fig. 9: Geocell and geogrid installation.

Once the placement of the geotextile over the geomembrane was completed, the biaxial tensor anchored in a trench was progressively placed on the sidewalk in the planned areas. The geocell was then installed on the slope. They provided backfill stability and facilitated gravel placement for large areas and long slope sections.

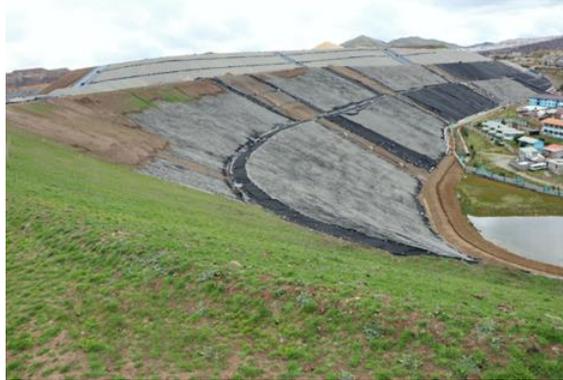
Fig. 10: Topsoil placement and revegetation.

Next, the granular material was placed for drainage purposes of the flow through the topsoil (see Figure 10), which discharged into perforated pipes placed transversally to the slope, and these into concrete collector boxes. Finally, topsoil was placed on top of the gravel for vegetation purposes with native species.

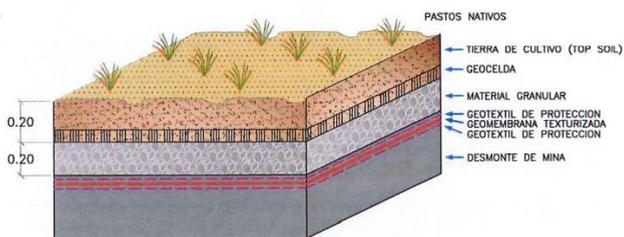
Fig. 11: Type I cover.

Type I: cover for acid generating material with revegetation.

This type of cover is used for mine waste that generates acidity. The design criterion used is that less than 5% of the annual precipitation reaches the acidity-generating material.

Topsoil or topsoil (0.20m thick): With the function of supporting the planted species, the thickness established was that necessary for the growth of the native grass species to be used for vegetation.

Granular material, crushed stone (0.20m thick): It has the function of filtering and draining water that could pass through the topsoil or by means of a catchment system.

Protective non-woven geotextile: The use of the geotextile was to avoid direct contact of the upper granular substrate with the geomembrane, avoiding possible cracks and cuts in the geomembrane that would prevent its function of waterproofing the slope of the mine waste rock.

Geomembrane: It was a HDPE material with a thickness of 1.5mm, whose function is to ensure the waterproofing of the mine waste slopes, because according to the analysis of the PNN (net neutralization potential), these wastes have a potential to generate acid drainage.

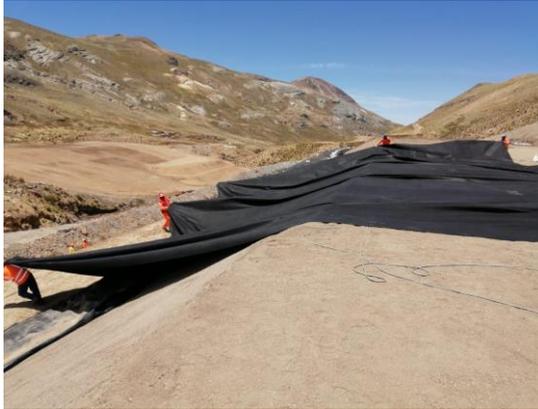
Fig. 14: Geotextile installation.

The first stage in the closure was the shaping and profiling of the slopes to then place the nonwoven geotextile, as shown in Figure 14.

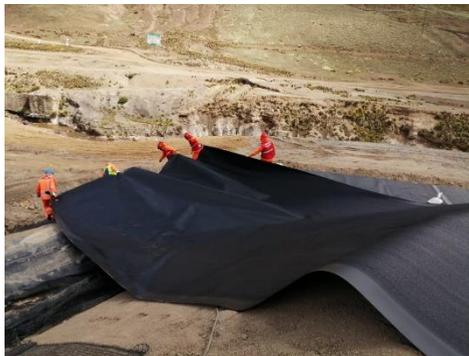
Fig. 15: Geomembrane installation.

The double-textured HDPE 1.5mm geomembrane was placed on both the slopes and the platform, as shown in Figure 15.

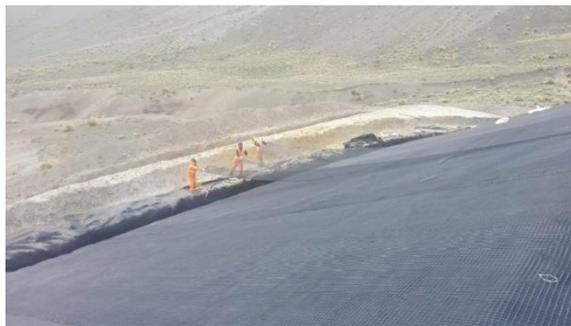
Fig. 16: Biaxial tensor installation.

As a fourth layer of geosynthetic, a biaxial polyester tensor was installed on the slopes, with the purpose of joining the geocell and confining the topsoil on the slopes, this benefited the stability of the cover, the tensor was anchored in trenches located on the dump platform.

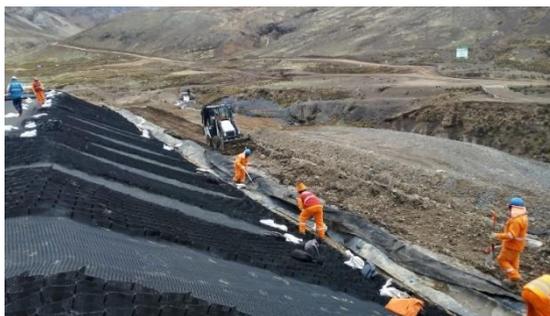
Fig. 17: Geocell installation.

The last layer of geosynthetic, the 10 cm high HDPE geocell was installed, which complemented the system with the tensor, the union of both materials was with Nylon ties. Figure 17 shows the placement of geocells on the tensor, which were laterally and longitudinally joined with nylon ties.

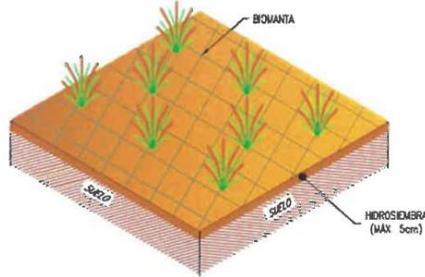
Fig. 18: Topsoil placement and revegetation.

Made up of hydroseeding and biodegradable mulch, this type of cover was used in areas where clearing and rocky areas with steep slopes were removed.

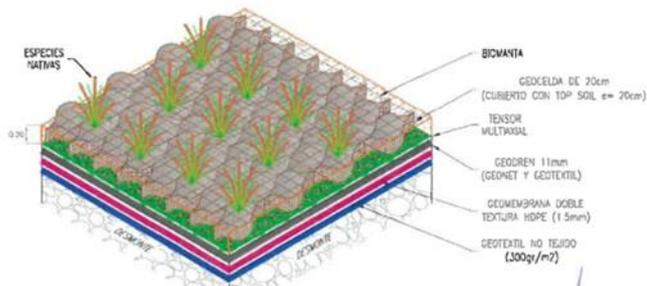
Fig. 19: Type II cover

They were used in the closure of the stockpile and on-site closure areas.

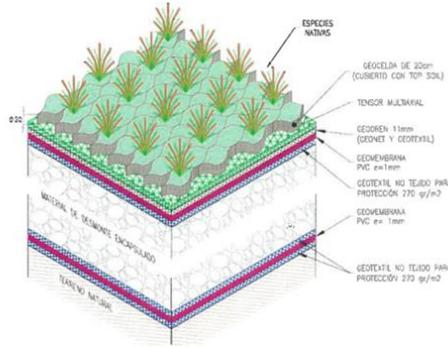
Fig. 20: Type III cover

This type of cover was used on the backfill placed at the manholes entrances.

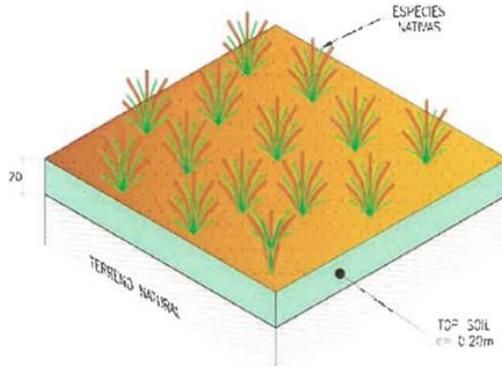
Fig. 21: Type IV cover

This type of cover was used to close the accesses except for the main access. Because the accesses must be maintained for maintenance and monitoring activities, this type of cover was used during the post-closure stage of the project.

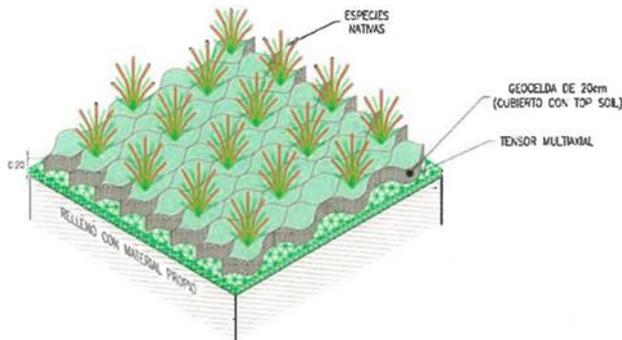
Fig. 22: Type V cover.

This type of cover was used in the closure of the chimney areas.

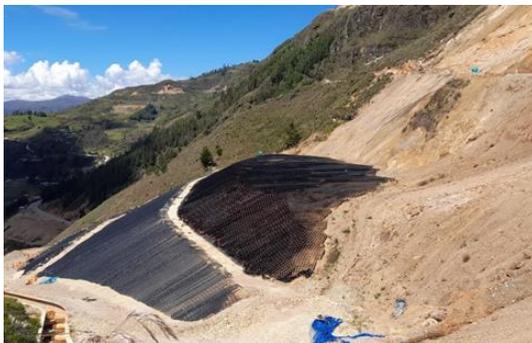
Fig. 23: Stockpile area.

In the stockpile areas, type 2 cover was used, whose geosynthetics and soil conformation was described above. The photo shows the installation of the geocells on the slope with inclination 2H.1V.

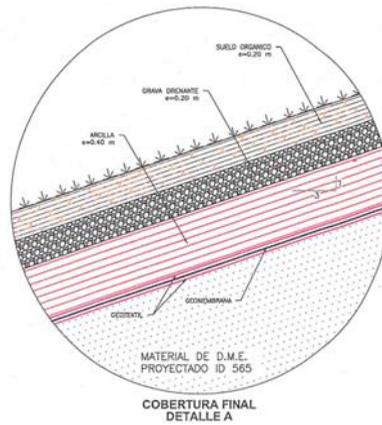
Fig. 25: Detail A: coverage in waste dump.

Detail A

Final cover of the waste dump for a 3H:1V slope.

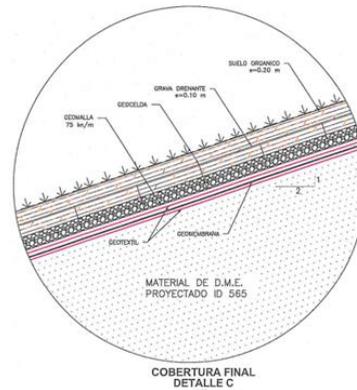
Fig. 26: Detail C: Waste dump slope coverage.

Detail C

Final cover of the starting embankment of the waste dump, for a 2H:1V slope.

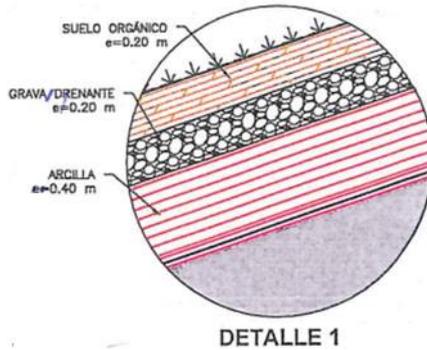
Fig. 27: Detail 1: Waste dump platform coverage.

Detail 1

Covering of the closing of the waste dump platform and sidewalk.

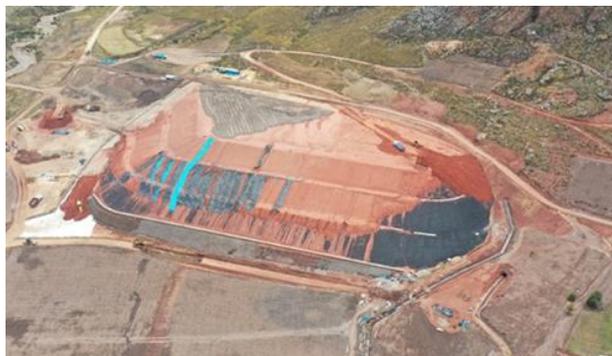
Fig. 28: Compacted clay backfills in projected waste dump.

Figure 28 shows a panoramic view of the projected waste dump, where the type A cover, mentioned above, was placed.

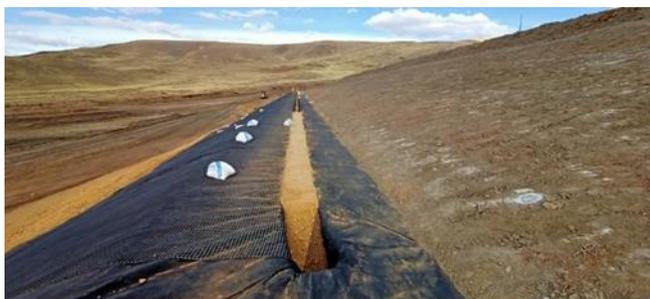
Fig. 29: Anchor trench for PET biaxial geogrid in the projected waste dump.

Figure 29 shows the placement of the PET geogrid in the anchor trench, as well as the granular backfill for subsequent compaction. It should be mentioned that the geogrid and geocell helped to improve the long-term stability of the organic soil on the slope, thus guaranteeing the vegetative growth of native species

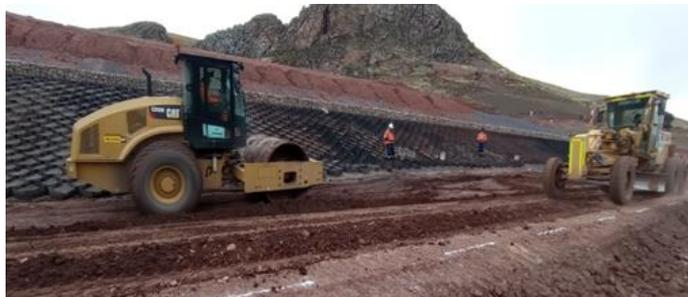
Fig. 30: Placement of geocell on slope in projected waste dump.

Figure 30 shows the geocells installed on slope with slope inclination 2H:1V, considering the type C coverage mentioned above.
