Degradation behavior of stressed polyester reinforcing products under alkaline conditions embedded in eluates and soils

Oliver Detert^{1*}, *Parviz Sadegh-Azar*², and *Matthias Strahberger*²

¹HUESKER Synthetic GmbH, Engineering Department, 48712 Gescher, Germany

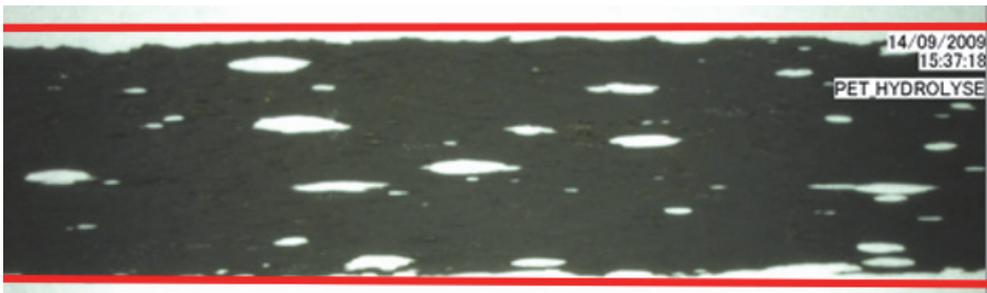
Under alkaline conditions with pH values above 9, external hydrolysis also sets in. In contrast to internal hydrolysis, external hydrolysis progresses much faster and causes surface corrosion leading to voids, cracks, and perforation. The loss of strength is disproportionately higher. Figure 1 shows a PET strand which was stored unloaded (no tensile force) in a saturated $\text{Ca}(\text{OH})_2$ solution (lime water). The red lines indicate the original width of the PET strand. Furthermore, the damage caused by external hydrolysis is clearly visible from the holes and cracks.

Fig. 1: PET strand after 4 years immersion in $\text{Ca}(\text{OH})_2$ at 50 °C without load (Greenwood et. al, 2016)

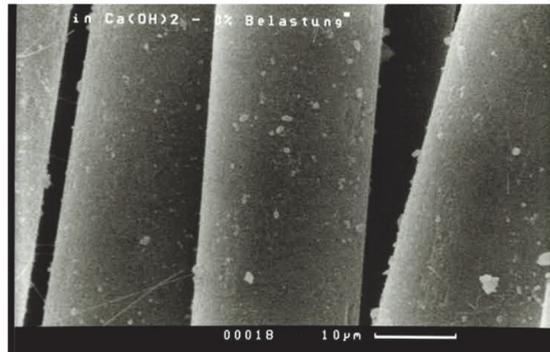
Fig. 2. PET fibres after being stored for 91 days in $\text{Ca}(\text{OH})_2$ without stress at 40°C (Müller-Rochholz and Bronstein 1994)

The images in Figure 2 to Figure 4 are taken with a scanning electron microscope (SEM). They show the surfaces from PET fibres that were simultaneously exposed to an alkaline environment (lime water, $\text{pH} = 12.6$ measured at 20°C) at 40°C and mechanical stress over a short period of time (Müller-Rochholz and Bronstein 1994).

was established between the surface structure of the PET fibres examined during external hydrolysis and the applied stress. The surface damage in (Figure 3) occurred after just 55 days at a relatively low mechanical tensile stress of 10 % of the maximum tensile strength of the material in an alkaline environment. The damage is significantly higher compared to the unstressed stored fibre after 91 days in the same eluate (Figure 2).

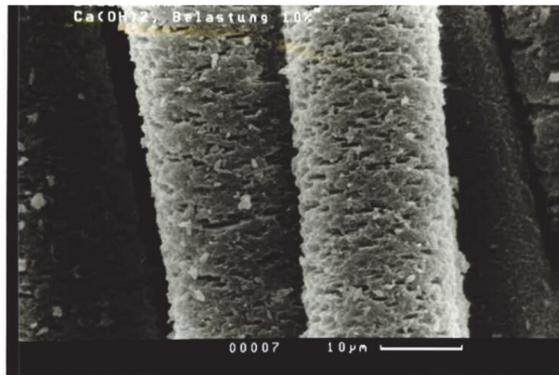
Fig. 3. PET fibres after being stored for 55 days in $\text{Ca}(\text{OH})_2$, stressed with 10% of the maximum tensile strength at 40°C (Müller-Rochholz and Bronstein 1994)

The damage patterns show the influence of mechanical stress on the formation of notches and cracks during external hydrolysis. As a result of these investigations, a causal relationship

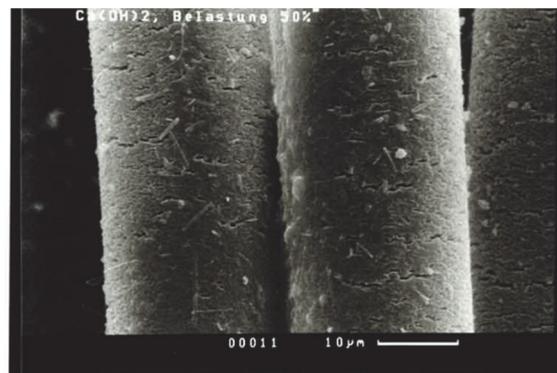
Fig. 4. PET fibres after being stored for 14 days in $\text{Ca}(\text{OH})_2$, stressed with 50% of the maximum tensile strength at 40°C (Müller-Rochholz and Bronstein 1994)

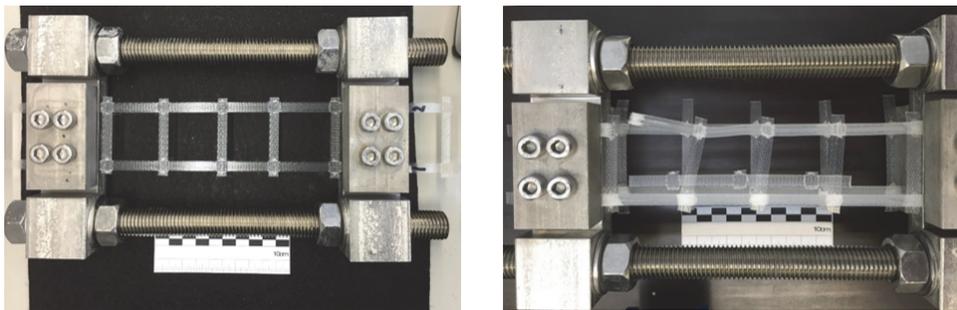
Besides the pH-values and temperature, also the specific surface area has an influence on the degradation process. To analysis this, geogrids made of PET strands have been tested. The samples have been tensioned by 35% of their ultimate strength, which corresponds approximately to the design strength of the material. In a first test series the samples have been placed in an eluate at 50°C and a pH value of 11,7. Figure 5 shows the geogrid sample before and after testing. It can be observed that the former transparent strands became milky, which is because micro cracks occurred in the material and changed the light refractive index. The whiter the surface the more micro cracks have appeared. After 28 days under these conditions the geogrid failed.

Fig. 5. PET strands loaded by 35% (approximately the design strength) at 50°C in an eluate with a pH value of 11,7 (left picture before testing, right picture after 28 days in the eluate)

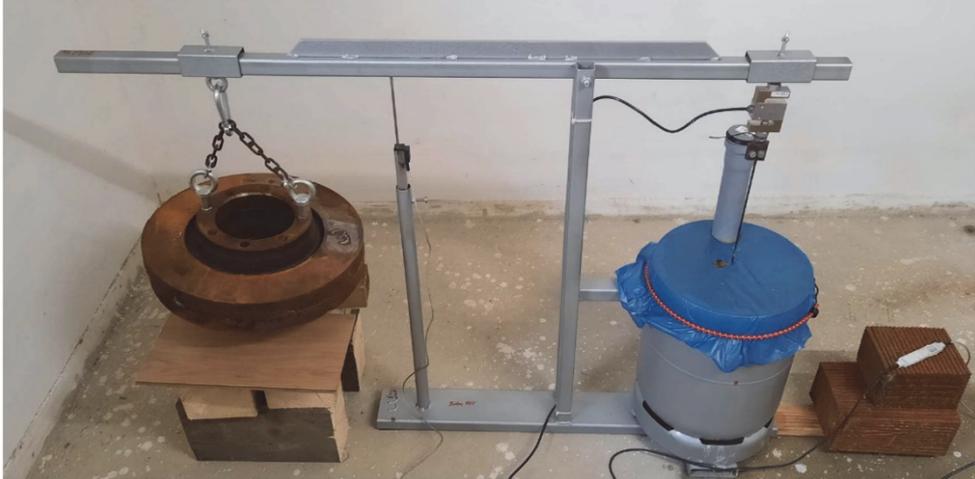
Fig. 6. Test device for testing loaded geogrid samples embedded in soil

Figure 6 shows the test set up. The geogrid sample is fixed at the bottom of the right container and to the horizontal bar at the top of the device. The grey container is then filled with soils. Via the horizontal bar and a counterweight, the geogrid sample is then stressed. The tensile load in the geogrid sample is measured via a load cell which is located between the horizontal bar and the geogrid sample. To compensate for deformations and tilting due to (creep) deformation and to keep the load constant, the fixings on the horizontal bar are designed to be movable. The container with the soil is then partially filled with water, so that the lower half of the soil is saturated and the upper half of the soil partially saturated. The water level is controlled by an overflow pipe in the centre of the tank. To reduce the water evaporation, a cover folie is attached to the container. A displacement transducer is attached to the device to determine the exact time of breakage. The pH value in the tank can be continuously monitored via a PVC pipe.

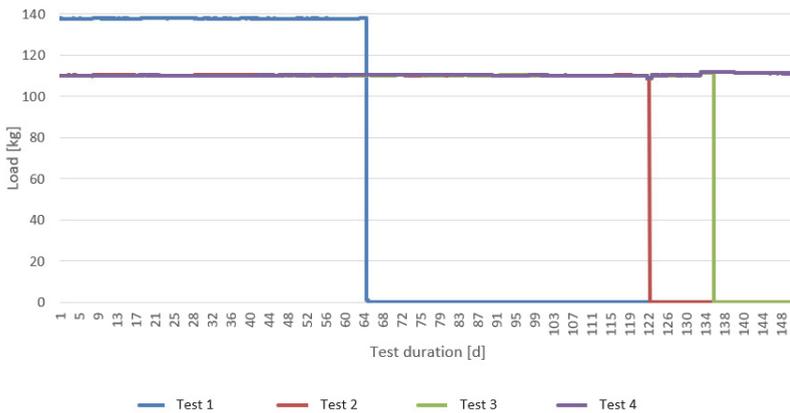
Fig. 7. Test results for test 1 to 4 – time until rupture

In figure 7 the load of the geogrid is shown over the time. At the moment of rupture, the load drops down to zero. As expected, test 1 breaks first due to the higher utilisation degree. The difference between test 3 and 4 and the difference between test 2 (only eluate) and 3 are in the same range, so that therefore no differentiation between those three tests can be done. The rupture of the embedded samples occurred in the partially saturated zone as well as in the saturated zone of the soil, as shown in figure 8.

In total 4 tests have been executed so far. A lime-sand mixture was used as soil material. The pH-value of this material was in between 12,6 and 12,7 and the temperature in between 13°C and 19°C over the duration of the tests. In test 1 the load ratio was 50% in test 2, 3 and 4 40%. Tests 1, 3 and 4 were with soil and test 2 only with the eluate. Tests 3 and 4 are identical. The results can be seen in figure 7.

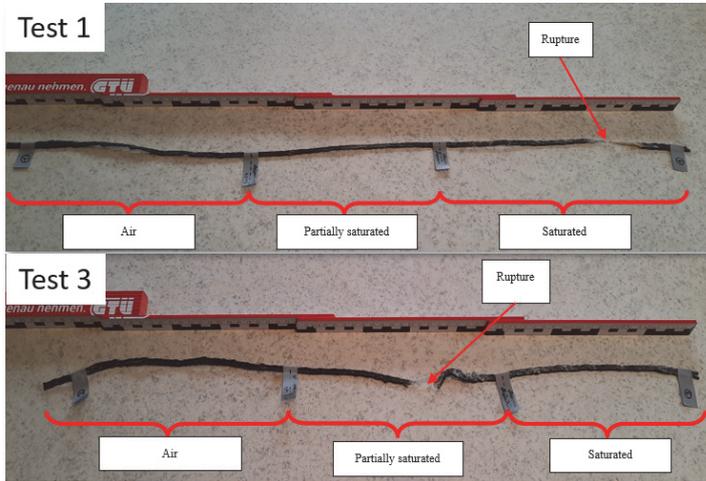
Fig. 8. Location of the rupture in the soil

Based on the limited number of tests it seems, that it does not play a role if the geogrid is embedded in the partially saturated or saturated soil or just in the eluate. As soon as the pH value is high and the geogrid under tension a degradation process of PET elements starts.
