Detection of Rail Defects Using Phased Array Ultrasonic Technique

Abstract. The Phased Array Ultrasonic Technique (PAUT) is an advanced non-destructive inspection method that utilizes an array of ultrasonic testing (UT) probes consisting of several small elements. The laboratory used an artificial crack on the rail steel grade 900A/ R260 test block to study the principles of PAUT and how to measure the defect's reliability and accuracy. On-site studies were done on railroad tracks with different structures. Rail steel grade 900A/ R260, Hadfield steel, and thermite welded joints. No defects were found during the inspection at the crossing nose of the two positions. Only a darker shade of color in the area has an impact load from the wheel applied when a train changes to another direction. Inspection was also performed for the Thermit welded rail joint with two position defects. The inspection results found defects such as porosity, with an echo (A%) value exceeding 80%, but it does not require rejection according to the BART standard.

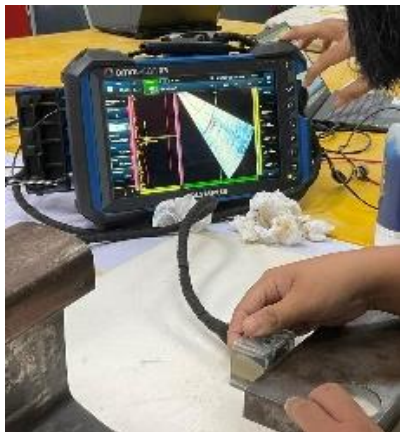
Fig. 3. OmniScan™ X3 64 Phased Array and TFM Flaw Detector with Advanced Capabilities

OmniScan™ X3 64 Phased Array and TFM Flaw Detector with Advanced Capabilities connected with a cable for the probe head and connected with the probe head is shown in Fig.3. As for testing, the laboratory will calibrate with steel prepared for accurate examination. When calibrating, a couplant was dropped to bring the probe head into contact with the steel. Then, PAUT was used to inspect the rail steel profile cross-section BS100A with artificial cracks, as shown in Fig. 4.

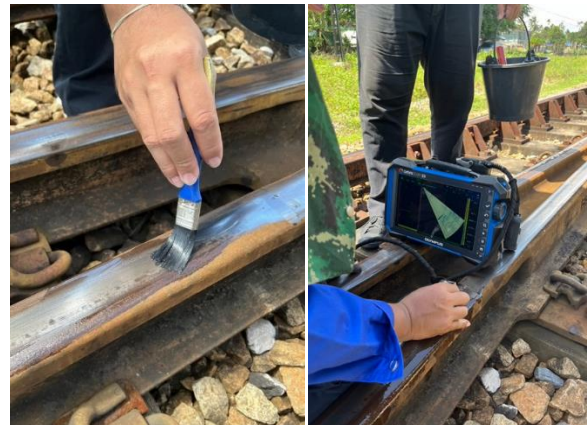
Fig. 5. PAUT at crossing nose (a) Dropping a couplant on crossing nose surface (b) the PAUT probe head into contact with crossing nose surface

On-site testing was done by OmniScan™ X3 64 Phased Array and TFM Flaw Detector with Advanced Capabilities with Probe 32 element in the bank of 16 to check the area of the frog and the thermit welding area, as shown in Fig 5. Use a couplant to apply to the area that needs to be inspected, Fig. 5(a), and use the probe to contact the area that needs to be inspected, as shown in Fig. 5(b).

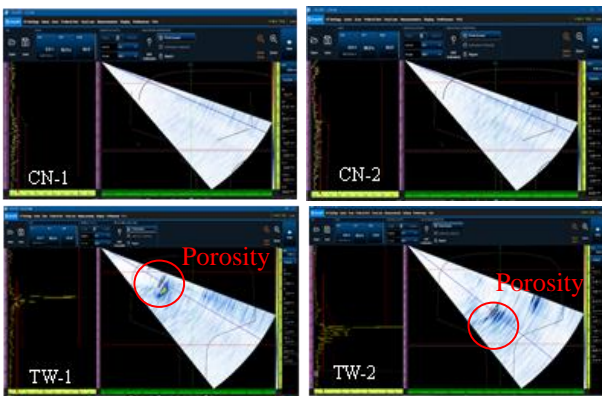
Inspection of the Thermit welded rail joint found two defects; the first has a depth of 14.49 millimeters, and the second has a depth of 31.38 millimeters, while inspection on Crossing Nose two positions has no defects but has color differences. Dark color zones are areas that have received a lot of impact force.

Fig. 8. S-scan images of the crossing nose (CN-1, CN-2) and thermit welded rail joint (TW-1, TW-2)

Table 3 shows the PAUT inspection of the A-scan section of the crossing nose in two positions and the thermit welded in two positions. It can be seen that the crossing nose in both positions has an echo value that found defect A% equal to 12.3% and 13.3. %, respectively, and the depth from the surface is equal to 21.41 mm and 16.99 mm. The distance from the probe to the defect equals 52.56 mm and 41.76 mm, respectively. Finally, the signal's angle sent through to the defect equals 66°, which has the same value in both positions.

Results from the PAUT inspection of the A-scan of the Thermit welded in two positions had the echo values found defect A% equal to 101.0% and 119.1%, respectively, and the depth from the surface was equal to 14.49 mm and 31.38 mm, according to the distance from the probe to the defect is 2.22 mm and 15.83 mm. The angle of the signal sent through the defect is 61° and 53°, respectively. It can be seen that the A% of the crossing nose is less than both thermit welded. The welded mechanism detects a defect because the crossing nose has no defect.

Following the standard of the American Railway Engineering and Maintenance of Way Association (AREMA) [13], the defects found in the thermit weld rail joint include porosity, which does not require rejection according to the BART standard [14].

Through on-site inspection by PAUT, it can be seen that no defects were found in the crossing nose area. However, the characteristics of different color intensities can be seen. Darker areas are more affected by the wheels than light-colored areas. As for the area where the Thermit welded rail joint is, two defects were found ; the first has a depth of 14.49 millimeters, and the second has a depth of 31.38 millimeters. Because Thermit welded is a weld that uses the principle of joint casting, it causes defects in the weld area. According to BART standards [14], if a defect such as crack, shrinkage, or lack of fusion is found, it will be rejected immediately. In this study, only porosity defects were found between the welding line and the rail, so there was no rejection of welds.
