Enhanced subsurface investigation utilizing electrical resistivity tomography and precise positioning tools (study case: Rongga landslide)

Moch Hilmi Zaenal Putra^{1*}, Adrin Tohari¹, Eko Soebowo¹, Yayat Sudrajat¹, Amar¹, Wahyudin¹, and Dadan Dani Wardhana¹

¹Geological Disaster Research Center, National Research and Innovation Agency, Bandung, Indonesia

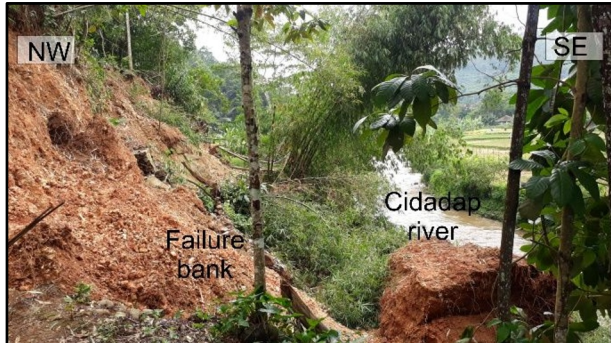
Fig. 7. Failure at Cidadap River bank

Second, river erosion at the Cidadap River bank (Fig. 7), located near the base of the slope, has likely intensified landslide dynamics. Heavy rainfall in recent months has accelerated the erosion process, exposing weathered claystone along the riverbank [13], [14]. This exposure to weathering weakens the claystone, reducing its shear strength and directly contributing to riverbank failure. The loss of bank strength further destabilizes the slope, making it more susceptible to landslides. This combination of erosion and weathering amplifies the vulnerability of the Rongga landslide area to collapse.

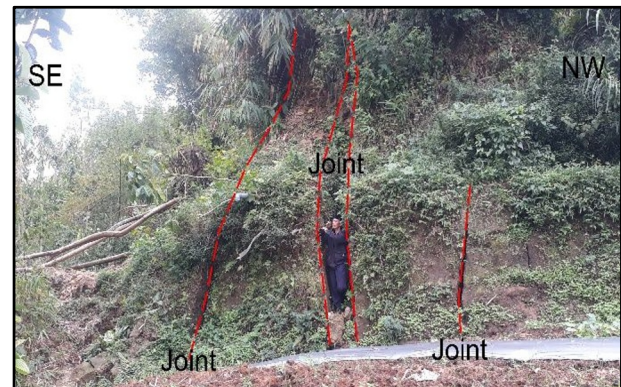
Fig. 8. Intensive joint in study area

Finally, Electrical Resistivity Tomography (ERT) results revealed the presence of a fault structure in the lower-middle region of the landslide area. This fault, indicated by the presence of joints measuring 20 to 50 cm wide as shown in Fig. 8, signifies tectonic influence in the area [15], [16]. The fault's formation is linked to an anticline with folded lithology-oriented southeast-northwest, suggesting that local tectonics contribute to the structural weaknesses in the slope. This fault structure amplifies the landslide risk, as it interacts with the surrounding hydrological and geological conditions, creating a dynamic and unstable environment prone to failure. Additionally, the fault plane's low resistivity readings on one side suggest variations in material composition, potentially indicating fluid pathways or differences in compaction and water content [17], [18]. This resistivity contrast is crucial for understanding
