Analysis of slope stability to determine the causes of collapse the primary canal in the North-Raman irrigation-area, Central Lampung

Abstract. A 25-meter primary-canal in the North-Raman Irrigation-Area (NRIA) collapsed in December 2021. Before the landslide occurred, the rainfall intensity reached 153 mm/hour. Field surveys at the time of the incident revealed that a large enough discharge overflowed from the Raman River, inundating the NRIA. This shows that landslides were most likely triggered by groundwater infiltration due to either high intensity rainfall or flooding. The soil conditions are also unable to support the primary-canal embankment. The present research objective is to carry out slope stability analysis to determine the causes of collapse of the NRIA embankment using the Geo-Slope and Plaxis 8.6 numerical models. Soil parameters are tested and measured in the field and laboratory. The safety factor (SF) at the study site is determined by both models, and then compared with the allowable SF to assess slope stability which should be bigger than 1.5 if no earthquake occurs. However, the Geo-Slope model produces an SF of 0.97. This means that the embankment is very v

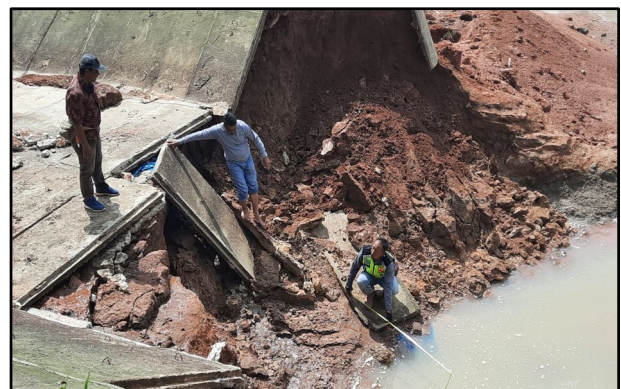
In December 2021, a 25-meter long primary-canal embankment collapsed in the North-Raman Irrigation-Area, Central Lampung, Pekalongan Regency (Fig. 1). This irrigation primary-canal crosses a river that flows to

Fig. 1. The primary canal in the North-Raman irrigation-area collapsed

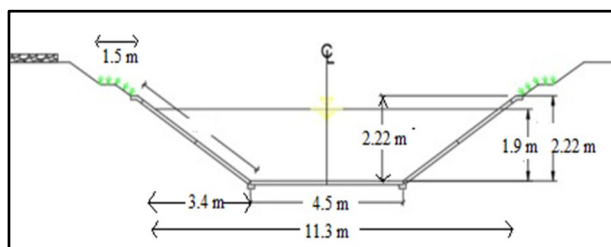
Fig. 2. Dimension of irrigation canal

The primary canal in BRU-1B at STA 5,375 has a base width of 11.3 meters, height of 8 meters, and the width of the top of the embankment is 1.5 meters. The 25-meter length of this canal which consists of a right embankment and a 4.5-meter-wide base, collapsed into the river and rice fields. As a result, the North-Raman Irrigation-Area stopped operating. In an addition, 4000 hectares of rice fields cannot be irrigated by this irrigation canal. Visually, the landslide that occurred was identified as a translational landslide where the sliding surface formed a straight line. Fig. 7 shows the condition of the channel before and after the landslide.

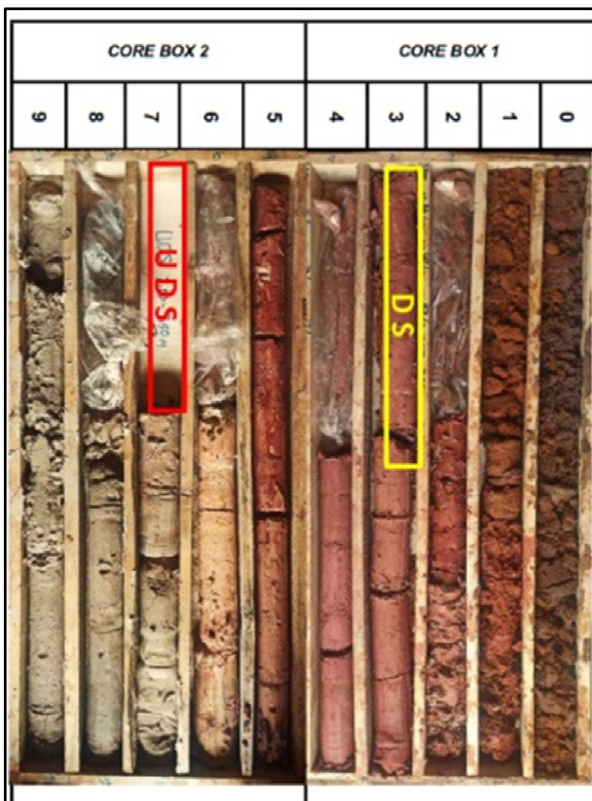
Fig. 5. Borehole sampling at BRU-1B di STA 5,375 up to 10 meters depth

rainfall data at the landslide location was obtained from BMKG Central Lampung. The rainfall station is the closest station to the landslide location. Geological data and soil properties were obtained from field surveys and the Geological Map of Central Lampung (Fig. 4). Fig. 5 depicts soil sampling (drill holes) carried out at BRU-1B at STA 5,375 to a depth of 10 meters. The required soil properties are soil unit weight γ in kN/m^3 , soil specific gravity G_s , effective cohesion c' in kN/m^2 , effective shear angle ϕ , void ratio, soil permeability, compression index C_c , consolidation coefficient C_v , average water content in percentage, and groundwater level.

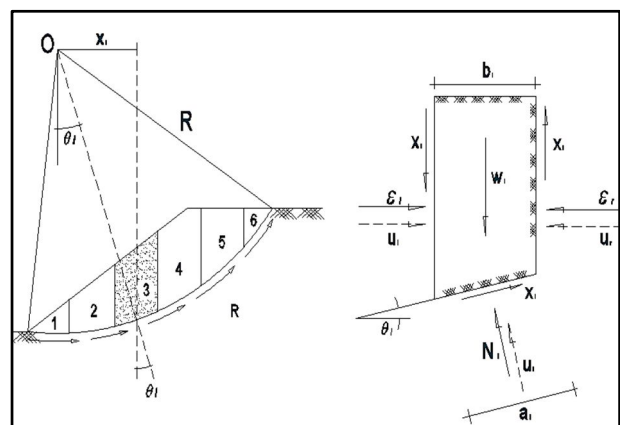
The LEM is the theoretical basis of the Geo-slope model. This method is used to predict slope stability based on the comparison between supporting forces and driving forces acting on the slope. The results of this comparison are referred to as safety factors (SF). The SF values that represent slope-stability conditions are presented in Table 1. The simplest equilibrium method is the wedge method. The wedge method is one of the most basic approaches to assessing slope stability. This method involves dividing the slope into several vertical slices and analysing the forces acting on each slice. Overall stability is then determined by adding up the forces from all the slices and calculating a safety factor. The derivation of these forces is explained in Fig. 6 and Equation 1.

Fig. 6. Dividing the slope into several vertical slices

$$SF = \frac{\sum_{i=1}^{i=n} (c' a_i + N_i \phi') R}{\sum_{i=1}^{i=n} (W_i + \sin \theta_i) R} \quad (1)$$

Where *SF* is safety factor, *R* is radius of the landslide circle (m), *c'* is effective cohesion (kN/m²), ϕ' is effective shear angle (°), *u* is pore water pressure, *W_i* is weight of the slide, $N_i = W_i \cos \theta_i$ is normal force on each slice, *a_i*

is circle curve length (m) and θ_i is slope angle of each slide.

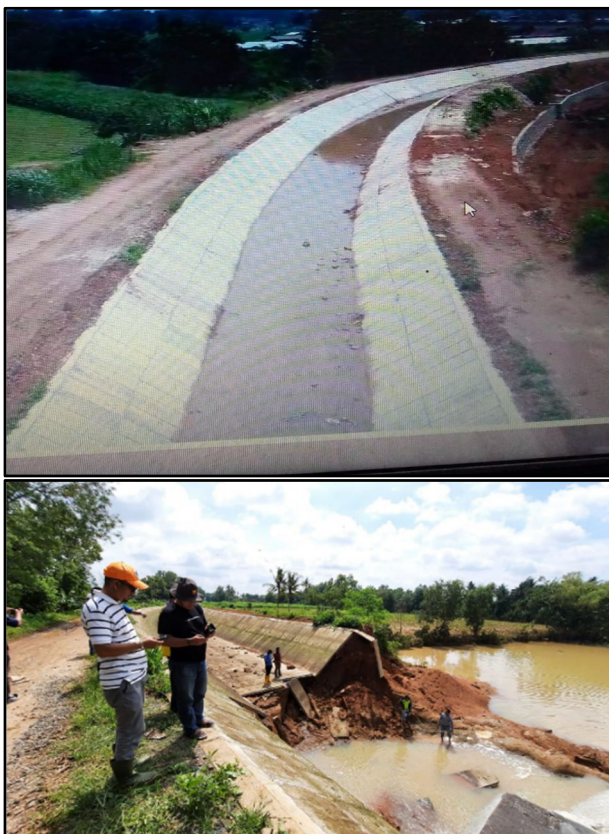
Fig. 7. The primary canal: before landslide (top) and after landslide (bottom).

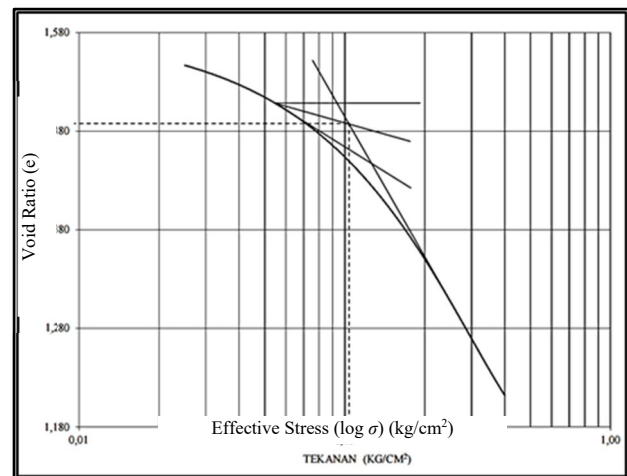
Fig. 8 presents the void ratio at the landslide location during the consolidation test. Based on the graph, the void ratio at the landslide location is 1.5. This value is quite high, indicating that the volume of voids is greater than the volume of soil grains. Therefore, it can be concluded that the high number of pores at the landslide location allows water infiltration into the soil, thereby reducing the stability and bearing capacity of the soil. The high void ratio at the landslide location causes the soil structure to become more porous and increases soil erodibility significantly.

Fig. 8. Void ratio at the landslide location during the consolidation test

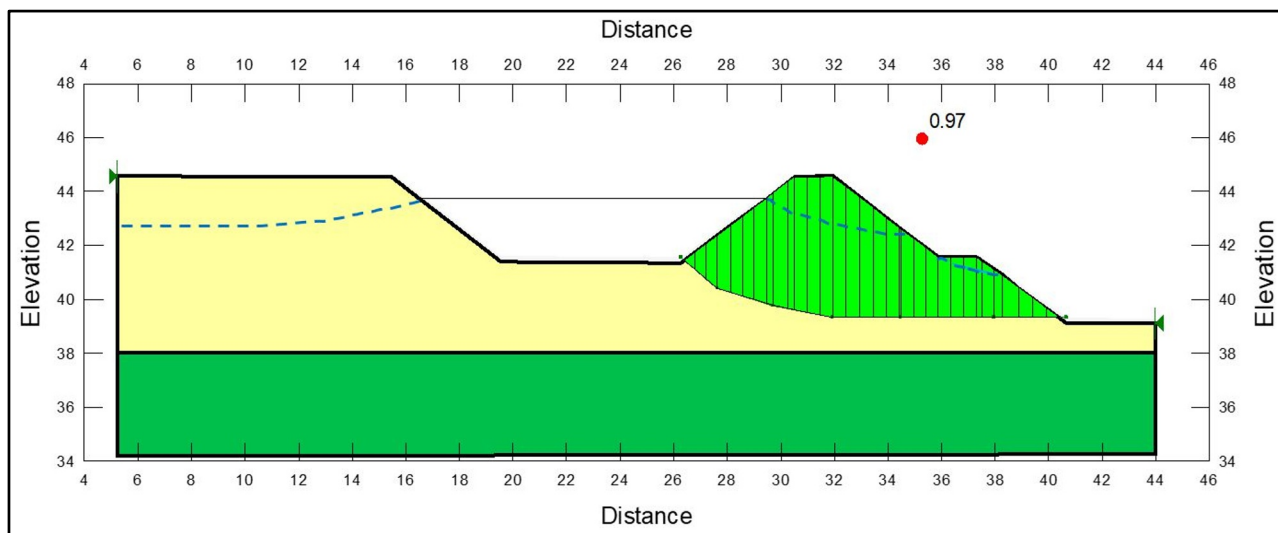
Fig. 9 shows the results of simulating the conditions of the irrigation canal-slope using Geo-slope model. The model results show that the safety factor is 0.97. Based on Table 1 regarding the relationship between SF values and slope conditions, the SF value below 1.07 indicates a high risk of landslides. Therefore, it can be concluded that the condition of the slope at the landslide location is classified as critical, where there is a high probability that frequent landslides will occur. By taking into account the SF and surface slip obtained from the Geo-slope model, these results are considered close to existing conditions.

Fig. 9. Simulation results of irrigation canal-embankments using the Geo-slope model
