# Geotechnical analysis of potential landslides on slopes in the Rimbo Panjang area of Padang City and mitigation

**Abstract.** The Lambung Bukik area of Padang City is a relocation area for the flash flood disaster in Batu Busuk Padang on 24 July 2012. This research analyzes the potential for slope failure in the Rimbo Panjang area, where many residents' houses are built on steep slopes. Geotechnical analysis was carried out to determine the soil characteristics in the Rimbo Panjang area, which was taken at four locations. The results of the classification show that the soil in the Rimbo Panjang area is inorganic silt - high plasticity (MH). The plasticity index value is 2.5 – 10.4%, indicating that the soil has low swelling potential. The activity value in inorganic silt soil is meager, namely in the range of 0.1 – 0.99, which is the mineral kaolinite and illite activity value. The activity values agree with the XRD test results, where the soil contains kaolinite and illite minerals with low swelling properties. The low swelling characteristic causes the slopes to have a low landslide potential. The safety factor value of the slopes is in the range of 1.79 – 2.71 > 1.5, so the s

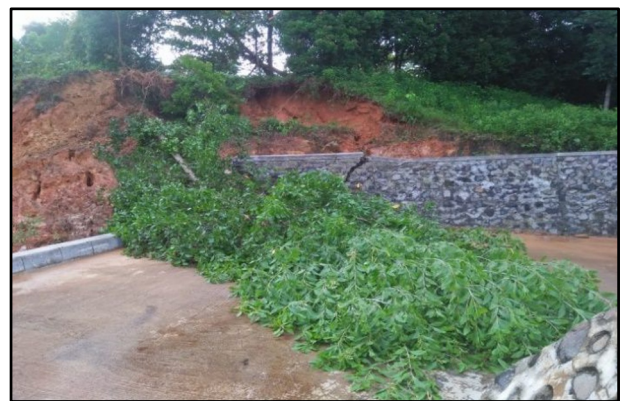
**Fig. 1.** Damage to gravity walls

High and prolonged rainfall around March 2021 caused landslides in front of the Science Techno Park building (SPT) Universitas Andalas. Landslides failed in the soil retaining wall structure, which was close to the slope where the landslide occurred. Figure 1 shows that the failure of the existing retaining wall is not caused by the dimensions of the retaining wall being unsafe against overturning, shearing, and bearing capacity but rather due to the occurrence of landslides on steep slopes that have not been provided with a retaining wall and are close to the existing retaining wall [11].

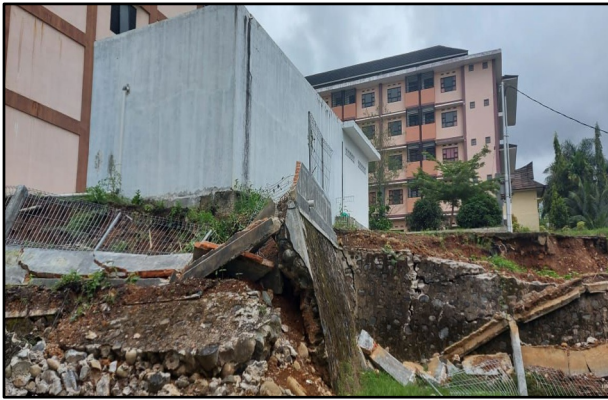
**Fig. 2.** Damage to gravity walls in student dormitories

Figure 2 shows the failure of gravity walls in student dormitories due to high rainfall.

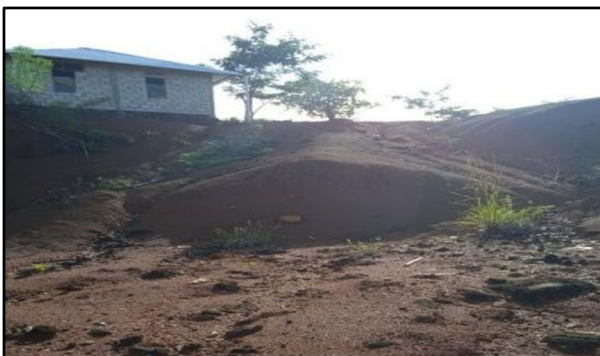
**Fig. 3.** Residential conditions in Rimbo Panjang

From the results of field visits to the Rimbo Panjang relocation area, it was found that many residents' houses were located on steep natural slopes with slopes greater than  $45^\circ$ , as shown in Fig. 3. These natural slopes are not equipped with soil-retaining structures, which is dangerous for houses built on these slopes. Steep slopes and high and prolonged rainfall are factors that cause landslides. Based on this, a problem-solving approach needs to be carried out using geotechnical analysis of potential slope failures in the Rimbo Panjang area and handling landslides.

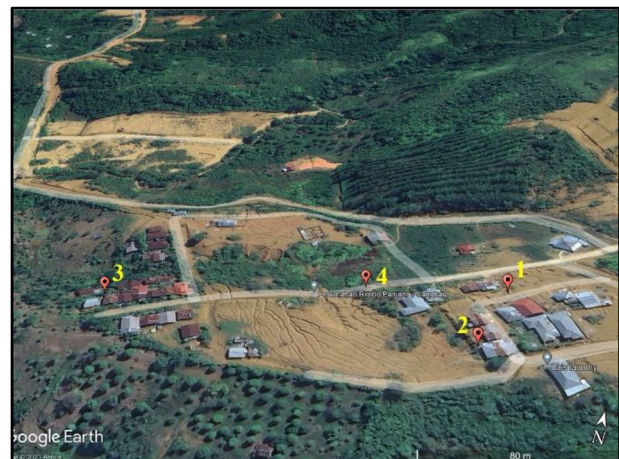
**Fig. 4.** Soil sampling area in Rimbo Panjang

In this research, a location survey was carried out to describe the sampling area. Soil sampling was carried out at four locations in the Rimbo Panjang area (Figure 4) using a hoe for disturbed soil and a sampling tube for undisturbed soil. Soil sampling was carried out for four days. The coordinates of points 1, 2, 3, and 4 on the map, respectively, are  $-0.910068, 100.450842$ ;  $-0.910476, 100.450720$ ;  $-0.910379, 100.448805$ ; and  $-0.910038, 100.450124$  as shown in Fig. 4.

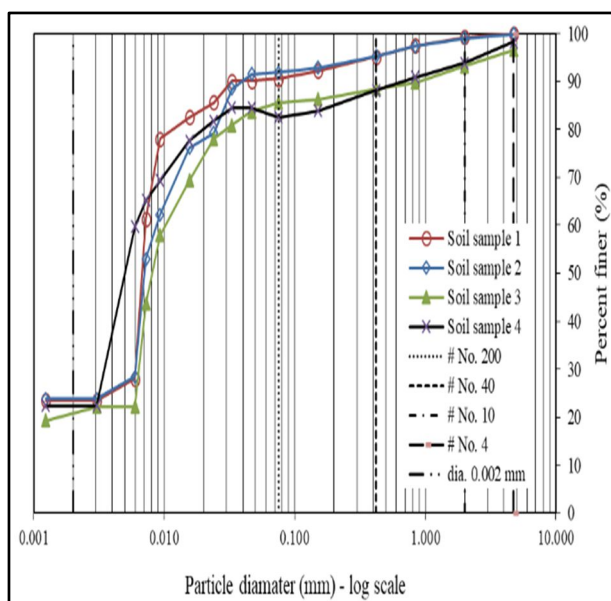
**Fig. 5.** Particle-size distribution for soil samples

Figure 5 shows the particle size distribution curve of soil samples taken at Rimbo Panjang research areas. The sieve analysis results show that the slope material in the Rimbo Panjang area consists of 60% - 67% silt, 22% - 24% clay, 9% - 15% sand, and 0 - 2% gravel. This value shows that the silt soil type dominates the slope material.

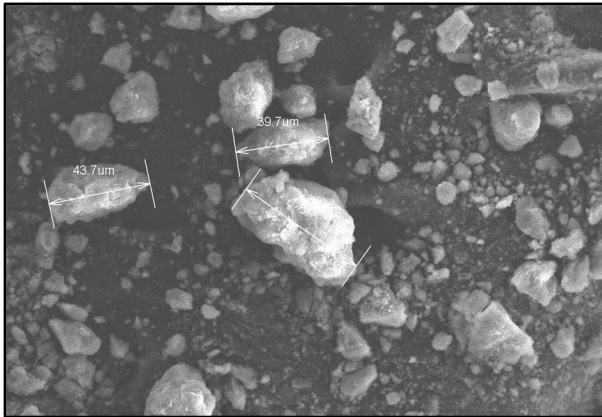
**Fig. 7.** Scanning electron micrograph of a specimen

Figure 7 shows the results of the Scanning Electron Microscope (SEM) test, where you can see the arrangement of groups of colloid-sized particles with variations in grain size with grain diameters smaller than 0.002 mm (2 μm) and grain variations greater than 0.002 mm.

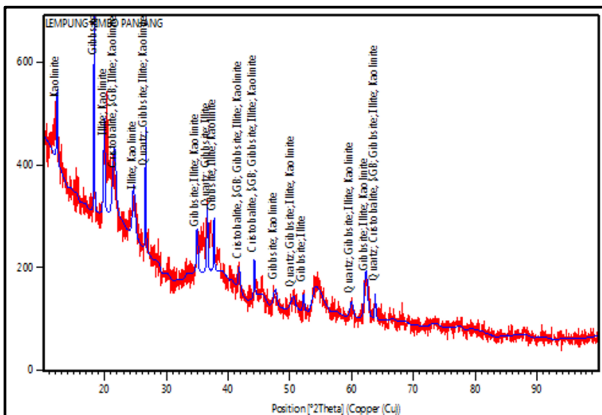
**Fig. 8.** X-ray diffraction of a specimen

Figure 8 shows the results of the XRD test on soil in the Rimbo Panjang area of Padang city. The graph shows that the soil in the Rimbo Panjang area quantitatively contains the minerals gibbsite, kaolinite, illite, cristobalite, and quartz.

The XRD test results show that the minerals found in the soil in the Rimbo Panjang area, such as illite and kaolinite, are minerals whose ability to absorb water is small, so their swelling properties are also small. When these minerals absorb water, the soil volume will increase by less. Because little water is absorbed, changes in soil volume are also small. Small volume changes do not affect the stability of the slope and do not damage the strength of the building structure that occupies the soil.
