Evaluation of the Degradation of Polypropylene Geotextiles under Real Coastal Conditions and UV Radiation Exposure

Abstract. Geotextiles are permeable polymeric fabrics used in coastal protection to allow water flow while retaining fill material. These materials are usually minimally exposed to solar radiation (UV) and other atmospheric agents, often being covered by soil or liquids. However, exposure during installation can cause degradation. This study analyzed the impacts of weathering on a polypropylene geotextile exposed to different UV radiation conditions in Natal/RN, Brazil. The samples were exposed for 29, 58, and 90 days under four conditions: on a wooden table, on beach sand, immersed in seawater, and on beach sand submerged in seawater. After exposure, tensile strength tests were conducted. The results indicated that the transverse tensile strength of the exposed samples remained within the confidence intervals of the virgin geotextile ($50.92 \leq \mu \leq 56.46$ kN/m), suggesting no significant degradation during exposure. The samples immersed in seawater exhibited the lowest standard deviation in strength, with an average of 1.993 kN/m. On the other hand, the sample

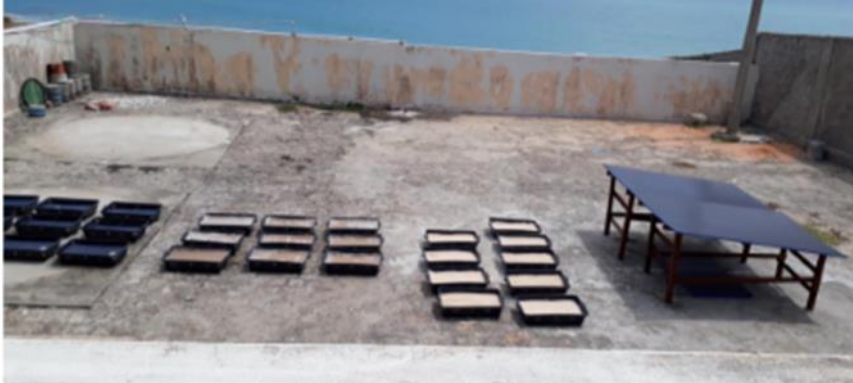
Fig. 2. Exposure location

different conditions: on a wooden table inclined at 6° (GT), on beach sand (GS), immersed in seawater (GW), and on beach sand immersed in seawater (GSW) (Fig. 2). Weekly, at different times, temperature measurements were taken on the surface of the samples to compare the thermal range of the samples with that of the environment. At the end of each exposure period, residual tensile tests were performed on the samples, using the same method as for the nominal tensile test. The degradation of the specimens was assessed through statistical interference and the definition of confidence intervals.

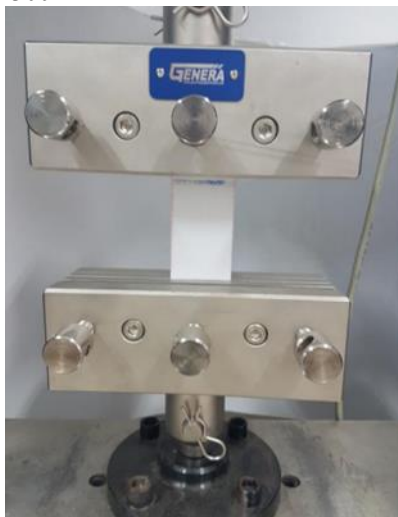
Fig. 3. Tensile Test

The behavior of the intact geotextile and after field exposure was evaluated through unconfined tensile tests using the narrow strip method, according to ASTM D5035 (2019). The tensile testing speed was 300 mm/min.

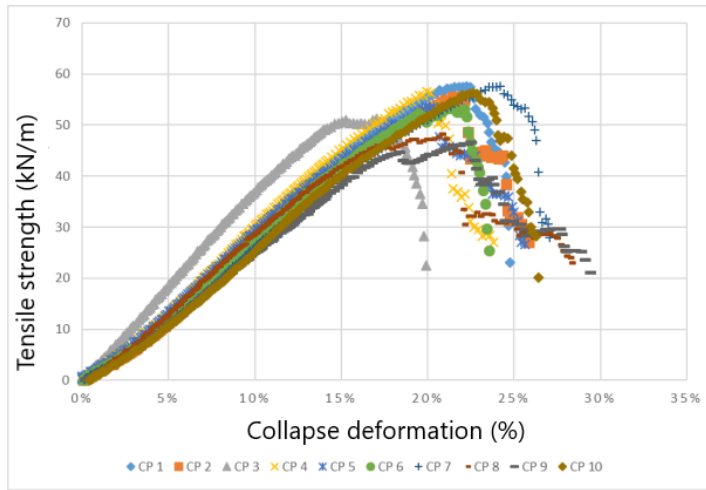
Fig. 4. Transverse Tensile Strength

Since the resistance of the group G0 was considered as the resistance of the intact material, it can be observed that the samples submerged in seawater and placed on sand (GSW) showed the worst results. However, these results are close to the standard resistance presented in the G0 subgroup. For illustration, the tensile test curves are shown in Fig. 4.

The results of the tensile strength tests in the transverse direction, conducted on the samples before and after exposure, are presented in Table 4. The analysis of the confidence intervals indicates, with 95% certainty, that the mean values of the exposed material and the intact material showed no significant differences. This suggests that the exposed geotextile did not undergo significant degradation.

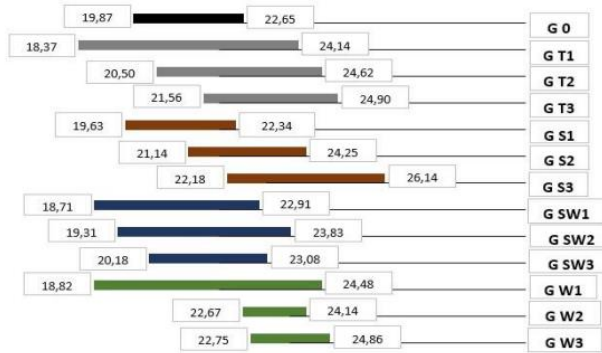
Fig. 5. Transverse Tensile Strength

Table 5 presents the deformation results at failure for the samples after the transverse tensile test. Figure 5 shows the confidence intervals discussed in Table 5. It confirms that the samples exposed to seawater and beach sand experienced greater deformations, although these were very small when compared to the intact geosynthetic.
