Slope protection using geosynthetic materials - a case study on the graveyard complex of mataram royal king

Abstract. This paper presents the study case of landslide occurred at the Imogiri Cemetery, Mataram Royal Kings Graveyard Complex. On March 17, 2019, a landslide occurred, it was expected to have been triggered by heavy rainfall of 148 mm/day intensity. The study was carried out by slope stability modelling using PLAXIS software. Based on the results of field observations and numerical analysis, the type of slope failure that has occurred is a translational landslide. The failure line is between hard soil layer that tends to be horizontal and weak surface soil. In anticipating the occurrence of subsequent landslides, a reinforcement solution is needed with a combination of Geosynthetic and bored pile at the bottom of the slope which functions as a counterweight. The output of this analysis safety factor value is around 1.55 for the static load. This design also considered the earthquake pseudo-static load, where the result of the safety factor was 1.15 and fulfilled the criteria stated in Indonesian National Standard for Geotechnic Design Requirement (the slope safety factor

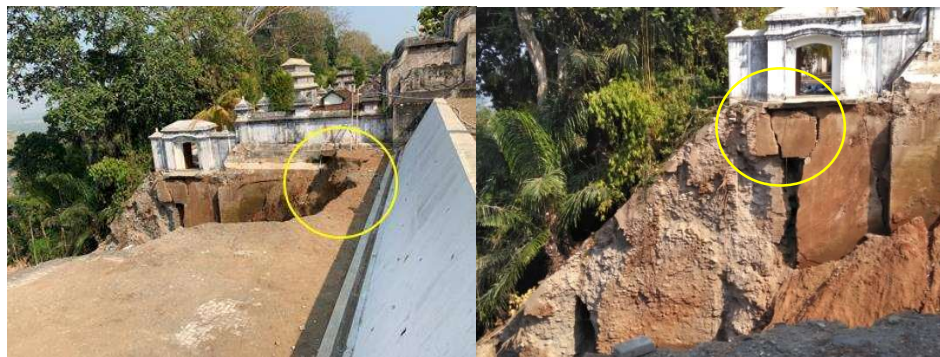
Fig. 1. Conditions at top elevation

foundations next to the landslide area and cracks that have occurred in the tomb structure above the slope (Figures 1 & 2).

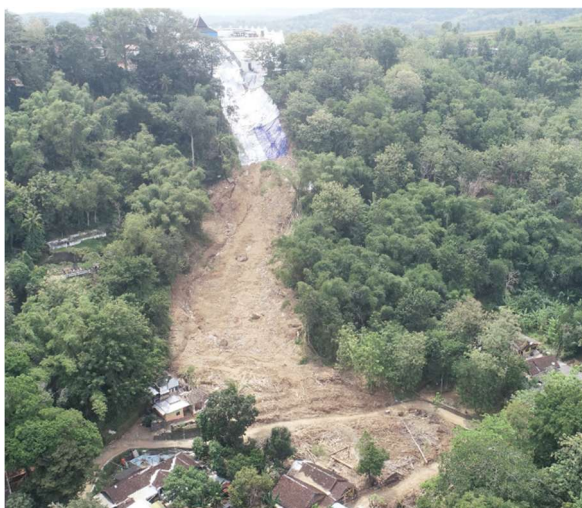
Fig. 2. Existing conditions after landslide

To reduce the hazards of landslides or stabilize the potentially unstable slope, an effective mitigation technique is needed to handle this landslide problem. The slope reinforcement applied is in the form of a retaining wall at the top and a combination of geosynthetics and bored piles at the bottom of the slope which function as a counterweight. Below is the conditions of the existing slope before slope reinforcement was carried out.

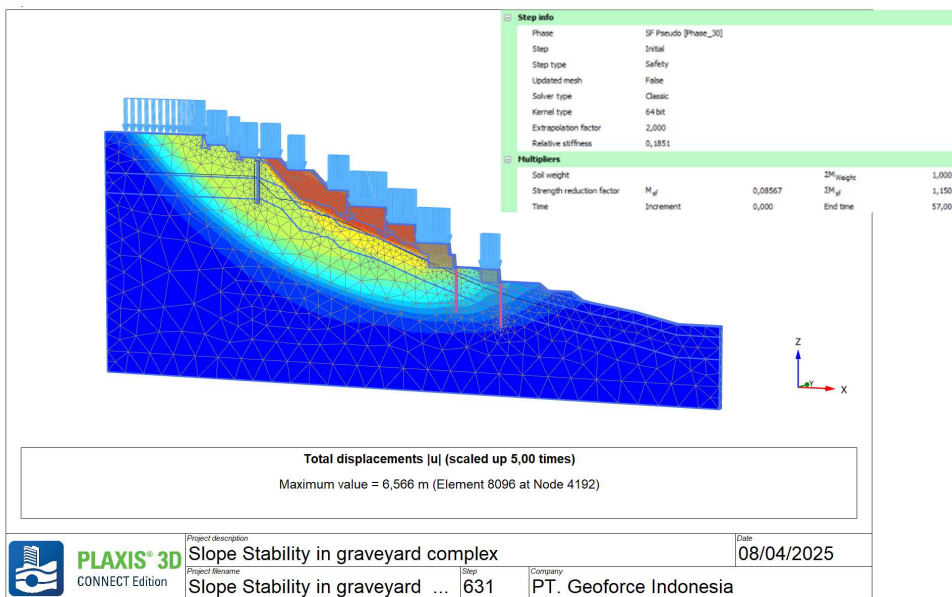
Fig. 9. Analysis results with earthquake load conditions

Pseudo-static analysis was carried out to see the safety factor in earthquake conditions with the PGA value calculated based on the earthquake map and the amplification factor obtained by the kh is 0.348g.

Identical to the previous results, the risk of collapse is still possible but has shifted to the ground surface so that the potential for the soil mass to collapse has decreased.

Based on the results of the analysis, the value of the safety factor is 1.15. The value of this safety factor is still above the SF limit value > 1.10 in accordance to Indonesian National Standard for Geotechnic Design Requirements (8460:2017).

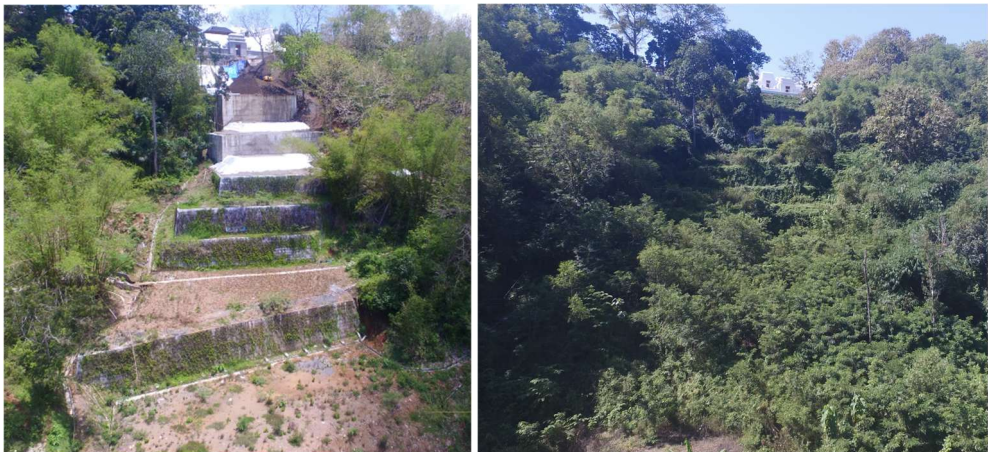
Fig. 10. Slope reinforcement several months after construction and current slope conditions

Slope reinforcement with geosynthetics has several components, one of which is found in the facing which can be a means for the growth of vines, so that the CO₂ released from the material manufacturing and installation process can be neutralized by the plants with the CO₂ absorbed and the O₂ released. This process is expected to be carbon neutral (every CO₂ released into the atmosphere from construction activities is balanced by an equivalent amount absorbed). Below is a comparison of slope conditions after reinforcement.
