# Field test of dehumidifiers for avoiding condensation in unheated historical wooden houses

**Abstract.** The UNESCO world heritage “Decorated Farmhouses of Hälsingland” represent a well-preserved Swedish regional timber building tradition from the 18th and 19th centuries, featuring wall paintings of high cultural and artistic value. The houses have remained unheated and naturally ventilated over centuries, and have relatively leaky building envelopes. Recent indoor climate measurements and observations, however, have identified occasional condensation on indoor surfaces during unfavourable weather changes in wintertime. Such condensation poses a risk of degrading the wall paintings and other valuable objects, although low winter temperatures prevent mold growth. To mitigate condensation risk, sorption dehumidifiers – working also at temperatures below 0 °C – were installed in one of the UNESCO farmhouses during a winter season. The dehumidifiers were programmed to limit the indoor air relative humidity (RH) at maximum 80 %, and their dried air was distributed to all rooms via a flexible ductwork. Additionally, climate loggers and passive tracer gas technique were employed to mea

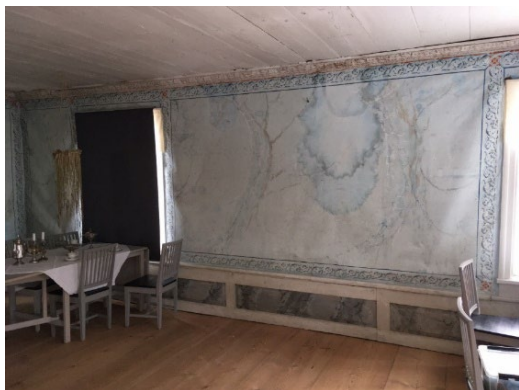
**Fig. 2.** Festivities room in Erik-Anders Farm, showing significant moisture «blooms» on the southwest exterior wall.

this phenomenon may occur sporadically each winter, often accompanied by freezing temperatures, increasing the risk of deterioration of decorations and materials. Fig. 2 displays an old miscoloring (due to water leakage) of a wall painting, which seems to have become more pronounced due to condensation/high humidity.
