Spots Identification of Natural Erosion for Hakka Rammed Earth Building: Zhang Bishi Residence Case in China

Abstract: The Hakka earth-rammed enclosed-dragon house, a distinctive architectural heritage in Lingnan region, holds immense conservation value. However, it faces numerous challenges from natural degradation and restoration complexities. This study analyzes the natural influencing factors, noting that in Lingnan, with small temperature variations, wind, rain, and solar radiation are the primary factors affecting its conservation and restoration. Using Rhino and Grasshopper, the paper analyzes wind and solar exposure conditions of Zhang Bishi's Residence, a representative case study. The simulation results align with field observations and scholarly findings, revealing that areas exposed to high wind speeds and low solar radiation suffer more severe deterioration. In contrast, the rear parts of the courtyard—shielded from wind and better lit—experience less damage. The study identifies varying degrees of natural wear across different orientations of the structure, highlighting the need for targeted protection. Based on these insights, the paper proposes a comprehensive cons

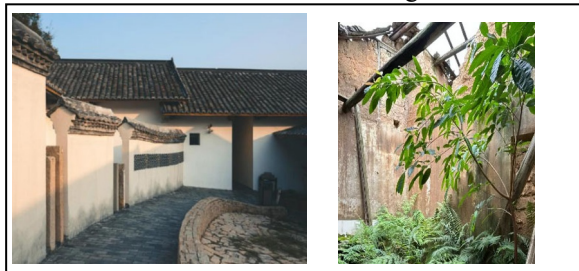
Fig. 1. Partial of well protected commercialized Hakka rammed earth house and the unwell protected registered rammed earth house in Lingnan (Source from the Author)

Regions such as Meizhou, Heyuan, and Huizhou in Lingnan are primary areas where Hakka earth-rammed enclosed houses are distributed, representing precious earth-rammed architectural heritage [6-7]. Government departments and local organizations have also implemented some proactive conservation measures. However, these traditional earth-rammed buildings continue to suffer from natural erosion and disrepair, with wall collapses being a common occurrence [8]. This phenomenon was also revealed in detail through physical surveys. Taking Meizhou as an example, although many Hakka earth-rammed buildings have been included in provincial and municipal conservation lists, such as Huiyang's Yang Jiaofu Enclosed House, Xueyuan Ancestral Hall's Dragon-Encircling House, and Jiufu Enclosed House, the situation remains severe on-site, with issues such as unrepaired roofs, collapsing walls,

and vigorous plant growth on earth-rammed walls (See Figure 1).

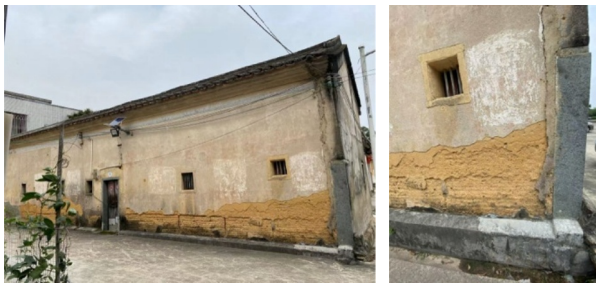
Fig. 3. The Erosion and Protection Quo of the Hakka Rammed House (Author Source)

However, Field survey results indicate that the stone materials used for the foundation are often small, ranging from 300-800 mm in size. The eaves height in front of the hall is 3.175m, with an eave’s width of approximately 1.220m. The eaves height of the circular dragon’s house reaches 6.080m, while the outer eaves width is 0.380m. The wall surrounding the Sun-grain ground stands at a height of 2.040m, with an eave’s width of 0.345m. The worst erosion is the lower base of the rammed wall, especially the corner of rear enclosed rooms in the northern part of the house (Figure 3) and the roof frame and tiles are seriously damaged.

In the case study, a comprehensive comparison between field inspections (Figure 3) and simulated data analysis (Table 2) revealed that the locations of severe damage to the rammed earth walls on site (Figure 3) coincided with the locations prone to erosion based on simulated wind speed and sunshine calculations. Therefore, the classification of these locations was accurate. The approach of using data simulation to determine vulnerability levels is feasible. The vulnerability classification based on simulated analysis data and visual images can provide a reference for other rammed earth buildings, and the data can serve as a reference for rammed earth buildings in subtropical monsoon climate zones.
