# Flood Dynamics and Floodplain Alterations Over Two Decades: A Hydrogeomorphological Study of the Larbaâ River, Northern Morocco

**Abstract.** Proactive tracking of flood dynamics is essential for identifying floodplain alterations, anticipating newly vulnerable areas, and ultimately updating flood hazard maps. This study inspected changes along the Larbaâ River pathway in Taza City using the hydrogeomorphological method over a two-decade period (2006–2025). We commenced by elaborating initial flood maps based on aerial photographs from 1982 and recent satellite images from 2025. We then relied on observational insights from field campaigns in 2006 and 2025 to identify changes in natural riverland. We supplemented the initial maps with on-site evidence, including sedimentary deposits, flood marks on structures and vegetation, and eyewitness reports from community members. The results showed that floodplain sections are divided into three riverbeds (the minor bed, middle bed, and major bed), arranging them according to a hierarchy of flood risk categories: high, moderate, and low. Certain floodplain sections near the Al Malha neighborhood are significantly modified through embankm

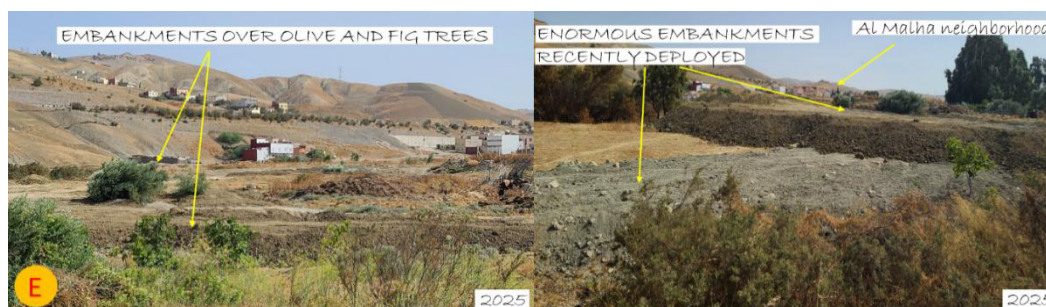
**Fig. 8.** Construction debris deposited over fruit trees in the floodplain at section E.

In some areas, farmers cover embankments with topsoil to enable cultivation (Figure 6C, C'). In other sections, residents consider these embankments effective flood barriers, leading to continued deposition and compaction of material in the riverbed. These practices have changed the shape of the floodplain (Figure 6B, B'), making the floodable area narrower and less able to handle large floods. Section F exhibits the most severe alterations, where the embankment has raised the floodplain to terrace elevation, creating a continuous surface extending to the active channel (Figure 7F, F'). Section E experiences ongoing embankment deposition over fruit orchards, including olive and fig trees (Figure 8).

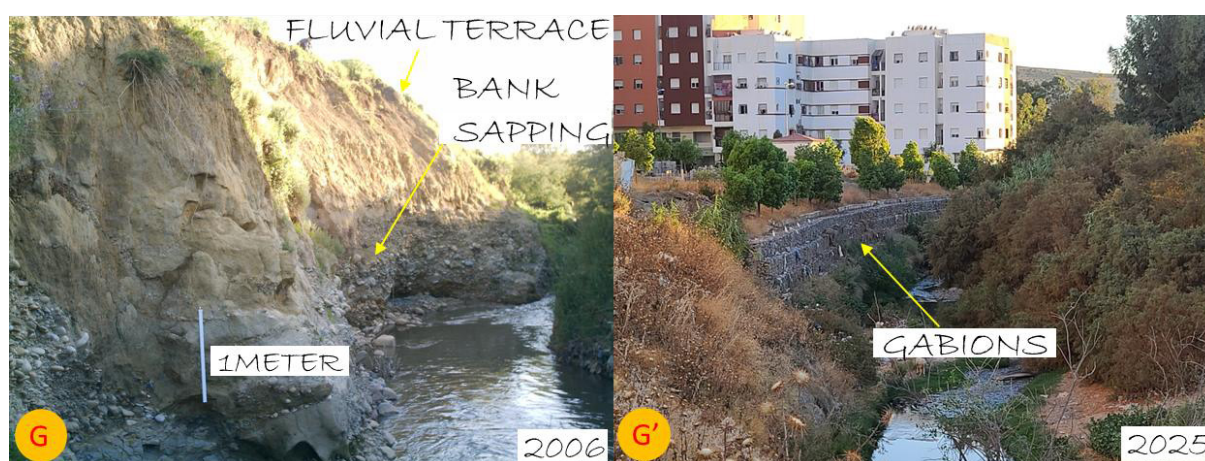
**Fig. 12.** Riverbank stabilization at section G. (G) Active bank erosion, 2006. (G') Gabion-reinforced bank with residential.

At section G, the river flows directly against the fluvial terrace, an area that has recently undergone extensive development. The river has actively eroded this bank for decades, causing progressive cliff retreat (Figure 12G). To enable development, gabion walls were installed at the bank base, and trees were planted along the cliff edge to stabilize the riverbank (Figure 12G'). This intervention has stabilized the area sufficiently to permit urban development adjacent to the river. However, this stability may be temporary. Water passes through the gabion structure, saturating the terrace base and creating persistent moisture conditions (Figure 12G'). This continuous wetting promotes groundwater circulation within the terrace, potentially increasing long-term terrain instability despite the apparent surface resilience.
