# Characterisation of the human influence of near-shore soft clay layers in site investigations

**Abstract.** Soft marine clay layers have been confined beneath thick gravel and rock fills as a result of extensive landfilling along the Stockholm coastline. These clays have been subjected to remoulding and subsequent reconsolidation under complex stress states involving both vertical loading and shear stresses induced by slope geometry. This paper presents a case study of such encapsulated near-shore clays based on CPT, CRS oedometer and CAU triaxial testing. The results show that interpreted overconsolidation ratios are frequently close to unity, while CPT- and fall cone-derived undrained shear strengths are lower than values obtained from consolidated triaxial testing. The findings indicate that standard empirical correlations developed for naturally deposited marine clays are not directly applicable to anthropogenically modified deposits, highlighting the need for adapted interpretation strategies in slope stability assessments.

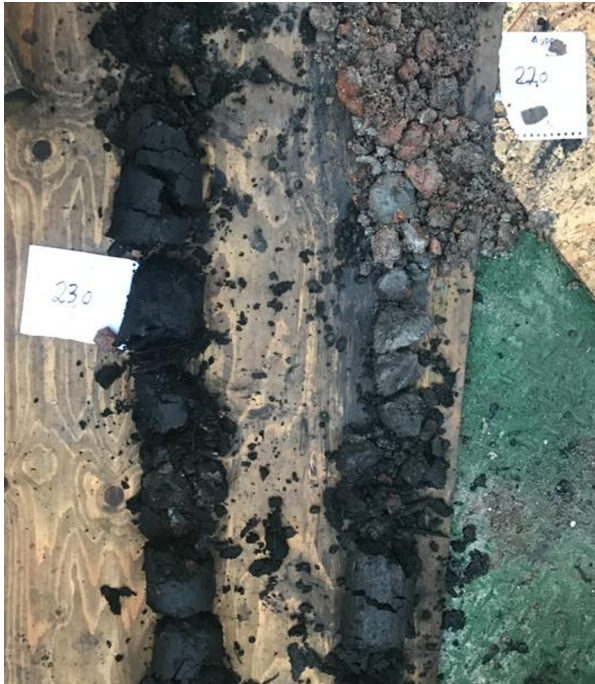
Fig 1 illustrates the interface between the encapsulated clay layer and the overlying gravel and rock layer at 22 to 23 m depth. The samples were obtained during a site investigation campaign in the centre of Stockholm. The samples in Fig 1 were retrieved using a custom-made piston sampler capable of penetrating the gravel layers. Due to frequent boulders in the fill, the transition between fill and clay is normally difficult to observe in detail.

**Fig. 1.** The interface between the encapsulated clay layer and the gravel fill layer in sample.

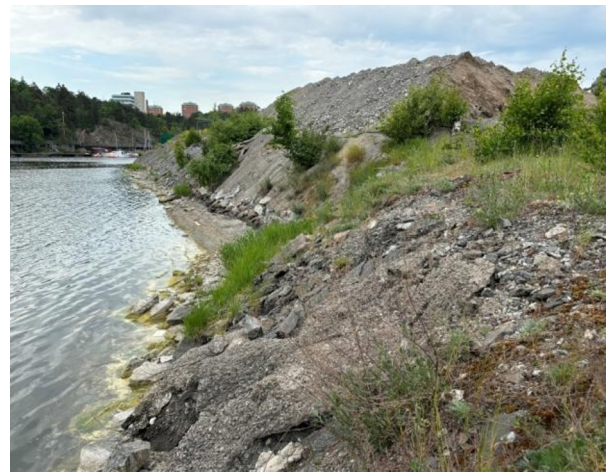
**Fig. 3.** Large piles of rock and gravel are stored in the area today.

Fig 3 shows the area today, where large piles of gravel and rock from nearby residential development are temporarily stored along the shoreline.

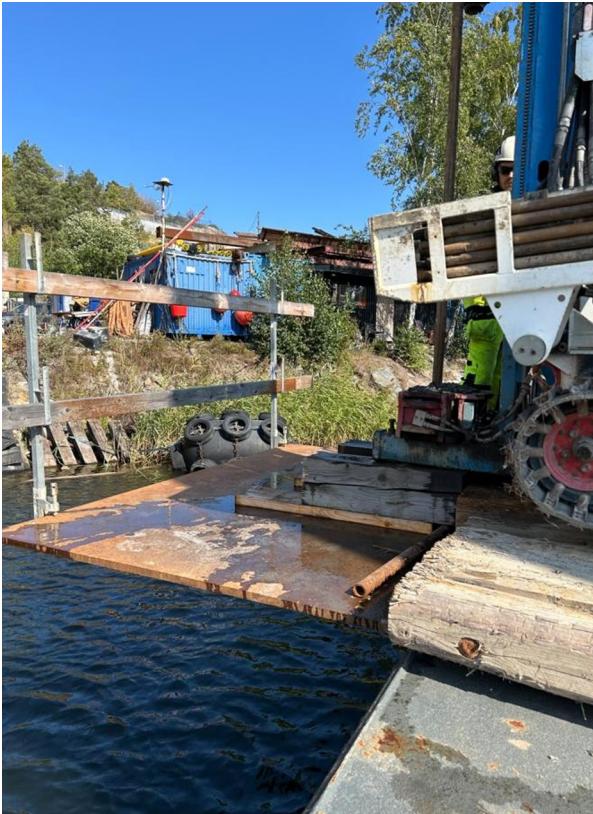
An extensive site investigation was carried out as part of the development of the area. A succession of site investigation campaigns covered the inland and the shores, with a large number of tests carried out nearshore (shown in Fig 4).

The site investigation included soil-rock drilling to determine the soil stratigraphy, disturbed and undisturbed soil sampling, and in-situ tests including cone penetrations tests (CPT). In areas with encapsulated clay, steel casings were pre-drilled through the fill to the clay layer, after which piston sampling and CPT were carried out in the clay. The pre-drilling with the casings extended from 5 m to around 20 m at some locations. The execution of the pre-drilling and the subsequent soil sampling could last one full day.

**Fig. 4.** Site investigations along the shore from a barge.

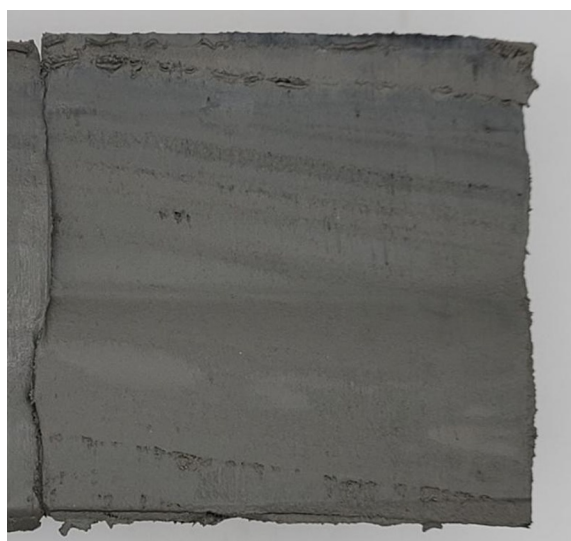
Some of the retrieved clay samples can be examined in detail to illustrate some of the features of the remoulded and subsequently reconsolidated encapsulated clay layers. Fig 7 shows a cross-section of sample A at 16 m depth. This soil layer has a 14 m surcharge load from the landfill material. The sample

has embedded layers of silt and sand, and an inclination of the layers of the soil, probably resulting from deformations in the clay during the construction of the landfill.

**Fig. 7.** A cross-section of sample A at 16 m depth.

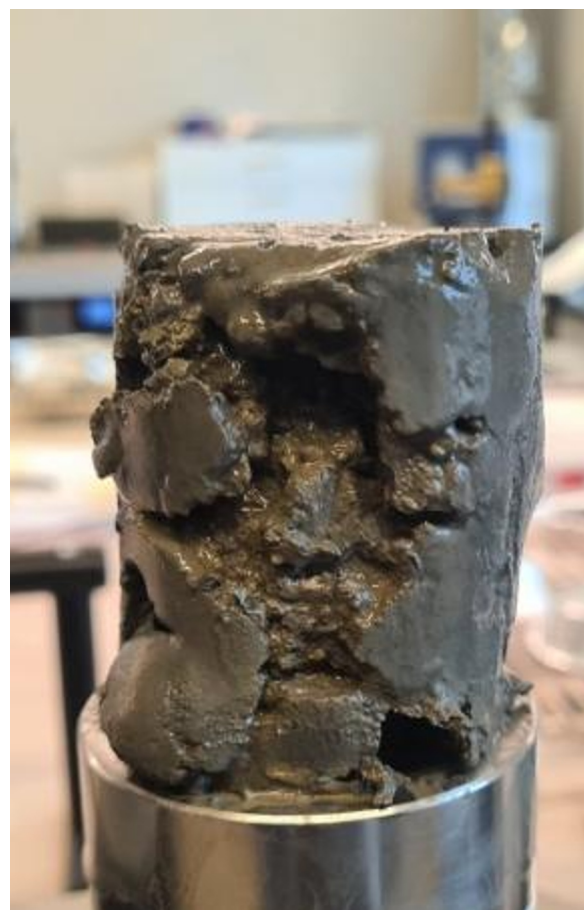
Fig 8 and 9 show sample B from a location near sample A, at 15 m depth. Fig 8 shows the sample after it was pressed out from the sampler tube in the laboratory, displaying large inhomogeneities and cavities in the sample. Fig 9 shows in the cross-section of the sample, showing large inhomogeneities as well in the sample.

**Fig. 8.** Sample B at 15 m depth after exposure of the clay from the sampler tube.

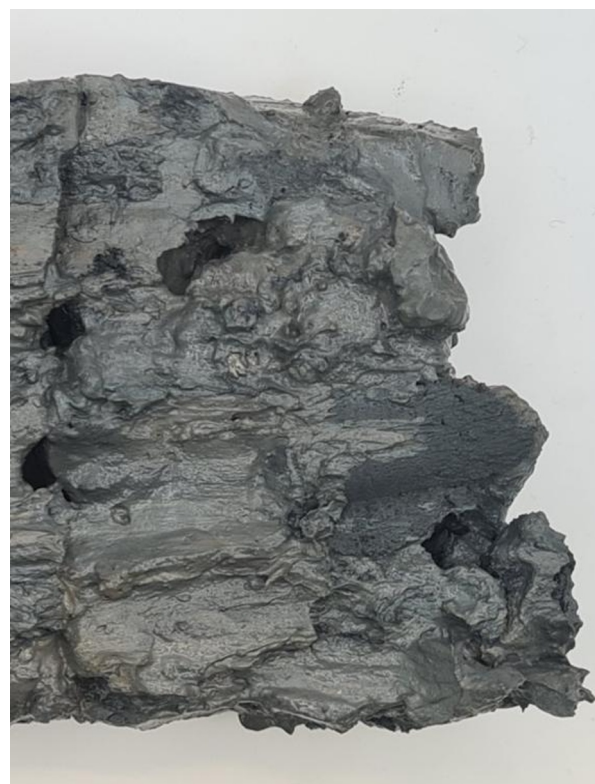
**Fig. 9.** A cross-section of sample B at 15 m depth.

Fig 12 shows a quite different response for Sample B: After an initial quick response in the encapsulated clay level in which the excess pore water pressure is comparable to Sample A, the pore pressure is reduced and approaches the hydrostatic groundwater pressure at the end of the clay layer. This shows the response of the CPT as a result of the inhomogeneity of the clay layer in sample B, which was shown in Fig 9.

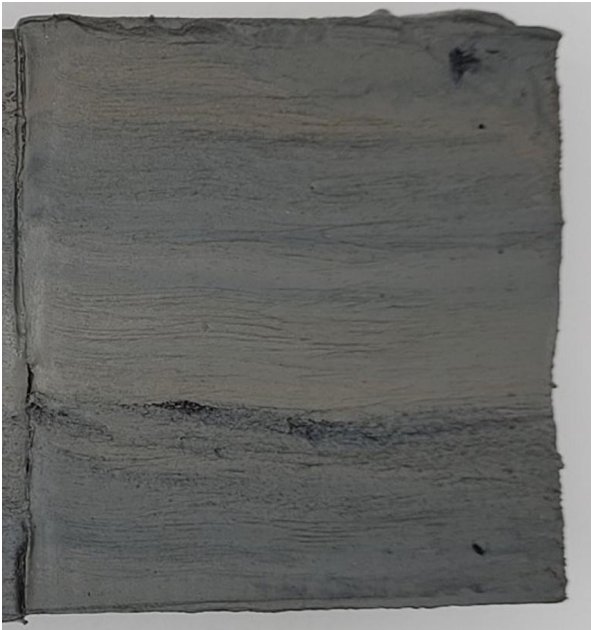
Fig 10 shows a cross-section of sample C at 12,5 m depth. This sample shows clear stratification but less inclination of the layers.

**Fig. 10.** A cross-section of sample C at 12,5 m depth.
