# US Highway 17 Hutchinson Island interchange: low-density cellular concrete embankments over soft soils in Savannah, Georgia

Guoming Lin<sup>1\*</sup>

<sup>1</sup> Terracon Consultants, Inc., Savannah, Georgia, USA

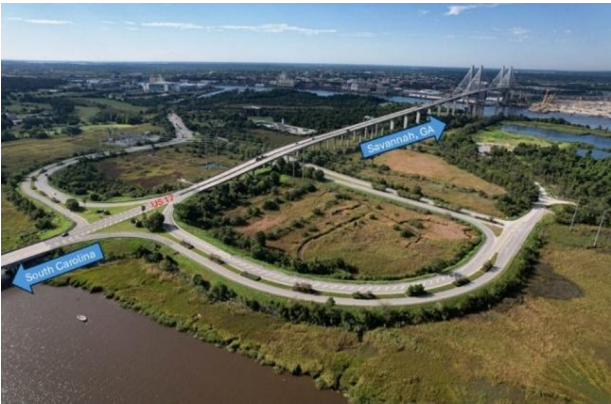
Fig.1. Overview of US 17 Hutchinson Island interchange.

US 17 traverses the eastern seaboard through historic Savannah, Georgia, and Charleston, South Carolina. After crossing the Savannah River, the interchange connects to a cable-stayed bridge via embankments up to 20 ft (6.10 m) with two symmetric loops (East and West Ramps) over low-lying marshland (Fig.1). The interchange and river bridge were originally constructed in 1954. At that time, the very soft marsh deposits were completely dredged out and backfilled with river sand, effectively controlling settlement and stability—an approach that predated modern environmental restrictions on dredging and wetlands.

Three rounds of geotechnical investigation were performed for two stages of construction. As shown in Fig.1, a Georgia Power transmission line crosses the interchange with eight towers at four stations. Borings at these towers—advanced via mud rotary methods using a CME 45 rig after placing matting over the marsh—showed subsurface conditions unaffected by interchange construction.

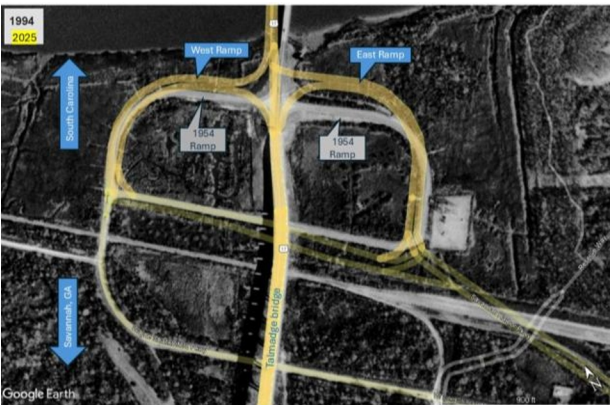
Fig. 2. Ramp layout relative to 1954 ramps.

Fig.2 overlays 2025 and 1994 aerial photographs to illustrate alignment changes. Each loop ramp is ~1,500 ft (457 m) long, descending from ~20 ft (6.10 m) near US 17 to ~5 ft (1.52 m) at the low end. Four deep borings, located mostly along the edges of the 1954 embankment, showed medium-dense sand beneath portions of the embankment (consistent with historical sand backfill). Near the toe, borings encountered soft marsh deposits, confirming that the new alignment crossed virgin marsh.

The 2001 reconstruction modified ramp alignments: the East Ramp was relocated and built largely over virgin marsh (the original 1954 embankment was

removed to create wetlands for mitigation); the West Ramp retained portions of the 1954 embankment and expanded northward over marsh (Fig.2).

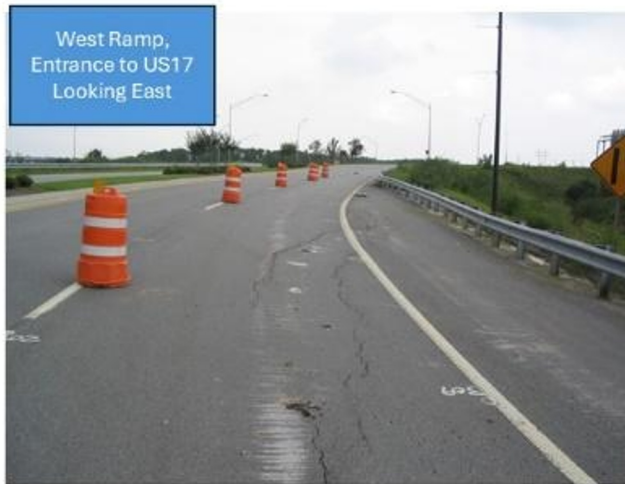
**Fig. 5.** West ramp pavement cracks in 2004.

Approximately three years after completion, the West Ramp developed a longitudinal crack extending from the shoulder to the center of the north lane (Figure 5). Six pavement cores along the crack revealed voids in two cores, shallowly beneath the pavement and up to 12 in (305 mm) in size. Approximately 1.1 cubic yards (0.84 m<sup>3</sup>) of flowable concrete was injected to fill voids [3].

Distress was not indicative of global slope instability. The evidence supports localized differential settlement where new embankment fill was placed adjacent to the preexisting 1954 embankment. Contributing factors included:

- Missing reinforcement layers and a lack of structural tie-ins at the transition between the new fill over the wick drained marsh deposit and the pre-existing embankment over backfilled sand.
- Differential load transfer between zones founded on dredged backfill sand vs. wick drained marsh clay.

Local LDCC fracturing, allowing cracks to reflect to the pavement surface.

- A series of parallel cracks from the middle of the south lane to the shoulder;
- Six pavement cores, found voids (30 cm deep) in two locations. Approximately one cubic meter of flowable concrete was used to fill the voids
- 65 survey monuments on pavements. No settlement from May 2004 to Jan 2005;

- Medium dense sands, not soft clays, underlay the ground below the embankment—consistent with 1954 dredged backfill.
- No geofabric reinforcement was encountered beneath the distress zone.
- Additional voids were found within the LDCC layer.
- Sixty survey points monitored for >6 months showed no movements; the cracked lane was closed for observation.
- No further surface settlements were detected, and pavement elevations remained level. Nonetheless, additional localized surface collapse occurred about eight years later, requiring saw cutting, void filling, and surface reconstruction.

3. Provide structural tie-ins—e.g., high-strength geogrid/geofabric, metal or fiberglass ties, or other mechanical connectors—to bridge transitions and distribute shear/settlement strains across the LDCC layer.
4. Detail LDCC with reinforcement or overlays (e.g., geosynthetic interlayers, crack arrestors) where settlement gradients are expected, to mitigate crack reflection to the pavement.
5. Plan staged construction rigorously and avoid schedule-driven compromises that shorten consolidation periods.
