# National road cliff protection analysis in Malibau Anai after Anai River flood, West Sumatra

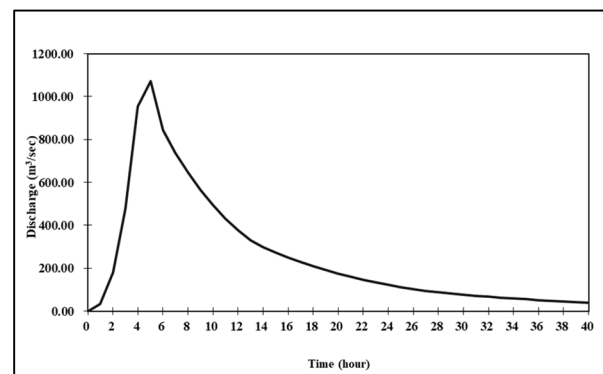
flood discharge ranges from 853 m<sup>3</sup>/s to 1,327 m<sup>3</sup>/s as shown in Fig. 2.

**Fig. 2.** Flood discharge graph

This difference reflects the complexity of hydrological dynamics from upstream to downstream of the river. Hydrological model simulations were also conducted to predict the impact of flooding on river bed erosion and cliff stability [8-10]. The simulations suggest that these hydrological fluctuations may increase erosion patterns and landslide risks [11].

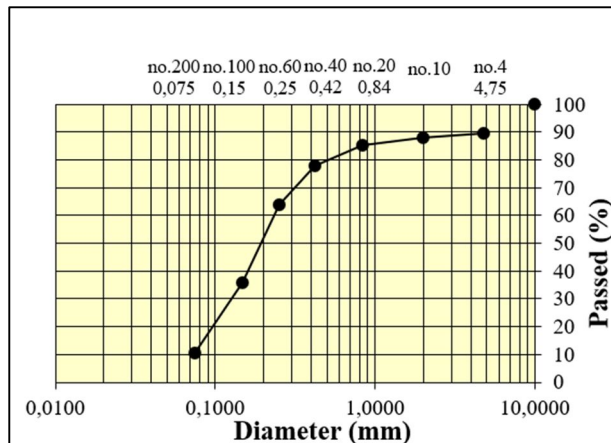
Based on the results of the sieve analysis, the disturbed soil sample from the Malibau Anai location contains 10.43 percent gravel/rock, 78.87 percent sand, and 10.70

percent fine-grained soil (clay/silt). With the gravel/rock percentage of below 15 percent, this soil is categorized as sand type (Fig. 4).

**Fig. 4.** Grain size distribution of the Anai River sediment filter test

The soil composition has significant implications for protecting the cliffs along the National Road in Malibau Anai, particularly following the flooding of the Anai River. The soil in these areas is predominantly sand, which has lower stability compared to coarse grained soils such as gravel. Sand is more susceptible to erosion, especially when exposed to strong water flow, during and after flood events.

The high sand content (78.87 percent) indicates that the cliffs around the national road are at significant risk of erosion, especially during heavy water flows after floods. This can reduce the stability of the cliffs, thereby increasing the risk of landslides and damage to the road infrastructure [4]. Therefore, implementing effective cliff protection measures, such as structural reinforcement and efficient drainage systems, is crucial for reducing the risk of landslides and ensuring the safety of national roads in Malibau Anai.

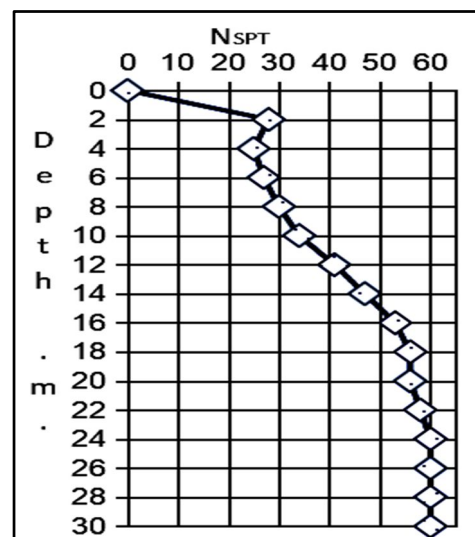
The soil test using standard penetration has been conducted in the cliff as shown in Fig. 6. Based on that test, the soil parameter then is calculated as written in Table 1.

**Fig. 6.** Nspt test result (source: redrawn after National Road Office West Sumatra)

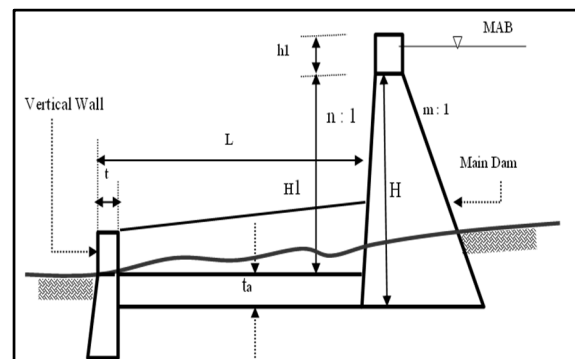
**Fig. 9.** Ground sill length on flat type

The Anai River at this location is a sediment transportation zone characterize by a steep and winding slope. The foundation needs to be strengthened to prevent erosion of the river bank wall by flood flows. This requires the construction of river slope control structures, such as a ground-sill and cliff base reinforcement, along with flow directing structures. In addition, a ground-sill should be constructed to protect the main dam from local downstream erosion (scouring), maintain the stability of the Sabo-dam foundation, and prevent the collapse of the cliffs [13]. The surface of the ground-sill should be flat (Fig. 9). The thickness of the ground sill is determined based on the erodibility of the riverbed and the size of the boulders present. In thick, soft rock layers, the apron should be set between 0.70 – 1.0 meters. If the river bed consists of sand and gravel, the thickness of the apron should be determined according to Table 3.
