The displacement of structures founded on expansive soils – unapparent causes

The article presents the method of diagnostics of structures, located on expansive soil in Bydgoszcz (Poland). The methodology and preliminary results of the measurement of displacements of a investigated construction were presented. On the basis of these results, the actual causes of damage to the diagnosed structure were analysed.

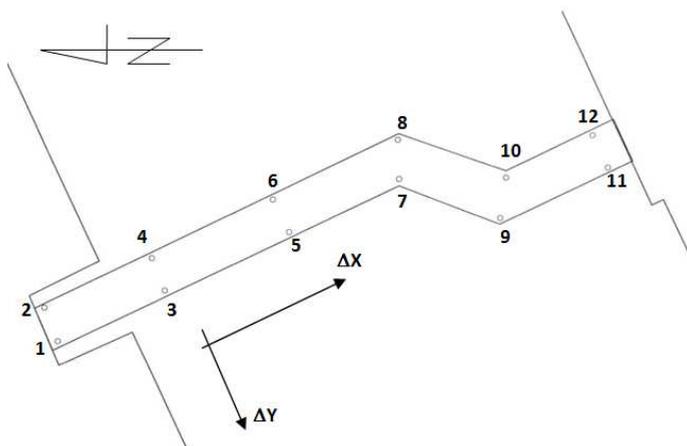
Fig. 4. Scheme of the arrangement of the structural supports.

The monitoring of both vertical displacements of supports as well as the vertical and horizontal displacements of the basic structure of the passage is foreseen. The arrangement of the supports is shown in figure 4.

The horizontal displacement was determined in accordance with the coordinate system shown in Fig. 4, in which the X axis is defined in parallel and the axis Y is perpendicular to the axis of the investigated structure.

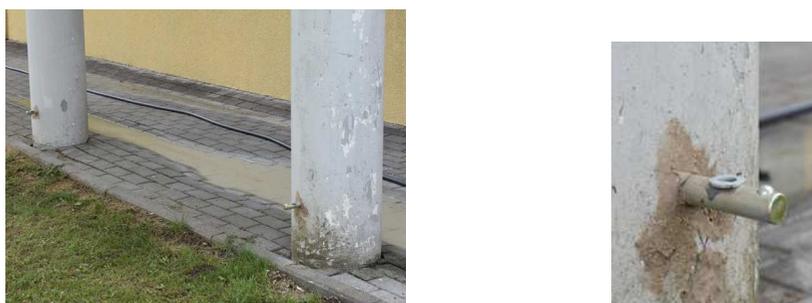
Fig. 5. External benchmarks.

The determination of vertical displacements of the structural supports was performed by precise leveling (using the Ni007 leveling tool). In order to carry out the research, a control network consisting of 15 benchmarks was set up. Benchmarks 1, 3-12 were placed at the bottom of the columns (Fig. 5) and the remaining ones, constituting a set of reference points, on stable neighboring buildings.
