Damage Analysis of Moldboard Plow

Abstract. Moldboard plow is a tool used to cultivate the agricultural land. The material of the moldboard is a double layer where the outer layer is high carbon steel and the inside is a low carbon steel. The findings on the side edge of the moldboard plow are often damaged due to bent deformation and then broken. The study was conducted to determine the cause of the damage through simulation and testing laboratory. The simulation results show that the moldboard is overloaded by its material capability. This is shown also from the results of testing the chemical composition that this material is a low-alloy steel single layer without surface hardening. Hardness tests conducted using Rockwell C show that this steel has a tensile strength of only about 400 MPa. This is reinforced by the results of microstructural observations showing that more than 99% of the phases are ferrite.

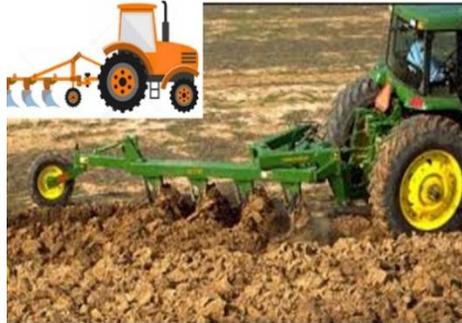
Fig. 1. Multiple moldboard plow

Currently, multiple moldboard plows are used as shown in Figure 1 (a) and (b) show the bottom of the moldboard plow. The edge of the moldboard is the most easily cracked, broken, or deformed plastic part.

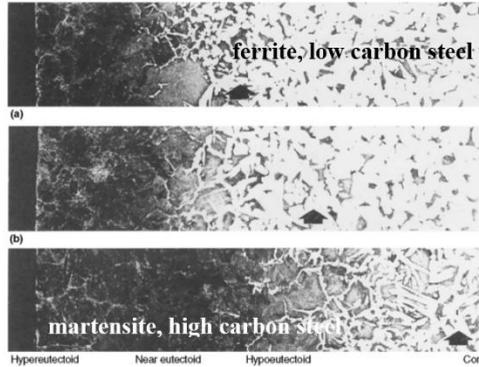
Fig. 3. Double layer microstructure consisting of martensite and ferrite [3]

Moldboard usually is made of two layers of steel. The outer layer is high carbon steel with the chemical composition are 0.9 to 1.05 %C. However, the middle layer has carbon composition of 0.08 to 1.3% [2]. Near to the surface of the double layer, the material contains martensite phase in the outer and ferrite in the inner, whereas martensite is consist of high carbon steel and ferrite is low carbon steel[3]. Figure 2 shown double layer steel.

The cause of the damage is because the composition of carbon is too low and on the outside surface is not done heat treatment on the surface of the moldboard so that no martensite phase. should the material used to make the moldboard plow has been done the addition of carbon composition on the surface through carburization process that will form martensite phase plated outside the bottom plow.
