Safety analysis of Novat tailings dam

Florian Tatu^{1,*} and Dan Stematiu¹

¹ Department of Hydrotechnical Structures, Technical University of Civil Engineering Bucharest, Romania

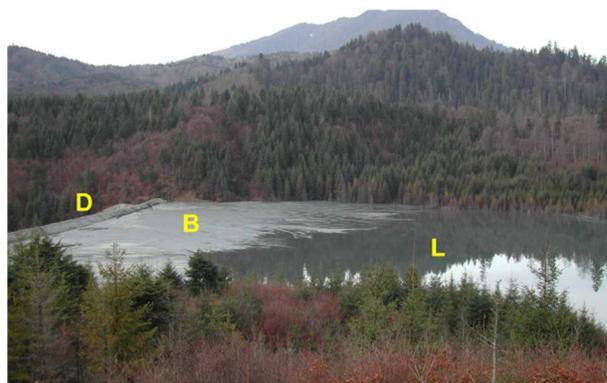
Fig. 3. Novat TDF, beach (B) embankment dam (D) and lagoon (L)

Prior to the accident, deposits from the TMF reached 802.0 maSL, with the clear water mirror reading 804.50 maSL.

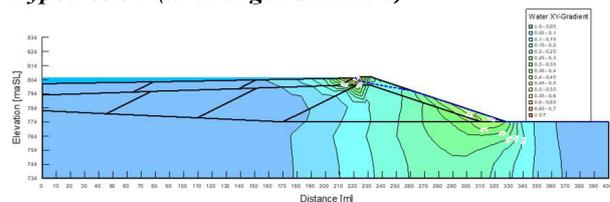
Fig. 11. Hydraulic Gradients, water level at 805.50 maSL

Hypothesis 1 (unchanged structure)

The safety factor obtained is below 1, which means that in these conditions there are problems with the stability and safety of the tailings dam.

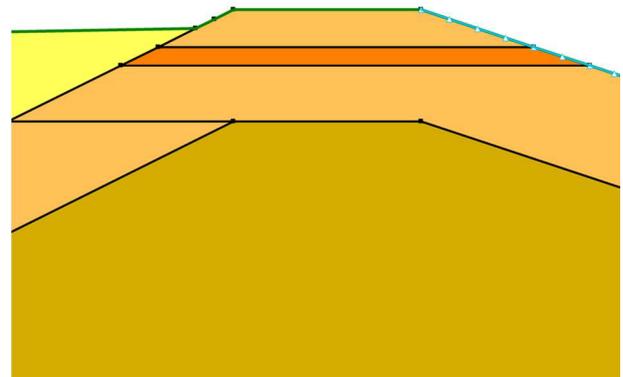
Fig. 15. Siphoning zone in the model

The siphoning area (weaker material) was introduced into the model at 2 m under the crest and with a layer of 1 m thick.

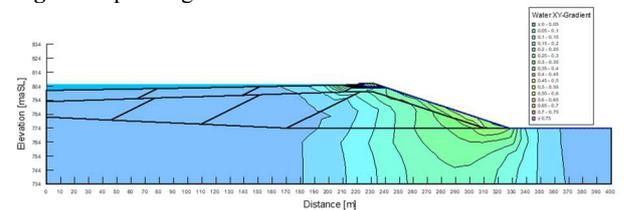
Fig. 16. Hydraulic Gradients, water level at 805.50 maSL

Hypothesis 2 (with siphoning)

The safety factor obtained is below 1, which means that in these conditions there are problems with stability and safety of the tailings dam [5].
