Considerable cracking in the foundation slab in a multi-storey underground garage

Marek Maj*, Tomasz Kowalik and Andrzej Ubysz

Wroclaw University of Science and Technology, Wybrzeże Wyspiańskiego 27, 50 370
Wrocław

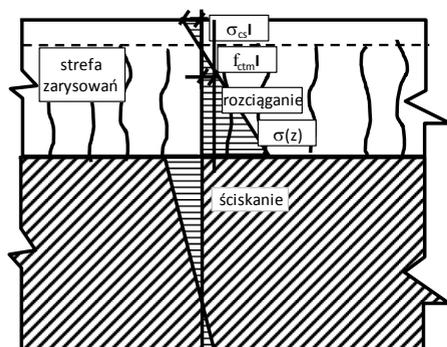
The floor, laid on a foundation slab made much earlier, is itself subject to contraction due to drying out. It has the same components of contraction that previously occurred in the slab. In the foundation slab, free contraction is restrained by the structural reinforcement, while in the floor, the contraction is blocked by its cooperation with the slab. The contact surface of the slab and the floor is not smooth, and it is additionally filled with a bonding layer. During the drying out of the floor and its contraction, this kind of connection causes an additional system of internal forces close to the surface of the slab and the floor, namely squeezing the slab and stretching the floor (Fig. 4). The resulting contraction stresses are to be transferred through the co-polymer fibres added to the concrete.

Fig. 4. Distribution of stresses in two slabs; the lower slab is older and the upper slab is younger and still maturing

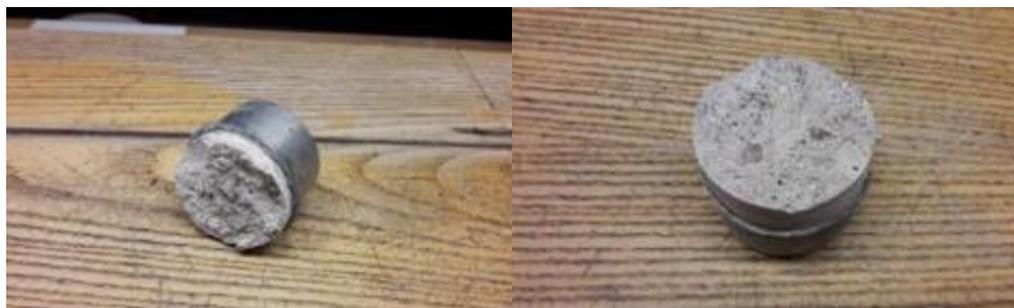
Two samples from core wells (Fig. 5 and 6) were taken from the floor and the foundation slab, and six samples were taken from the floor using the ‘pull-off’ method (Fig. 7 and 8). Control tests were carried out on the concrete floor using the sclerometric method.

Fig. 7, 8. 'Pull off' samples for strength tests
