Typical failure forms and improvement measures of power grid fasteners

Abstract. By investigating the fastening defects of power grid components, it was concluded that unreasonable design, insufficient corrosion protection, improper assembly and insufficient fastening were the four typical forms of bolt failure. In response to the above problems, improvement measures such as design review, material sampling inspection, construction supervision, and operation and maintenance inspection were proposed.

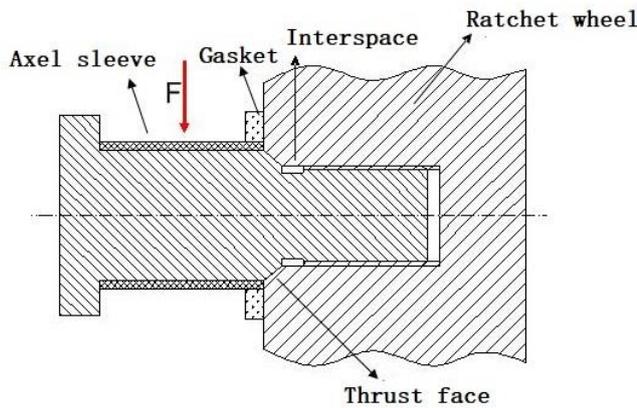
Fig. 8. Schematic diagram of correct assembly of bolts.

Fig. 7 had shown the photos of the accidental fault bolts left in the ratchet wheel. It could be clearly seen that the thrust bearing pad had a more obvious indentation left on the surface of the ratchet wheel, which could be inferred that the connecting rod bolt was incorrectly assembled. The correct assembly was shown in Figure 8. The gasket was sleeved on the shaft sleeve. It was in free contact with the surface of the ratchet and it was impossible to leave a residual indentation. In this case, the 45°bevel of the bolt was tightly coupled to the 45°bevel of the ratchet internal thread, which could effectively cushion the impact of the bolt root during the switch operation. However, the actual assembly was shown in Figure 9. The gasket was pressed under the sleeve, so that the 45°slope of the bolt could not be coupled with the ratchet. In this way, the root of the bolt would be subjected to a large impact of additional bending moment stress when the switch was opened and closed, and eventually the root of the thread undercut would have a relatively rapid early low-cycle fatigue fracture.
