Analysis of rainfall-triggered landslide in Baleagung Village, Magelang Regency, Central Java

Abstract. The majority of Magelang Regency is considered as intermediate and high susceptible areas against landslide. As happened in Baleagung Village in January 2018, a landslide has damaged local residency buildings. The landslide occurred because of high-intensity rainfall on the day before. Meanwhile, cracks formed in several areas that were indicated by the slope around the village were still actively moving. Therefore, mitigation is urgently needed to minimize the risk of further landslide movement. This study aimed to analyze the mechanism of ground movement at Baleagung Village which was affected by rainfall. This research was conducted by using back-analysis method to determine the initial groundwater level conditions and its effect on the slope stability. Soil parameters were obtained by laboratory testing and permeability tests in the field. Subsequently, rainfall data was collected from Himawari-8 satellite and used as the data input parameter for numerical analysis using SEEP/W and SLOPE/W. The results obtained from back-analysis showed that rainfall infiltration into the so

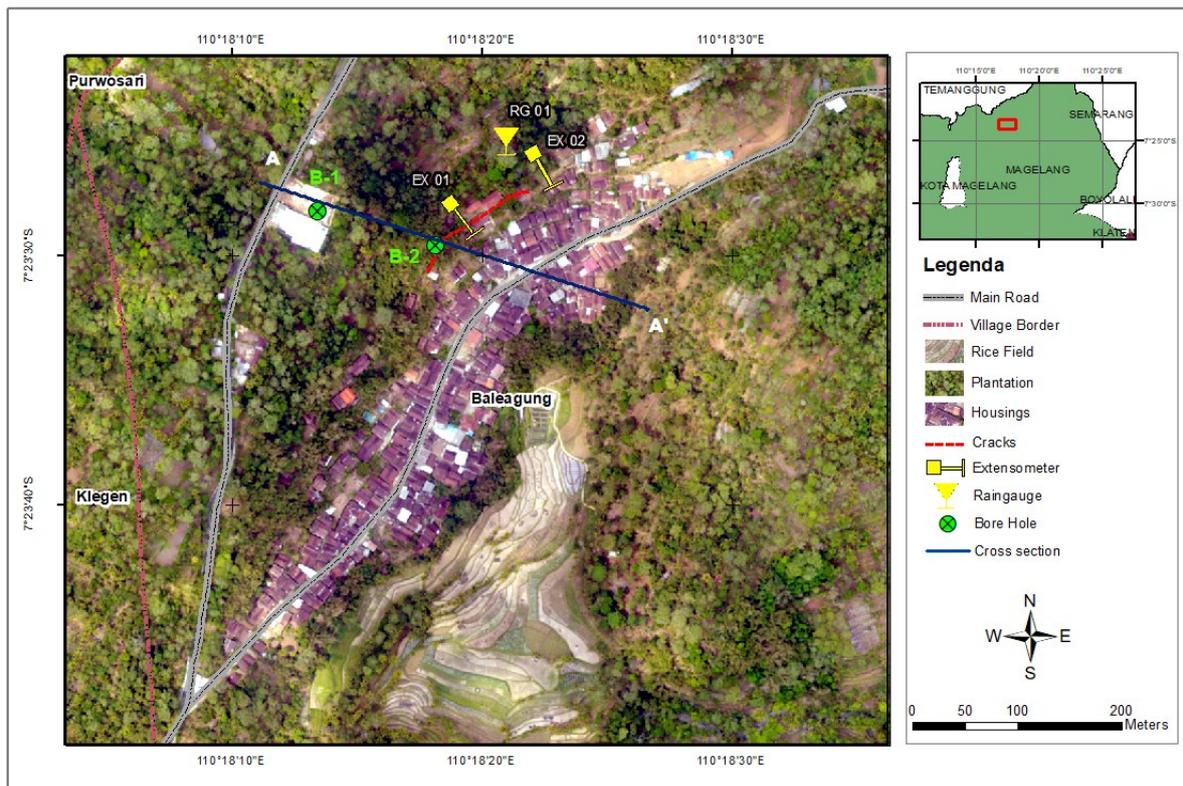
Fig. 3. Aerial photograph of the research area

Based on Digital Elevation Model (DEM) from aerial photographs, Kupon Sub-village at Baleagung Village has the slope steepness value ranging from 25% to 96%. From Table 1, the slope is classified as 'steep' to 'very steep'. From field observation and aerial photography mapping (Figure 3), it is shown that the land use on the research area commonly are for plantation land, shrubs, wet rice fields, and residency. The plantation land is generally used as a bamboo plantation by the local community, which does not have strong roots to accommodate soil movement. To observe landslide activity, two monitoring devices i.e. an extensometer and rainfall station, were used and its location are shown in Figure 3.

Soil sampling in the field was carried out at two points, B1 and B2. The detailed location of the borehole is shown in Figure 3. Through laboratory testing, the soil index properties such as water content, Atterberg limits, specific gravity, and grain distribution analysis of samples were collected.

Landslide simulation was started with the slope geometrics determination at the most critical cross-section, as shown in Figure 3 (cross-section A-A'). The model analysis of this study was SEEP/W and SLOPE/W. Each material parameter was defined according to its analysis (Table 7). SEEP/W with saturated/unsaturated material model was being used for infiltration and rainfall wetting effect analysis. Hydraulic properties and water content for each layer were inputted.
