# Implementation of earthquake mitigation at the engineering faculty, university of mataram

**Abstract.** After the 2018 Lombok earthquakes, buildings within the Engineering Faculty of the University of Mataram (FT Unram), were severely damaged and there have been no comprehensive treatments. Facilities to support earthquake mitigation, such as signs for evacuation routes and assembly points (temporary evacuation sites), are still minimal, and even if they are available many of them are not designed and placed properly. Some parts of the buildings have been partially renovated, meanwhile, there are new buildings constructions that have not been investigated related to disaster mitigation. Anticipating the re-occurrence of big earthquakes in Lombok, it is very necessary to carry out activities for implementing earthquake mitigation at FT Unram. The activities are divided into three stages, namely *first*: conducting direct reviews for inventory and documentation of all vulnerable points, followed by making of maps and building plans; *second*: determining the proper locations of assembly points, creating labels and signs for evacuation routes and assembly points, and making tutoria

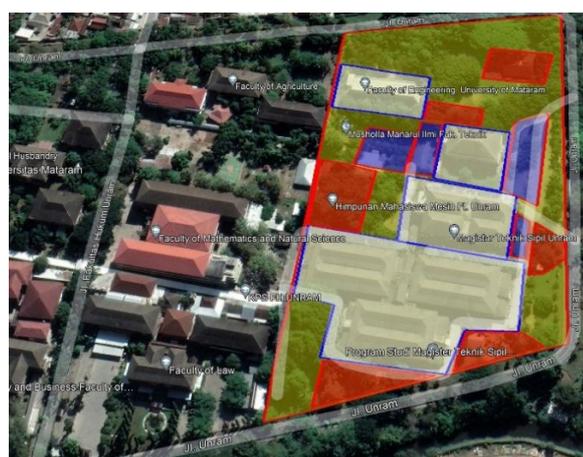
Assembly points and evacuation routes are proposed based on the Evacuation Plans in Fig. 19. The buildings and surrounding closest areas are considered not to be used for assembly points [8]; they are marked as areas with white colors. Permanent obstacles including a wind power turbine, a large power transformer, and semi-permanent buildings are considered not possible for assembly points; they are marked as areas with red colors. Temporary obstacles including parking areas are also considered not suitable for assembly points; they are marked as areas with blue colors.

The results of the calculation are depicted in Table 2, where we get free spaces of about 15,000 m<sup>2</sup>. If it is assumed that only 10% of them can be used as assembly points, then the available spaces are about 1,500 m<sup>2</sup>. Considering the capacity of 1000 people (according to the number of students, lecturers, staff, and guests), we will get approximately 1.5 m<sup>2</sup> area per person, which is still suitable for social distancing conditions (if an earthquake occurs while we are still in pandemic conditions). In a normal condition where people only need free space of about 0.3 m<sup>2</sup> according to standard [8], the available spaces are quite enough.
