# Study on early warning of rapid sinking of large land caisson in silt layer

<sup>1</sup>CCCC Second Harbour Engineering Co. Ltd, Wuhan

The south anchor caisson foundation of a suspension bridge is the first large-scale land caisson constructed with a deep silt layer. The plane size is 70×63meters (m) and the total height is 67.5m. There are 30 rectangular wells (10.84×10m) in total. Except for the steel shell concrete caisson in the first section, the rest are reinforced concrete caisson. The process of “three times of height connection, three times of sinking” was adopted to complete the height connection and sinking of the caisson.

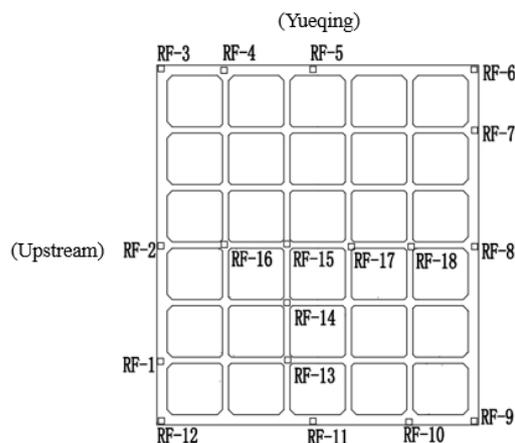
**Figure 1.** Arrangement of earth pressure gauge at the bottom of caisson.

Figure 1 shows the arrangement of measuring points for earth pressure at the end. The change curve of water level (difference in water head inside and outside,  $\Delta w$ ), mud surface support area ( $A_m$ ) and earth pressure before the first rapid sinking is shown in figure 2, and the change of earth pressure before the second rapid sinking is shown in figure 3. In the stagnation stage before the first rapid subsidence, the average earth pressure at RF-3, RF-9, and RF-12 points was 2.19MPa, and the average ultimate earth pressure was 2.73MPa. Except for the monitoring points at the corner points (hereinafter referred to as the edge points), the average earth pressure in the stagnation stage was only 0.65MPa, and the average ultimate soil resistance was 0.68MPa. The average of earth pressure at the corner points before the

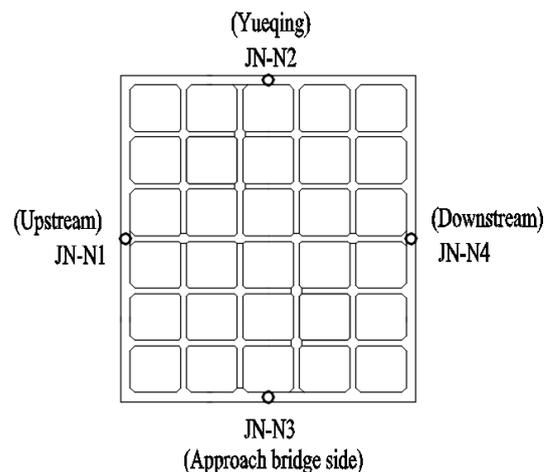
**Figure 4.** The layout of settlement monitoring.

The layout of the top position measuring points on the top of the caisson is shown in figure 4. The system records the spatial coordinates of the measuring points once in 5 seconds, and can monitor the subsidence. The rapid subsidence rate curves are shown in figure 5 and figure 6.
