# The damage effect on the structural capacity of school building columns due to tsunami inundation in Banda Aceh city after 16 years

**Abstract.** The 2004 Indian Ocean earthquake and tsunami caused catastrophic damage to buildings and infrastructure in Banda Aceh. The impact and damage depended on several factors such as the distance of the area from the coast. It was reported that in Banda Aceh, the tsunami wave inundation reached the city center and affected over a third of the population. Due to priority reasons at the time, although the structure was submerged in tsunami inundation, numerous public facilities including school buildings still in use without any proper repair. This study aims to determine the effect of column damage due to the tsunami inundation on the strength of the building. The school building of SMPN 6 Banda Aceh is selected as the case study. Seven analysis cases were carried out to simulate the degradation of the column cross-section caused by tsunami inundation. The reduction of the column cross-section was determined from 5 to 25% with increments of 5%. The analysis results revealed that the decrease in strength has occurred from the case of 5% degrad

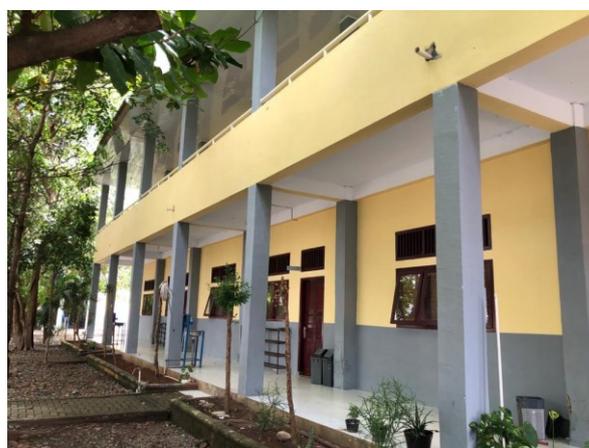
Fig 1. Column conditions

Direct observations at the SMPN 6 Banda Aceh building revealed that the concrete portion of the column which was submerged by the tsunami has cracked. Moreover, some of the concrete covers have peeled off and the exposed reinforcement was corroded. These conditions are shown in Fig. 1.
