# Experimental study on the performance analysis of river levee using new substance for improving earth surface resistance

**Abstract.** The reasons why levee breaches during floods are largely due to overtopping, seepage, and structurally induced piping. According to an analysis of domestic and overseas reported cases of levee breaches, overtopping was found to be the cause for approximately 40% of all cases of breach. Despite such efforts of previous research to establish disaster prevention plans associated with levee breaches, to enhance our understanding of the processes and reasons, further research regarding the prediction of levee breaches must be undertaken by accumulating test data under several different conditions and further verification of the data using numerical models must also be undertaken. In this study, development of technologies regarding a new environmentally friendly bio-polymer capable of protecting levees from erosion is being undertaken. Breach mechanisms was assessed using an image measurement system that collected data regarding the breach progress of the levee, close-up views of the breaching surface, and the formation of the final breaching cross-se

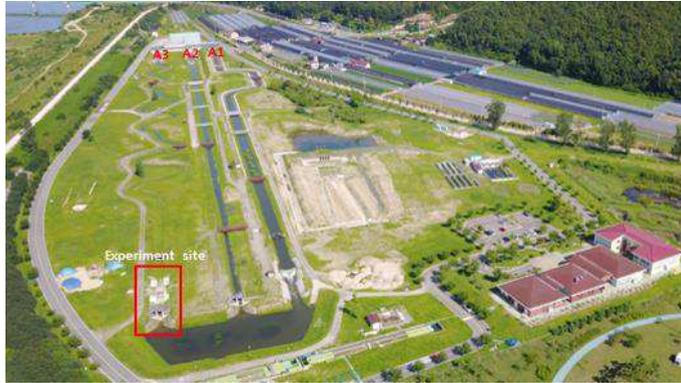
**Fig. 1.** View of REC in Andong, South Korea

In this study, hydraulic experiments were carried out by building a mid-sized levee model in REC (Andong River Experiment Center) in Figure 1. By building a measuring system using image devices on site, failure mechanisms and processes were analysed during an overflow. In addition, levee slope was covered with a bio-soil for the purpose of analyzing

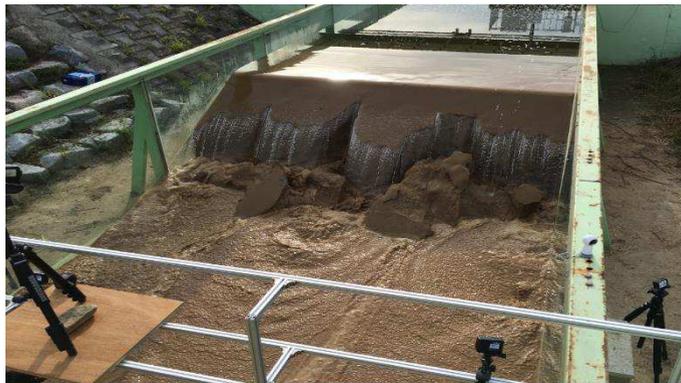
**Fig. 2.** Hydraulic experiment for levee failure by overtopping

the stability and performance of the levee applied with the new substance. Figure 2 shows view of hydraulic experiment in REC.

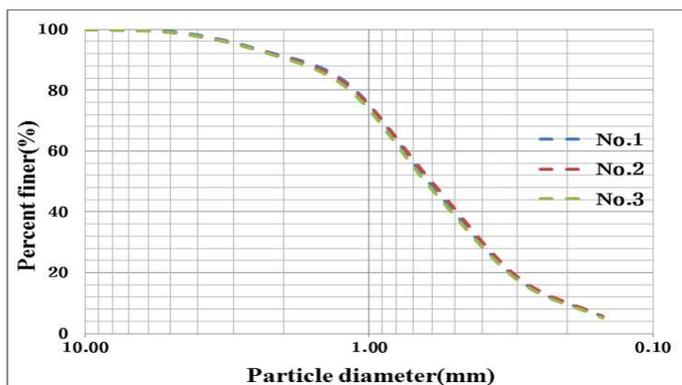
**Fig. 3. Grain size distribution**

Based on the soil classification system, uniform well-graded sand (SW), in which 50% is retained on or above a No. 200 sieve was used. By using this type of soil, which is vulnerable to crack, the performance of the bio-polymer mixed with the most vulnerable of materials becomes more apparent, and the formation of overflow breach cross-sections is induced. Since the sand used in the experiment changes each time, three times of particle size distribution tests was conducted to verify the consistency of each test in Figure 3.

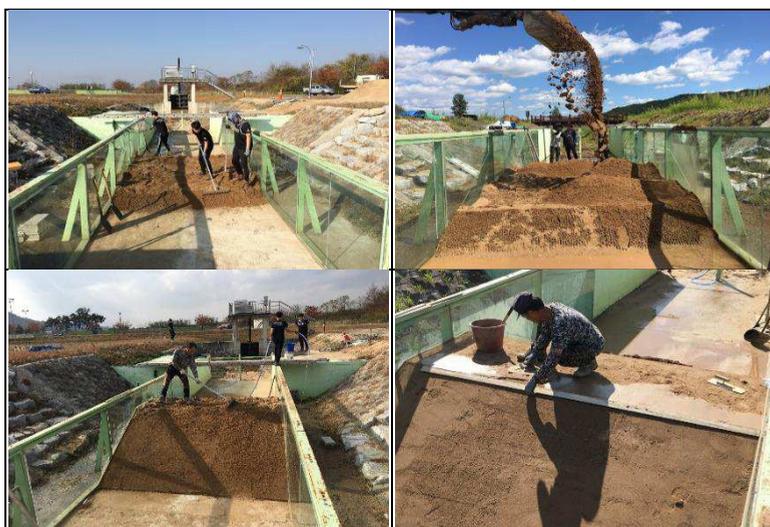
**Fig. 4. Building a levee model**

Using an excavator ( $0.2 \text{ m}^3$ ), the sand was then dropped from a height of 3 m and was used to build the base of the levee. Next, the levee was built by repeatedly placing water-packed 20 cm layers on top of each other. The application of a new material was based on a provided recipe from the joint research institute KAIST, a powder type bio-polymer was mixed with water. The bio-polymer solution was then mixed with soil, and this mixture was spread across the levee surface to a thickness that was appropriate for experiment conditions in Figure 4. Thereafter, the experiments were undertaken following a period of 3~5 days of curing, a time at which overflow failure experiments would become possible.

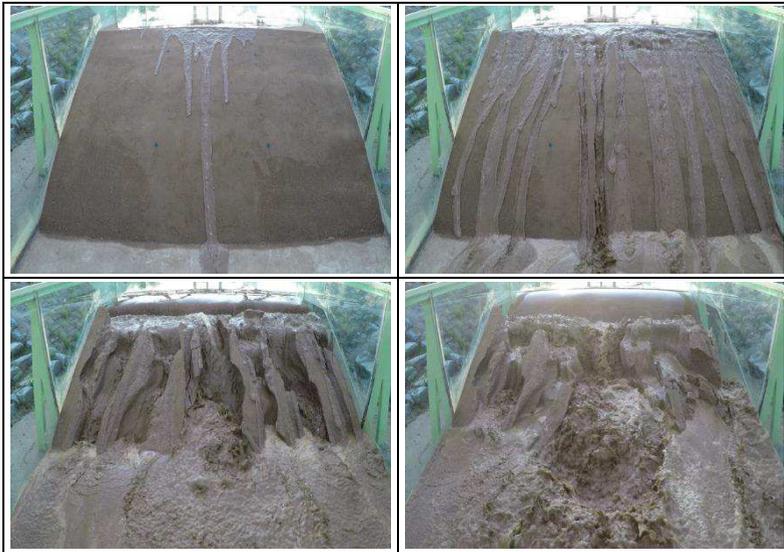
**Fig. 5. Breaching shape under time since onset of overflow**

The first step presented the appearance of levee failure 30 seconds after overflow began, in which gradual erosion was observed across the levee crown and slope surface towards the land side area, from the point at which the overflow occurred. This is considered to be the step in which an initial flow was created on the levee slope, which led to erosion and the development of the main flow waterway.

The second step presented the appearance of levee failure 60 seconds after overflow began, continued flow and development of flow velocities along the levee slope resulted in erosion along the direction of the flow of water, which presented the development of gully erosions forming a small valley.

The third step presented the appearance of levee failure 90 seconds after overflow began, a stairwell shaped overflow flow was developed due to erosion across the levee crown. As the width of the breach expanded under continued flow, the overflow volume increased and

accelerated levee erosions and vertical erosions were formed on the overflow cross-section.

The fourth step presented the appearance of levee failure 120 seconds after overflow began, the complete failure of the levee crown and the rapid increase of overflow volumes resulted,

and caused the breach width to reach its maximum levels due to the strong tractive forces. Figure 5 shows breaching shape under time since onset of overflow.

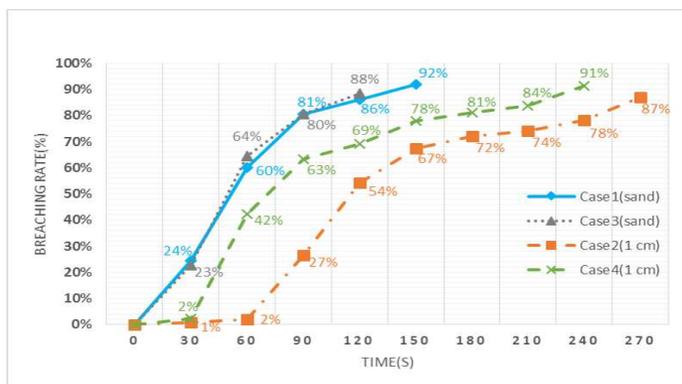
**Fig. 6. Breaching rate**

Through a pixel-based analysis performed to analyze levee surface loss rates for the levee that applied new material (Case 2, 4), surface loss was between 1 ~ 2% 30 seconds after the overflow began, 2 ~ 42% after 60 seconds, 27 ~ 63% after 90 seconds, 54 ~ 69% after 120 seconds, 67 ~ 78% after 150 seconds, 72 ~ 81% after 180 seconds, 74 ~ 84% after 210 seconds, 78 ~ 87% after 240 seconds, and 88 ~ 90% after 270 seconds. The results indicated widely varying loss rates at the 60 second mark and 90 second mark. This was considered to have been due to the effect that cracks developed during the curing process had on the initial failure rates. What was interesting to note was that the margins of the loss rates were reduced to within 10% with the passage of time.

Compared to the earthen levee (Case 1, 3), the levee that applied new material was found to take 2.25x longer to reach total levee failure. Through the levee surface loss rate analysis according to the passage of time performed through the pixel based analysis, the initial breach velocity of the earthen levee was found to be 1.43x faster than the levee that applied new material, and the failure was also found to accelerate more rapidly with the passing of time in Figure 6.
