MEASUREMENT OF INUNDATING FLOW FROM A BROKEN ENBANKMENT BY USING VIDEO IMAGES SHOOT FROM A MEDIA HELICOPTER

Abstract. The heavy rain disaster in the Kinugawa River basin that occurred along with the passage of the Typhoon 18 caused the embankment destruction in the middle reach of the river on September 10, 2015. Due to the overflow, the houses in the vicinity of the embankment collapsed, causing a flood inundation spreading over a wide area. Because the embankment breakwater occurred during the daytime, the state of the inundating flow was recorded from various angles by media helicopters or drones. In this study, we developed a method to extract quantitative flow information from a helicopter video image in which the shooting position and angles are changed one after another, because it was taken in emergency. In the analysis, the images were orthorectified after stabilizing the images, from which surface velocity distributions were measured by image-based technique such as the large-scale particle image velocimetry (LSPIV) or the space-time image velocimetry (STIV). As a result, the time change of water entering from the broken embankment and the total inundated water volume du

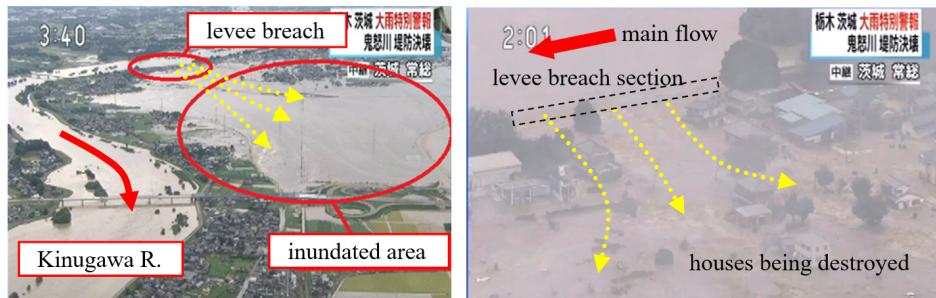
Fig 1. Location of levee breach and inundated area.

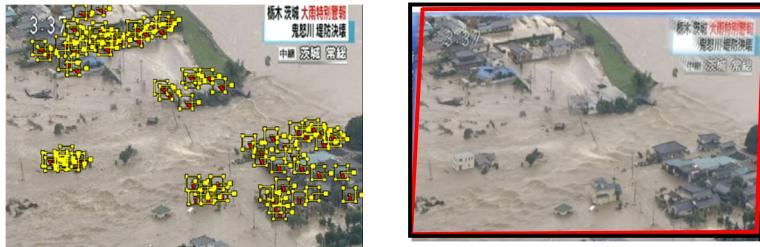
Fig.3 Application of marker tracking method. left : yellow square is the search window and red line is the shift vector, right : stabilized image.

marker tracking (MK) method as indicated in Figure 3. A free software (Blender) is used in this step. Figure 3 provides an example of the background shift measurements by using MK method. MK method can measure the background shift vector by applying a technique similar to the particle image velocimetry (PIV). In the example shown in Figure 3, a lot of reference windows indicated by yellow squares are set manually on the positions of objects

that are fixed to the ground such as houses. In Figure 3, a shearing deformation is detected and with this information the second image is deformed to coincide with the first image. This process is repeated for all the extracted frames indicated in Table 1. The third image row in Table 1 provides the deformed image for the last frame.

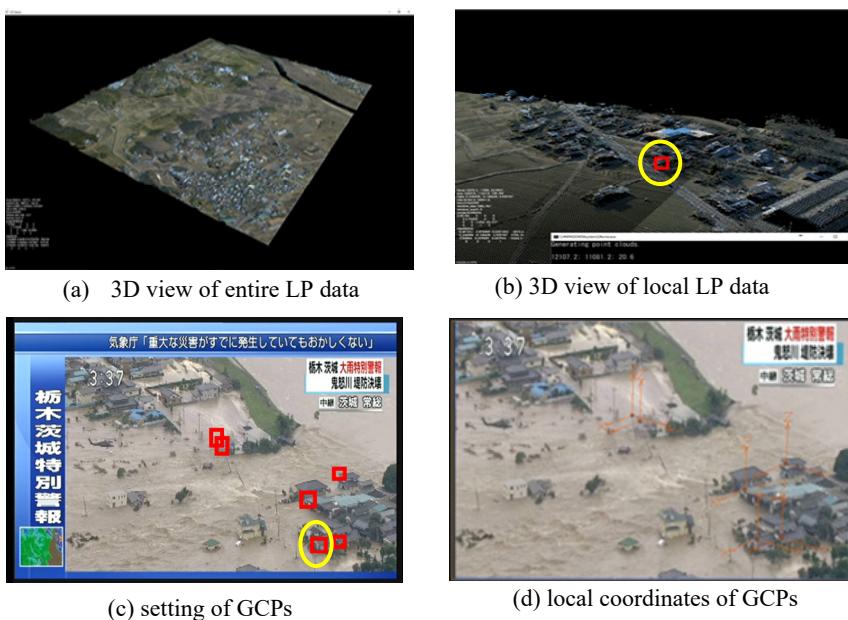
Fig.4 Picking up GCPs using LP data.

In the second step, three dimensional coordinates of more than six ground control points (GCPs) to use for the image rectification are obtained by using detailed LP data of the site. Specifically, the LP data is expressed as CG shown in Figure 4(a) and the detailed original measurement data is plotted as indicated in Figure 4(b). The GCPs are carefully selected at some fixed points such as the tip of a roof as shown in Figure 4(c) and their coordinates are obtained from the original LP data shown in Figure 4(b). For example, the position shown as a dotted circle in Figure 4(b) corresponds to the tip of one of the roofs in Figure 4(c). The respective 3D coordinates of GCPs are obtained from the original LP data. The local coordinates for each GCP is shown in Figure 4(d).

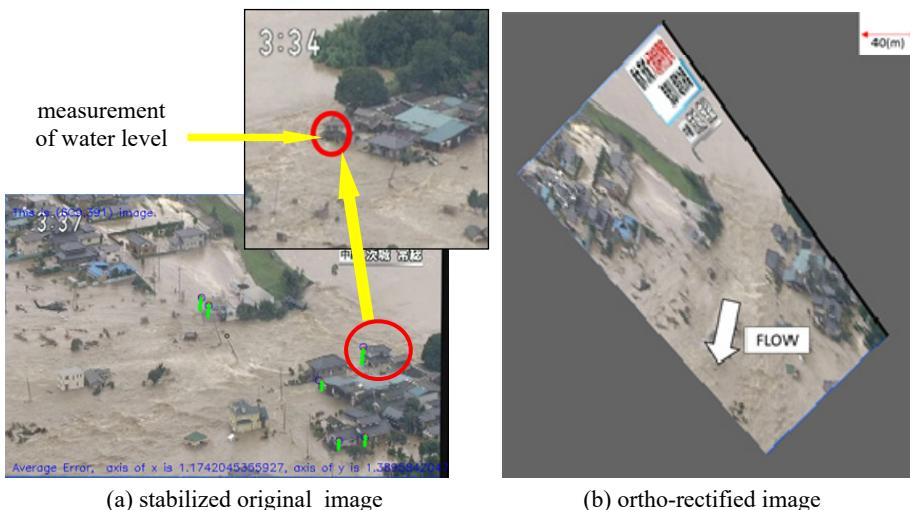
Fig.5 Image transformation of stabilized oblique image.

determined in the 3rd step and the water level. In KU-STIV, a line segment drawn vertically from the GCP to the water level appears when the parameters for transformation is appropriate. Such vertical lines, green in colour, are shown in Figure 5(a). The water level was measured from an image viewed from another angle indicated in Figure 5. The ortho-rectified image is provided in Figure 5(b) demonstrating the overflow from the levee breach section.

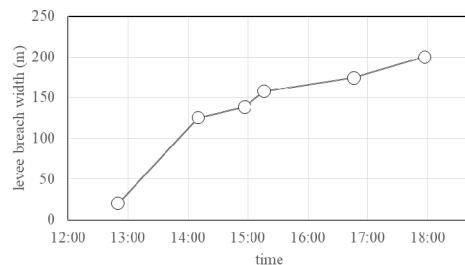
Fig. 6 Time variation of levee breach width.

According to the interview survey of local people, the levee breach started at 12:50 and the initial width is estimated to be about 20 meters. Other than the images indicated in Table 1, there are several scenes in which the width of the breakage can be observed clearly. The physical scale of the width were estimated by comparing with the detailed LP data introduced in Figure 4. Figure 6 shows the time variation of the levee breach width. It is obvious that the width increased quickly for one hour after the breakdown and after that it increased almost linearly with time until it reached the maximum width of about 200 meters, causing a huge amount of inundated water into the residential area.

By combining the time variation of the breach width shown in Figure 6, the outflowing mean velocity in Figure 8 and the estimated overflowing critical water depth, the evolution of accumulated inundated water volume is estimated as shown in Figure 9. The surface velocity coefficient that convert surface velocity to depth-averaged velocity was set at 0.85 in this case. According to the present calculation, the inundated water volume was estimated to be about $1.10 \times 10^7 \text{ m}^3$, which roughly agrees with the officially reported data.

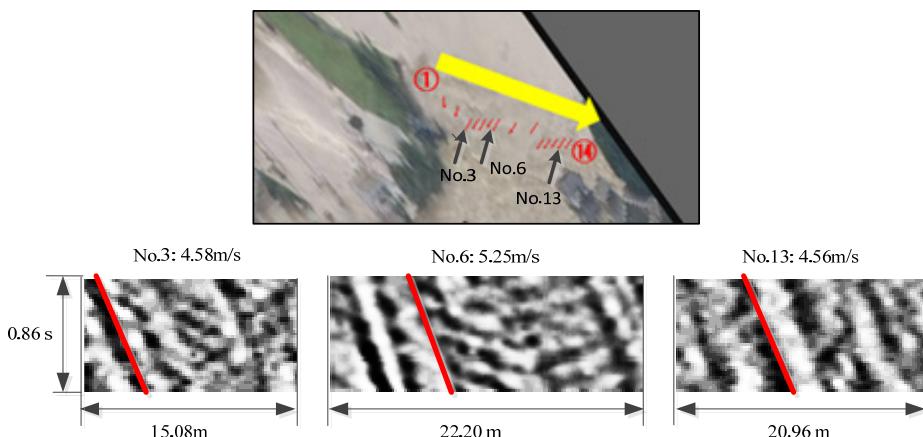
Fig. 7 STIV analysis for the scene 3 at 15:37.

In order to estimate the overflowing discharge from the levee breach section, surface velocity distribution at the entering section was measured by the image-based technique STIV rather than LSPIV, because STIV is applicable for obtaining quantitative data even under deteriorated images such as the scenes provided in the present disaster. As an example, the measurement result by STIV at 15:37 is provided in Figure 7 together with some of the space time images (STIs). Although the texture appeared on an STI includes noisy patterns, an inclined pattern corresponding to the flow velocity is visible. In Figure 7, the texture on STI is enhanced by applying a histogram equalization filter. The average surface velocity is then calculated by taking the average of the total velocity data and it was

5.05m/s for the scene 3 at 15:37. The time variation of the outflowing mean velocity measured by analysing similar procedure for the other scenes is provided in Figure 8. The mean velocity takes a peak value of about 5m/s after 15:00 and decreases gradually to less than 3m/s before 17:00.

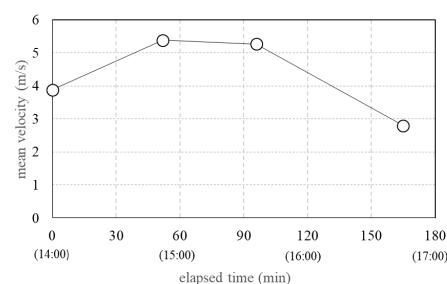
Fig. 8 Time variation of mean velocity outflowing from the levee breach section.

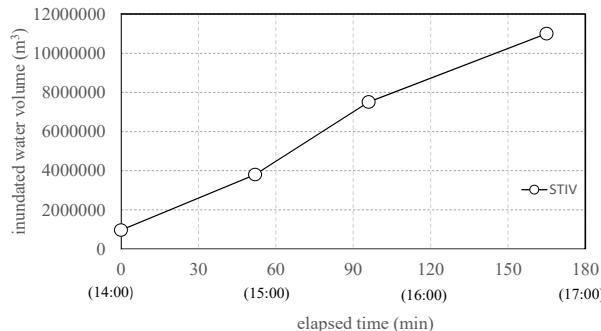
Fig. 9 Accumulated inundating water volume.

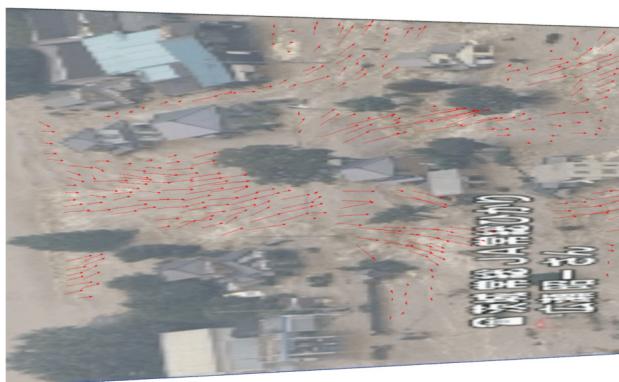
Fig. 10 Surface velocity distribution obtained by LSPIV for the scene 3.

In order to obtain the spreading flow features from the breach section, the large-scale particle image velocimetry (LSPIV) technique was applied to the ortho-rectified images. In the present analysis, a LSPIV software was developed so that the template for the pattern matching in LSPIV can be placed at an arbitrary point. This is because a template that contains a part of a house would yield erroneous values. Therefore, the templates were carefully set so that they include only water flowing area. Figure 10 provides an example of surface velocity distribution for the scene 3 obtained 13:47. The template size was set at 40 by 40 pixels with a physical dimension of 2.4 meters and 26 frame images were used to obtain the short time average data of 0.87 seconds. The result shows that the overflowing

water was accelerated downstream of the breach section and the flow spreads widely in between the residential area. The vector field presented in Figure 10 can be used as a measurement data when an inundation simulation is executed in this area.
