Ecology and mining industry development in high-mountain areas (the Inner Tien Shan)

Abstract. The genesis and transformation in time of risks in the areas of high altitude tailings storage facilities with respect to changing climate are considered. Based on the example of the Kumtor mine in the center of the Tien Shan at a height of 3600–4300 m, three groups of risk factors were allocated concerning a large, ecologically hazardous facility – the tailings dam containing cyanide waste. For one of the factors, calculations of an accidental dam burst were made using the Fault Tree Analysis (FTA) method. It was concluded that the construction of large-scaled and geoenvironmentally hazardous facilities in less researched high-mountain areas has to be drawn upon detailed and permanent monitoring of the facility itself and its environment. It is crucial to be prepared for operational adjustment of projects and an immediate rehabilitation of constructed facilities.

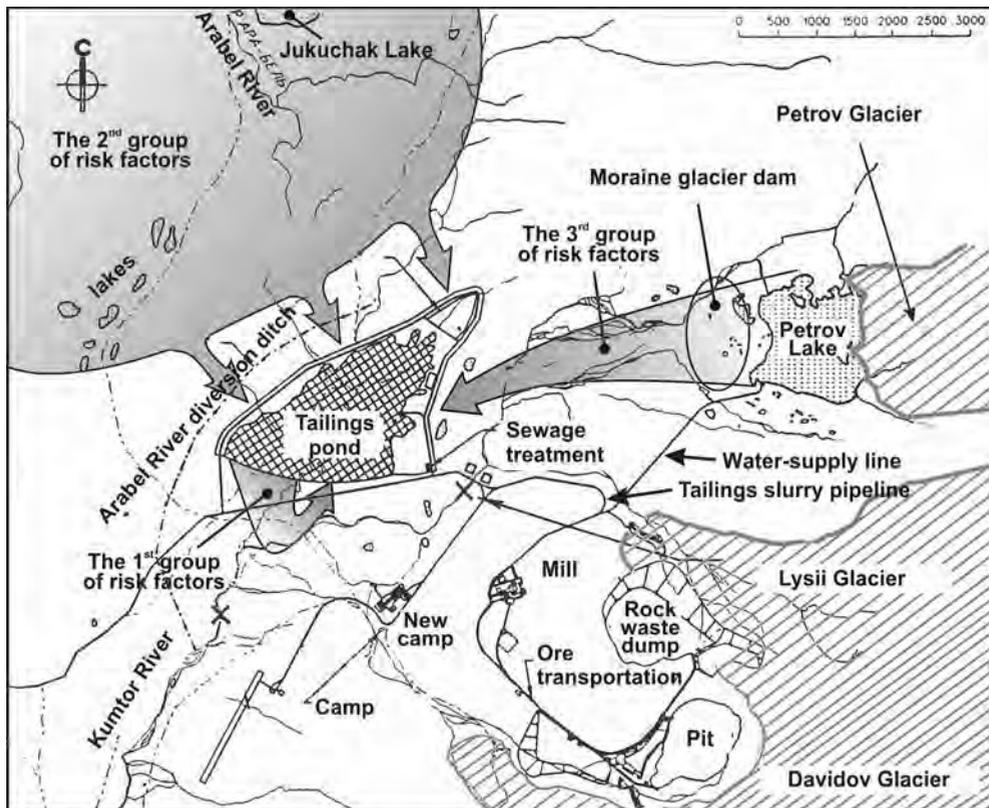
Fig. 1. The groups of risk factors

The practice of subsequent operation of the facility, detailed monitoring of the dam's condition, engineering-geological and geophysical research at the site revealed a number of factors (circumstances and processes) that could lead to the destruction of the facility with catastrophic environmental consequences. Conventionally, there are three groups of risk factors: (1) – internal physical and geological factors in the base and body of the dam,

leading to a loss of its stability; (2) – hydrogeological and hydrological factors within the catchment area; (3) – glaciological and thermodynamic processes in the structures of the moraine and glacial complex of the Petrov Glacier.

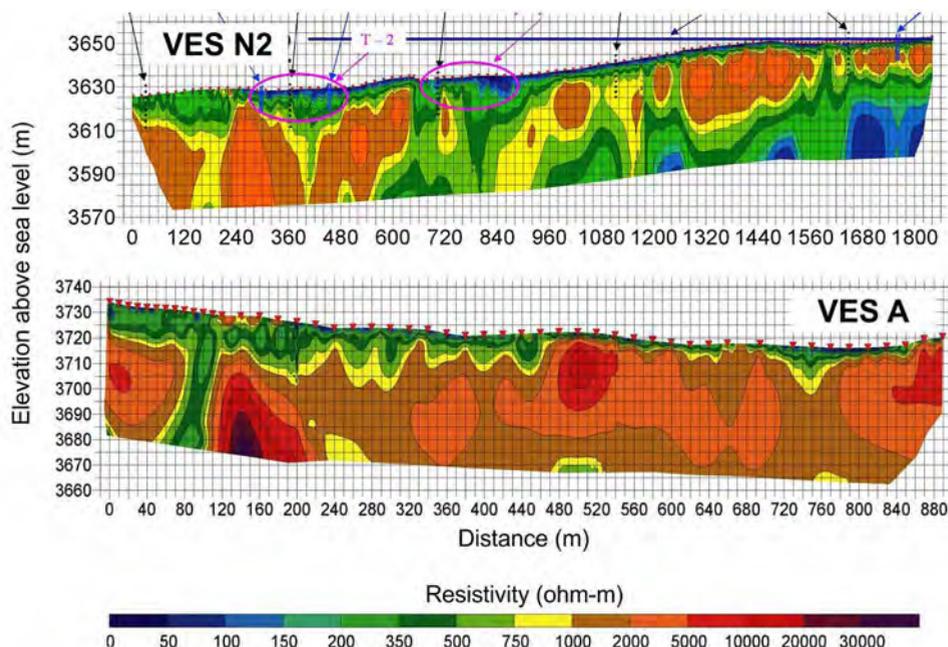
Fig. 2. 2D geoelectrical images of the subsurface along (a) the tailings dam and (b) Arabel River diversion ditch.

The genesis of the hazards from the first group is determined by the peculiarities of the composition, structure, properties, and thermal regime of the alluvial terrace soils on the border with lacustrine loamy silt deposits of low thickness (up to 2 meters) with a gentle slope (1 to 2 degrees) towards downstream at a depth of approximately 4 meters. These deposits with thin lenses and layers of ice have very low strength characteristics (according to the data of [2], their friction angle is between 1.5 and 2.5 degrees). They had been frozen at the beginning of development, but melted during the facility construction and became the cause of the evolution of large deformations and displacements on the dam-base interface at a velocity of up to 6 mm/month. The situation is aggravated by the fact that the dam base lays on the recent and ancient meanders of the Arabel River. Here the underflow, recharged by infiltration of the tailings water, is preserved, in spite of the diversion of the stream flow to the artificial channel beyond the TSF. Geophysical investigations revealed a system of tabetisol areas (Figure 2a) formed by these meanders at the dam site. In the course of its construction and operation, facility rehabilitation required high effort and additional financial costs to stabilize the dam by the construction of a shear key. At the same time new questions arose, concerning the redistribution of seepage flows in the base and body of the dam, as the soil of the shear key freezes.

Thus, insufficiently detailed engineering and geological study of the dam soil foundation, especially changes in the physical and mechanical properties of all the lithological varieties in the section at the boundary cryogenic condition, did not allow geologists, engineers and project leaders to precisely calculate and predict the stability of the object, even in the short term. This is an illustrative example of how important it is to study the internal fine structure of the rock mass in high mountain conditions at the base of engineering structure foundation and the properties of each structural element despite its insignificant thickness compared to the size of the constructed projects.

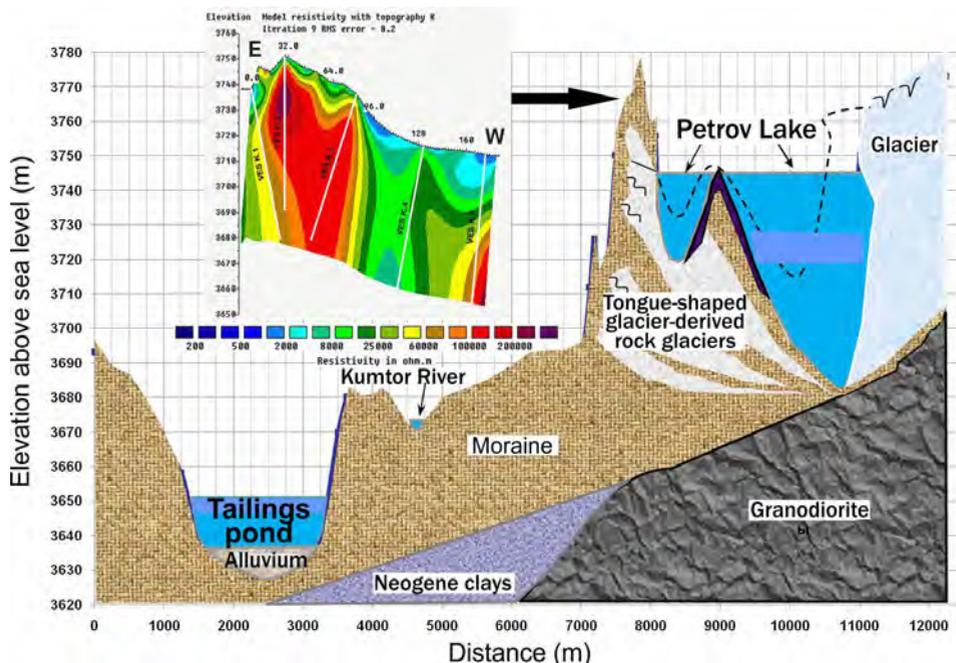
Fig. 3. Schematic geological cross-section in the area of formation of the debris flow and flood hazard in case of Lake Petrov dam breaching. The inset shows the geoelectrical image of the dam cross section.

Factors of the third group form the danger of Petrov Lake moraine dam breaching (Figure 3), followed by the formation of a heavy debris flood, of which the solid phase will contain large blocks of buried glacier ice [3]. In [4] we discussed various reasons and scenarios for the development of such catastrophic process. During the spreading of debris flow along the outwash plain and the Kumtor River, a stream blockage in a narrow part of the valley and the overflow through a low lateral moraine into the tailings pond, followed by the destruction of the tailings dam and the release of cyanide-containing waste substances into the environment is not unlikely. It should be noted that the small difference in altitude (approximately 10 m) between the Kumtor valley bottom and the lateral moraine that surrounds the tailing pond can be eliminated when removing debris from the Lysii Glacier or in time by the degradation of the moraine itself through buried glacier ice melting. Judging by the special "pockmarked" relief of its surface, these processes are already actively occurring.

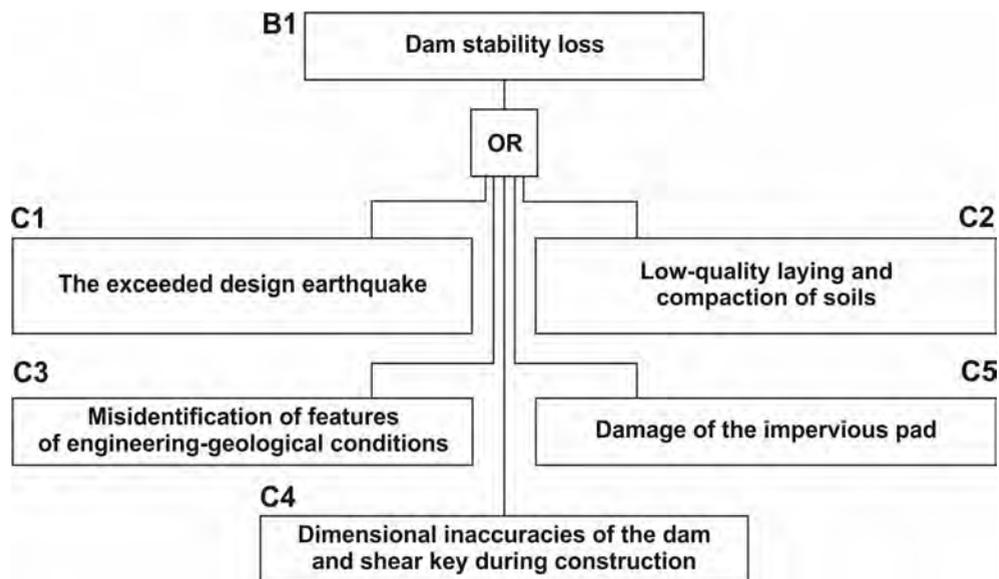
Fig. 4. Fault tree for scenario B3

The Fault Tree Analysis (FTA) method was used to quantify the risk of failure in case of dam stability loss. Figure 4 shows the "fault tree" for scenario B3 with its elements.

Taking into account the durability of the dam, the average annual probability of a dam failure under static conditions is $R_s = 1.76 \times 10^{-4} \text{ year}^{-1}$; under seismic load $R_c = 3.83 \times 10^{-4}$

year⁻¹. The regulatory risk for earth dam of Class 2 is 5×10^{-4} year⁻¹ during the operation period.
