# Numerical simulation of the effect of fault inclination on the sudden water of the fault bottom plate

**Abstract:**The main reason for the frequent occurrence of water accidents on the bottom plate of the working surface near the mine fault in China is that the excavation activities cause the fault to activate and direct the pressure water of the aquifer. The distribution of ground stress fields and plastic regions under the influence of extraction disturbance spree is analyzed by using the flac3D simulation software FLAC3D simulation software. The results show that the greater the inclination of the fault, the greater the shear stress and the normal stress at the fault level, and the deeper the activation range of the mining fault is larger than that of the shallow one, and the small inclination positive fault is more likely to produce the fissure between the working surface base plate and the aquifer, and the small inclination positive fault should be left with a wider water-bearing coal column in the actual safety design. Using this software, the evolution of the stress field and plastic zone in the adjacent mining area is a preview, which is of great application value to pre

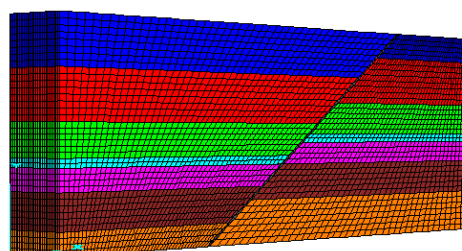
The fault inclination is established with 3 numerical calculation models of 25°, 45° and 75° respectively. As shown in Figure 1 below.

Figure 1 Numerical calculation model

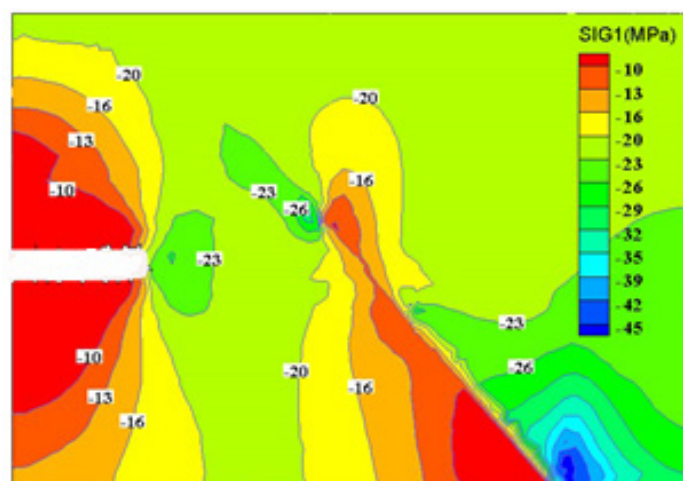
Taking the above-mentioned fault inclination of 45° fault as an example, the stress distribution near the fault is analyzed after the coal seam is excavated. The design is: the work surface forwards 20m, 35m, the first main stress distribution cloud map, as shown in Figure 2, 3.

**Figure 2** Cloud map of the main stress distribution at 20m coal seam mining

When the coal seam mining 20m, the stress in front of the work appeared high stress concentration, the maximum stress concentration of stress concentration reached -23.51Mpa, the stress concentration maximum at the tip of the fault reached -30.31Mpa, the stress concentration area in front of the work and the stress concentration area at the fault tip extinction had not been completed, so no coal and gas protruding occurred at this time; The maximum stress concentration value at the fault tip extinction reaches -30.80Mpa, due to the influence of work surface mining, the coal rock body in the front fault tip is activated, the stress concentration area above the work side and the stress concentration area at the fault tip is destroyed, and the coal rock into the work surface is highlighted by coal and gas.

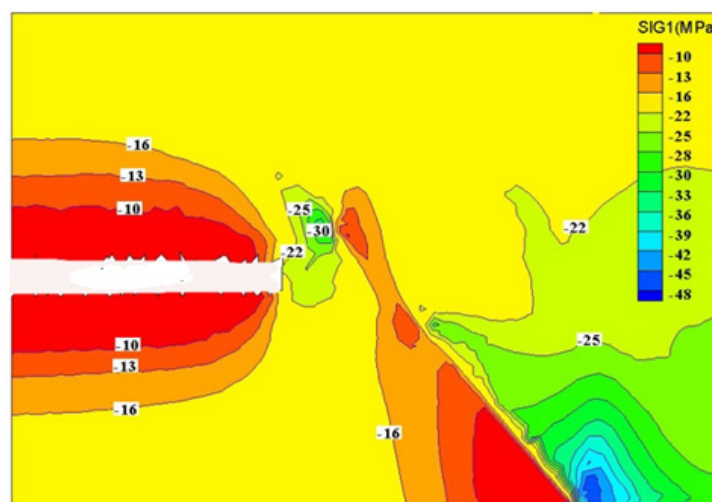
**Figure 3** Cloud map of the main stress distribution at 35m coal seam mining

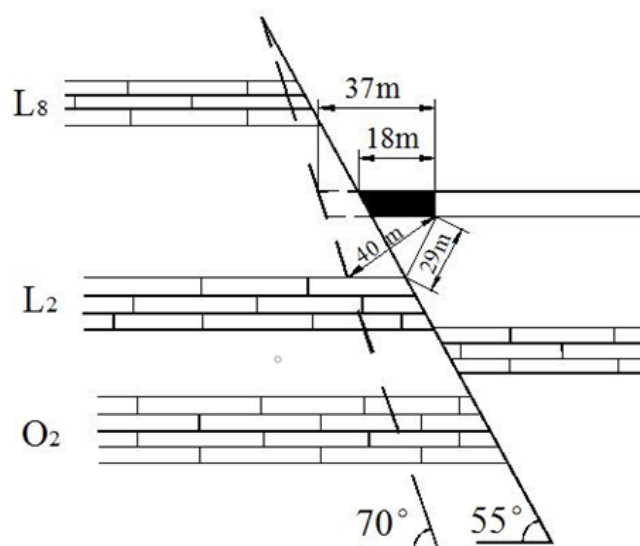
revealed that the fault in the deep inclination becomes smaller, only 55 degrees, so that the actual length of the coal column reduced to 18m, the water barrier layer is 29m (Figure 5), and finally under the pressure of 1.78Mpa, the sudden water volume reached 92.78m<sup>3</sup>/min, resulting in flooding wells.

**Figure 5** Work surface water profile diagram

The working surface of a mine 1601 in the coking mining area is located on the upper plate of Xiazhuang fault, the original estimate is that the inclination of the fault is 70 degrees, and the waterproof coal column is reserved for 37m, 40m thick from the water layer of the base plate. However, from the actual mining process

Based on the numerical calculation conclusion, the analysis indicates that the above-mentioned causes of the sudden water are: (1) the inclination of the square fault before the work is too large, resulting in the actual retention waterproof coal column width is too small; (2) the small inclination positive fault, to consider the characteristics of mining easier activation work surface plate, leaving a sufficiently wide fault water-free coal column.
