# Evaluation on water bursting risk of working faces near collapse column during the mining process

**Abstract.** Collapse column water bursting occurs from time to time in the coal mining process of North China Type Coalfield in China, which causes great economic loss and personal injury. Therefore, great attention must be paid to the harm of collapse column. 1301 working face and 1306 working face in the west wing of No.1 Mining District of Zhangji Coal Mine in Shanxian County are close to No.2 collapse column. Water bursting risk evaluation must be carried out before mining two working faces to ensure safety production. On the basis of fully analyzing the geological and hydrogeological conditions of the 3<sub>up</sub> coal seam in the west wing of No.1 Mining Area, the "Three Zones(caving zone, water conducted fracture zone and sagging zone) Theory of Coal Seam Roof", "Strata Movement Theory" and "Water Bursting Coefficient Theory" were used respectively to calculate and evaluate the water bursting risk of No.2 collapse column during the course of mining the 1301 working face and 1306 working face. The results show that: firstly, in the process of mining the 1301 working face,

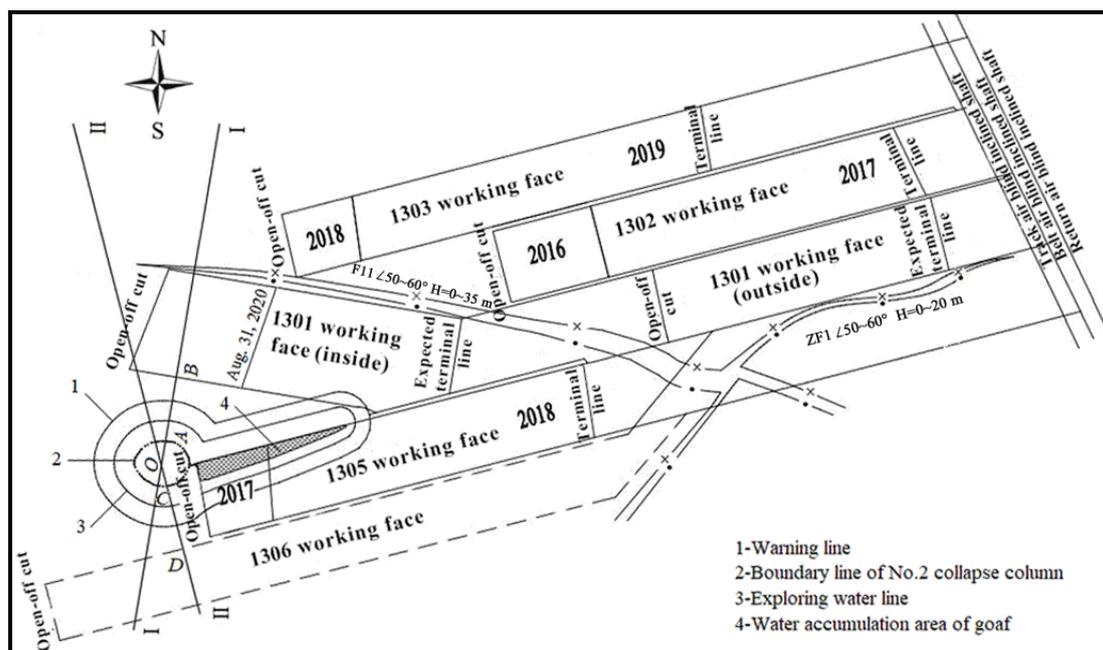
By the end of December 2020, three working faces of 1302, 1305 and 1303 had been mined successively. The holing-through excavation in open-off cut of 1301 working face had been completed, and it is expected to start mining at the end of February 2020. It is planned to arrange the 1306 working face near the 1305 working face with a 5 m coal pillar between the working face and the goaf of the 1305 working face (Fig. 2).

Fig. 2. The working faces' layout of 3<sub>up</sub> coal seam in the West Wing of No.1 Mining Area in Zhangji Coal Mine

about 90 m(Fig. 2), and an area of about 7791m<sup>2</sup>. The collapse column is mainly composed of sandstone, mudstone and other rock blocks. The rock blocks are mixed in size and angular, and compacted and cemented tightly. 4 water detection boreholes were all no water, this indicated that the collapse column is weak in watery at that time.

Affected by fault F11: ∠ 50~60 ° H=0~35m, 1301 working face is separated into two working faces: 1301 working face (inside) and 1301 working face (outside), 1301 working face (inside) is close to No.2 collapse column(Fig. 2).

The 1301 working face(inside) is located to the north of No.2 collapse column with a minimum horizontal distance of about 125m. Points A and B are respectively located at the outer edge of the No.2 collapse column and the outer edge of the track roadway of 1301 working face(inside), and the two points are the closest points between the working face and the collapse column. The straight line passing through the two points is the I-I section line(Fig. 2), Figure 3 is the I-I geological section. The 1301 working face(inside) starts from protective coal(rock) pillar line of No.1 Mining District in the west, to the B1 hole in the east, to the F11 fault in the north, and to the 1305 working face in the south. The working face is 605~664 m long from east to west and 152~220 m wide from north to south. The thickness of 3up coal is 6.30 m(B1 hole, located in the working face), and the coal roof is mainly composed of fine sandstone, siltstone and sandy mudstone, generally, it belongs to medium-hard rock. According to the literature[18], after the coal seam mining, the height of the water conductive fracture zone is calculated as follows:

According to the plan view of the coal mining project in  $3_{up}$  coal seam(Fig. 2), there is no obvious fault structure between the western section and neighbouring belt roadway of 1306 working face and the No.2 collapse column. It could be regarded as a complete section of the formation, and the critical water bursting coefficient can be 0.1 MPa/m. The tow points' water bursting coefficients would be all less than 0.09 MPa/m, and the No.2 collapse column would have smaller water bursting threat to the coal seam mining in the 1306 working face.

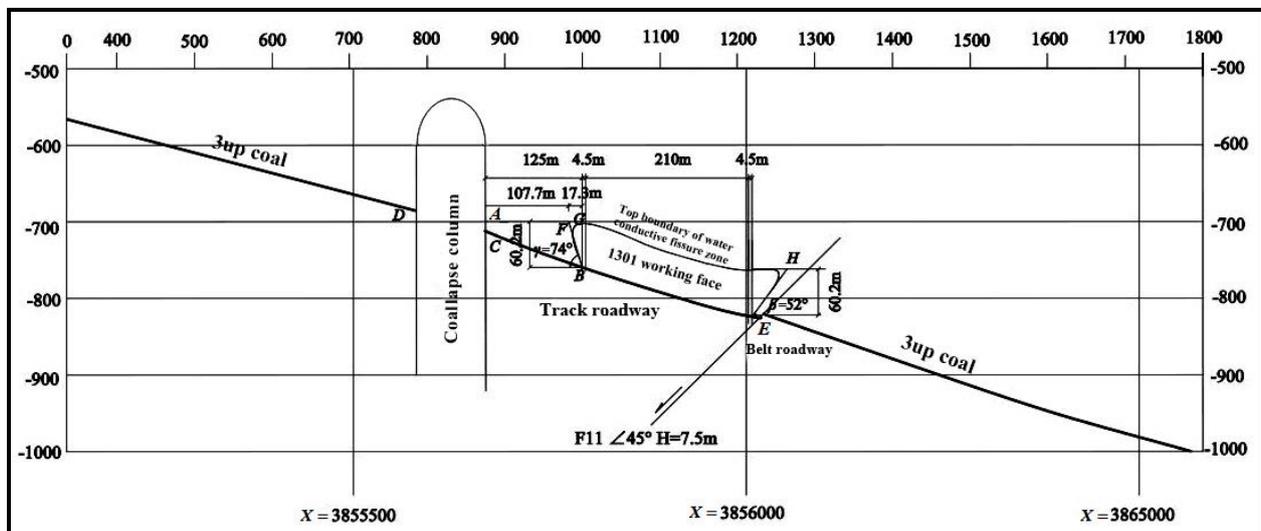
Fig. 3. Geological section map of I-I line

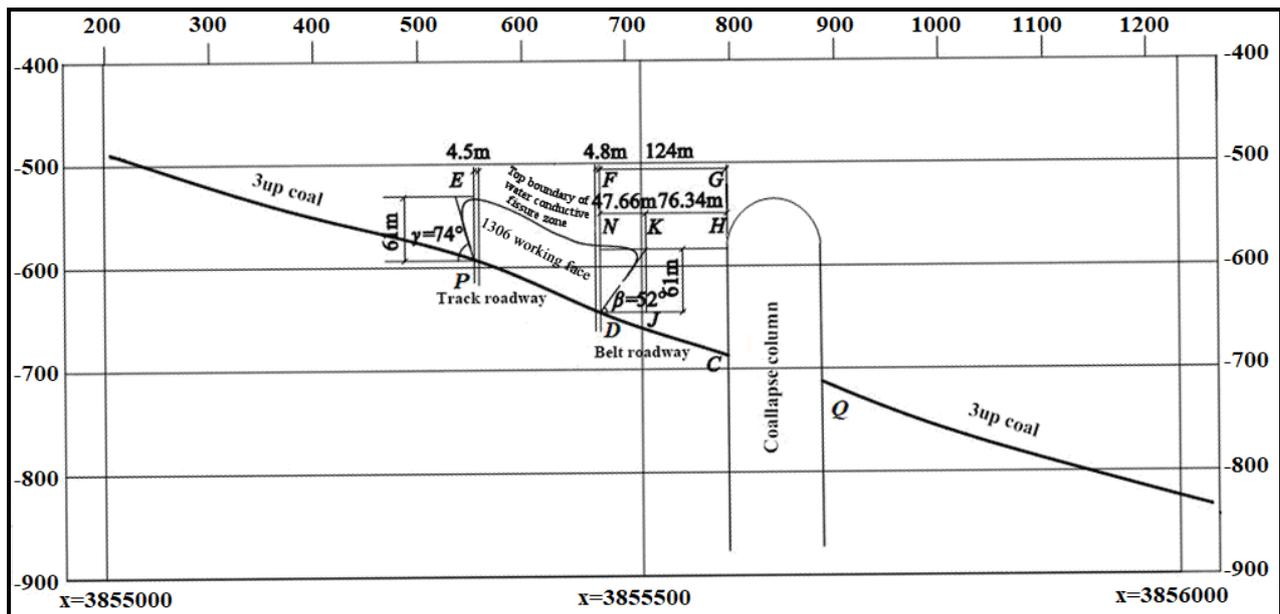
the track roadway of 1306 working face, and the two points are the closest points between the working face and the collapse column. The straight line passing through the two points is the II-II section line(Fig. 2), Figure 4 is the II-II geological section. Thus, in the process of mining at 1306 working face, the horizontal distance  $KN$  between the highest point  $K$  of the water conductive fissure zone at point  $D$  of the track roadway and the point  $D$  at outer wall of the track roadway(Fig. 4) would be:

Fig. 4. Geological section map of II-II line

$$\begin{aligned} T_K &= \frac{P_K}{M_K - 10} = \frac{P_K}{KH - 10} \\ &= \frac{1 \times 1000 \times 9.8 \times [19.13 - (-584.09)] \times 10^{-6}}{(124 - 47.59) - 10} \\ &= 0.089 \text{ (MPa/m)} \end{aligned}$$
