Predicting remaining life of lattice steel transmission tower based on condition assessment and corrosion hazard data

Abstract. This paper presents a novel approach for predicting the remaining life of lattice steel transmission towers in Malaysia. The transmission tower components assessment grouped into ground corrosive condition, foundation condition, lattice steel body of the tower, and conductor. Significant and scientific field investigation and visual assessment evaluate the state of the tower. The corrosion hazard, which is a product of climate and air pollution data, is used. Three separated lines and 84 towers were selected with different ages of the tower in service. The Weighing Scoring Method with Analytical Hierarchy Process to impose the weighed factor was used. The survival function analysis is used to predict service life, and the tower remaining life was determined. The paper shows how to use the model to predict the remaining life of a transmission tower and how this can be used to advise maintenance planning.

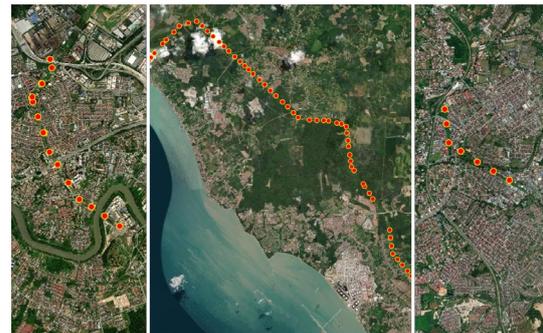
Fig. 1. Location of transmission tower in this study.

The atmospheric corrosion level was published in a separate study. The corrosion hazard map was generated based on ten years' climate and air pollution data of wet deposition from 17 measurement stations in Peninsular Malaysia [4]. Figure 1. shows the location of 80 towers in the different transmission lines. In this study, a visual assessment on 8 members for each side of the tower was taken. The thickness of the galvanized Zink coating was measured at 32 points inside and outside the face of the lattice steel tower member.

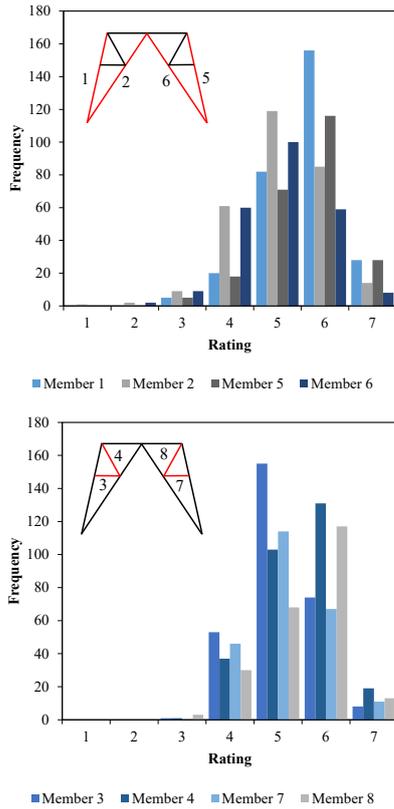
Fig. 2. Corrosion rating distribution for main member and bracing.

Corrosion was the common sign of deterioration observed during the assessment. The corrosion was on the galvanized coating with no significant further corrosion to the carbon steel member. The galvanized Zink coating observed has more than 100 microns of thickness. Figure 2 shows the distribution of corrosion on tower members. It shows that corrosion is observed more often on redundant members with less slanted or flat-oriented members. There is 25% soil with high and highly corrosivity conditions recorded and affecting the concrete condition. Figure 3 shows the Partial correlation graph of soil corrosivity and concrete condition.

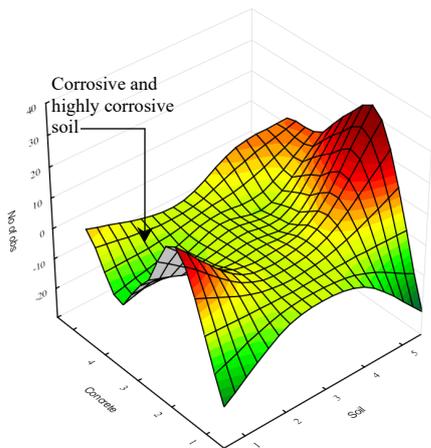
Fig. 3. Partial correlation graph of soil corrosivity and concrete condition.

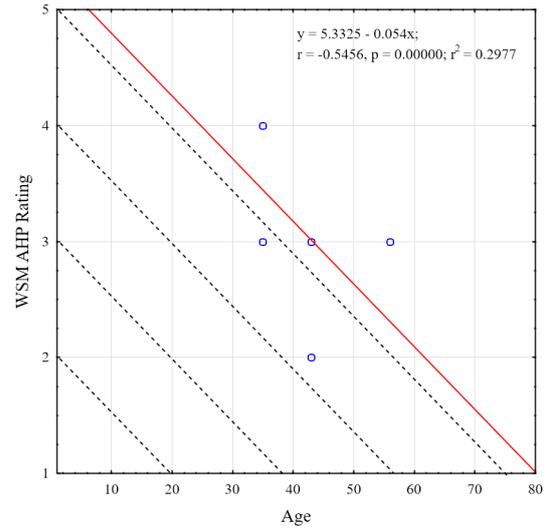
Fig. 4. Linear fitting of brushed data of condition rating and age of the tower.

The multi-criterion decision analysis with AHP produced weighing for each sub-component with 19.5%, 22.5%, 21.2%, 23.1%, 13.7% and the *CI* of $0.084 < 0.1$. Figure 4 shows the linear fitting curve for the tower condition rating and age of the tower. It is found that the predicted age of a tower from this study can reach more than 70 years when it has a condition rating of 5 with an *r*-value of 0.5465. The predicted life of a tower will gradually reduce by about 20 years for each decrease of the tower condition rating.

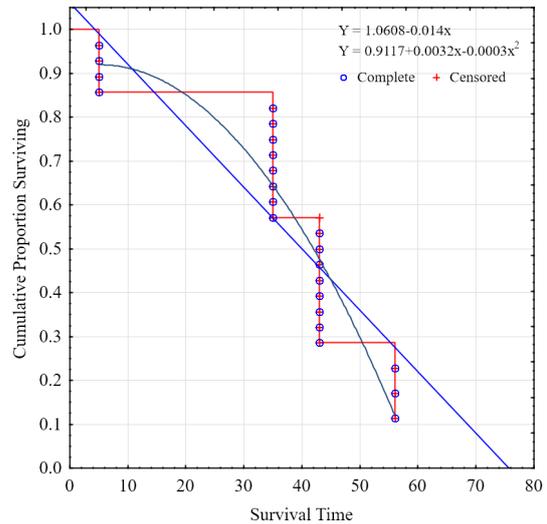
Fig. 5. The survival function plotted as a step function with fitting curve of linear and quadratic mode.

The predictive remaining life of the lattice steel transmission tower in this study uses Kaplan-Meier survival analysis. The Kaplan-Meier model is based on estimating conditional probabilities at each time point when an event occurs to estimate the survival rate at each point in time. In the survival study, the tower condition rating and the age at which each rating is applied as the condition changes through time. Figure 5 shows the survival function plotted as a step function with the fitting curve of linear and quadratic mode. Visually, the range of predicted life of the tower from the survival function seems to be a good approximation of 60 to 78 years.

The Kaplan-Meier model is used when the expression of the baseline hazard is unknown, and it is just estimated at points in time where one or more reductions of the physical state of the tower have occurred. The tower's mean residual or remaining life (*mrl*) can be predicted using the fitting equation as in Equation 3.
