Challenges in ensuring stability whilst providing environmental compliance for existing TSFs

Edoardo Zannoni^{1*}, *Vernita Govender*¹, and *Morne Germishuys*¹

¹Knight Piesold South Africa, Johannesburg, South Africa

Abstract. The stringent requirements for tailings storage facilities (TSF) following the publishing of the Global Industry Standards for Tailings Management (GISTM) have required in depth stability supported by advance testing and modelling, where in the presence of a hazardous tailings facility would require knowledge of the barrier system. Often a buttress is required to increase the factor of safety from the one originally designed, complying with stability as well as environmental requirements, and most importantly without triggering any failure during construction. The paper aim to present a project where the facility requires a buttress as the original design in the early 2000's was not acceptable in today's requirements. The stability pivot over a multi-layered barrier system (which does not allow Mohr-Coulomb failure criterion) and the different waste classification between the tailings and the buttress material, requiring different barrier requirements, yet

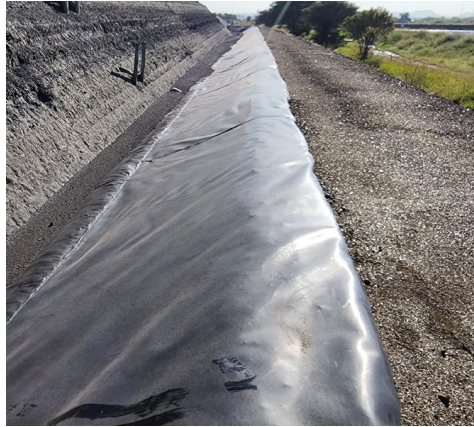
Fig. 1. Existing toe wall.

The current barrier system beneath both TSF's is deemed to be working based on the groundwater monitoring around the site and the leakage measured below the barrier system. The new barrier design was developed with the main principle to keep the waste stream independent from each other as the footprint of the buttress would require a considerable cost if a Class A barrier system was adopted throughout. The presence of an existing toe wall as shown in figure 1 was considered as the boundary between the type 1 waste from the TSF and the type 3 waste from the buttress.

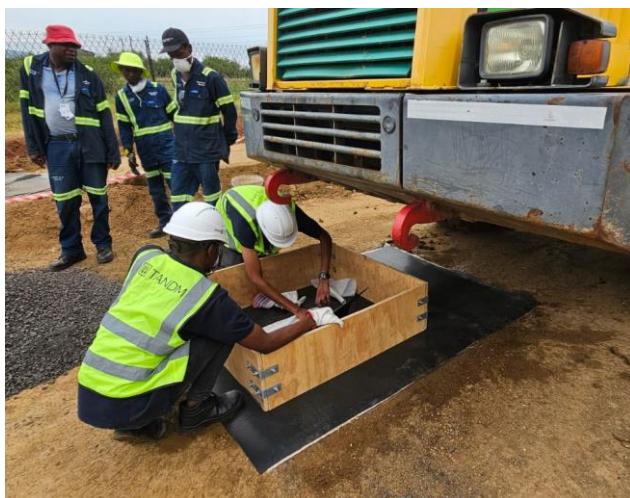
Fig. 4. Testpad under construction to monitor damage and strain in the geomembrane.

A protection geotextile has been specified to prevent damage by the buttress material ($D_{max} = 24\text{mm}$) with a unit weight of 1500 g/m^2 in polyester continuous filament. According to Hornsey [6], this compares to a 2200 g/m^2 polypropylene geotextile. Furthermore, a testpad has been constructed to check both damage to the liner as well as any strain in the geomembrane as illustrated in figure 4. Results from the testing confirmed that the maximum strain in the geomembrane with a load of 500 kPa (full height of the buttress) results in a strain of 1.5% calculated using the Tognon et al. method [7] as illustrated in figure 5, which is below the value of 3% for which geomembrane would exhibit stress cracking potentials.
