# Experimental findings concerning the evolution of breach resulting from the seepage at earthen dams under different scenarios

**Abstract.** Piping is one of the major phenomena which threaten earth-fill dam stability and safety. Piping depends on several geometric, hydraulic and geotechnical parameters and can cause erosion within the dam structure. This study involves time-dependent evolutions of the breach shape and flow rate from the breach corresponding to four different scenarios. Both homogeneous and clay cored earth-fill dams were constructed by using a sand-clay mixture consisting of 85% sand and 15% clay. The weak layer was created at bottom or at top of the dam bodies. The temporal evolution of the breaches was recorded using high-quality cameras installed at upstream, downstream and lateral sides of the flume. A magnetic flow meter placed on the discharge pipe measured the inflows. The flow rates from the breach were calculated by using the continuity equation describing the mass conservation. The so-obtained experimental findings are presented and interpreted. The primary objective of these experimental studies is to enable the calibration and validation of the numer

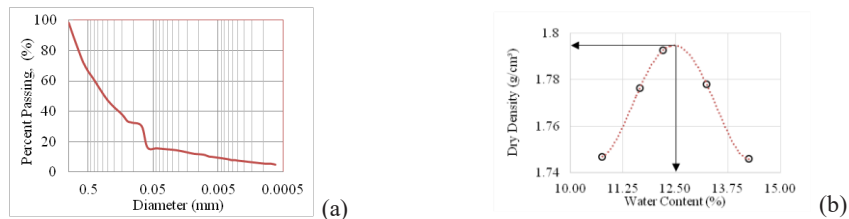
**Fig. 2.** a) Grain size distribution and b) dry density-water content relationship.

The particle size distribution curve of the mixture is given in Fig. 2a. According to Unified Soil Classification System, the mixture was identified as Clayey Sand with symbol SC. The specific gravity of the mixture was determined as 2.63. The permeability of the mixture was calculated as  $k=4.66 \times 10^{-4}$  cm/s. The cohesion and internal friction values obtained from the direct shear test, were found as 15.33 kPa and  $33.93^\circ$ , respectively. Proctor test results were depicted in Fig. 2b. The details concerning soil mechanics tests results and the piping experiments findings mentioned in this paper are given in the papers presented in the scientific meetings held in the past, such as [1] and [2].

The number of proctor test blows was selected as 13 instead of 25 to promote piping within the dam body. When the dam bodies were constructed, each layer was prepared so that the bulk density of  $2 \text{ g/cm}^3$  was satisfied. Each layer of 14 cm initial thickness was reduced to 10 cm after the compaction.
