The Reeds Performance Study on Traditional Architecture as Building Material in Wae Rebo Village

Indri L. Juwono^{1,*}, Dalhar Susanto²

¹Architecture Departement, Universitas Indonesia, Depok, Indonesia

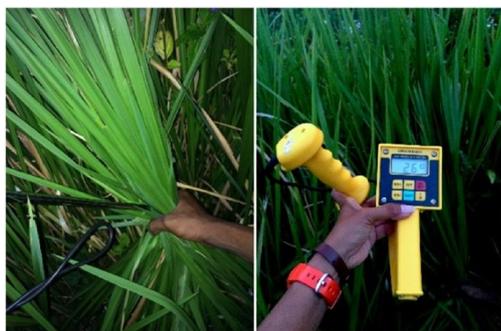
Fig 2. Measure humidity at Mules Island

Reeds are taken by using a sickle with a span of a hand (20 cm) from its roots. Humidity measuring was made during the day at 16.30 for a sample of reeds with a 5 cm handheld.

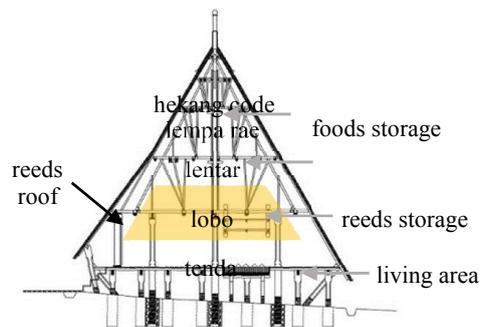
Fig. 3. Section of Niang Gena Jengkong (source: Monica Louis)

Measurements were made at *lobo* level from Niang Gena Jengkong. The location of this *lobo* is as high as 250 cm from the tent level, surrounded by reed roofs and placed on wooden boards that become *lobo* mats on a stove that lights up in the morning, afternoon, and evening. These reeds were taken from Pulau Mules two months earlier and smoked to dry.

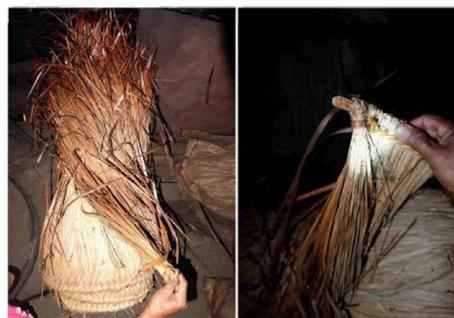
Fig. 4. Bundled of reeds (a). Construct reeds on the rattan (b).

The Draminski HMM used to measure during the afternoon at 14.00 inside on a bundle of reeds sheets with a diameter of 50-60 cm and a roll of reeds that had been tightened in rattan.

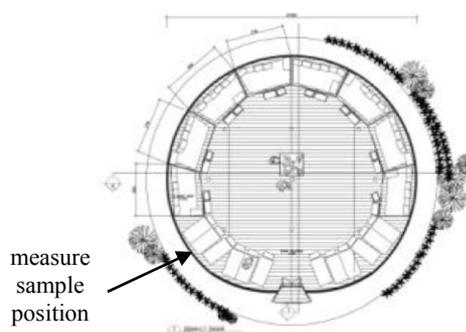
Fig. 6. Mbaru Niang plan (source: Monica Louis)

Measurements were made on three houses with different reeds ages, namely Niang Gena Ndorom which was in 2009, Niang Gena Jekong which was built in 2011 and Niang Gena Mandok which was built in 2013, by measuring the humidity level of room and reeds material for three days with a certain time interval at 7:00, 13:00, 17:00 hours and 20:00 hours. It placed on the reeds roof inside the gathering area around the stove.

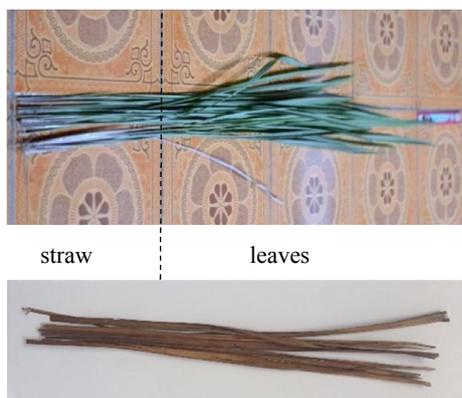
Fig. 9. Harvested reeds – 110 cm length (above)
 Leaves sample of reeds – 30 cm length (down)

Before the test, the reeds were left in the laboratory with room temperature 24°C and 65% humidity. From each stage is separated the straws and leaves of reeds because it is estimated to have a much different tensile strength. Straws or leaves of reeds are cut along 10 cm as a material test specimen of 4-6 sheets.

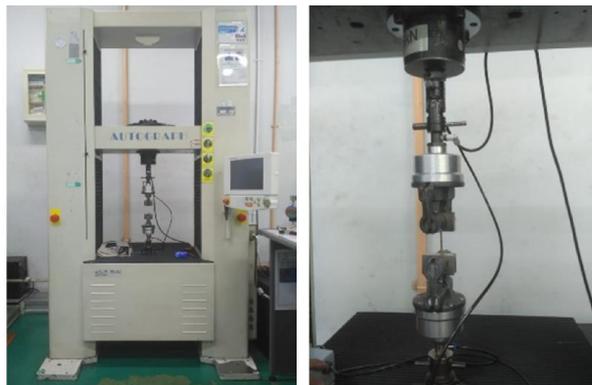
Fig. 10. Placing in the clamps of the Shimadzu AG-IS 20 kN Machine unit (left) Clamps (right)

The tensile forces and the displacements of the reeds were assessed with using a Shimadzu AG-IS 20 kN universal testing machine with a measurement range of strength values up to 20 kN. This machine is designed to

The tested specimens were shaped as strips with the same length of 10 cm. However, the width may vary as the leaf specimens are wider than sticks. Leaves have approximately 5-10 mm in width while straws are around 1-2 mm in width. The reeds (straw/leaves) was placed in metal clamps of the machine as pictured. In order to prevent the delicate plant material damage in the area of the clamps, a slice of rubber was taped inside clamps.

The computer program used to read this tensile test is Trapezium which will output data in the form of tables and graphs of initial load to peak load before the reeds are broken. Of the six samples in each group of data tests, the average load values were obtained from the four best samples (in Newton). The tensile strength was calculated from the following equation:

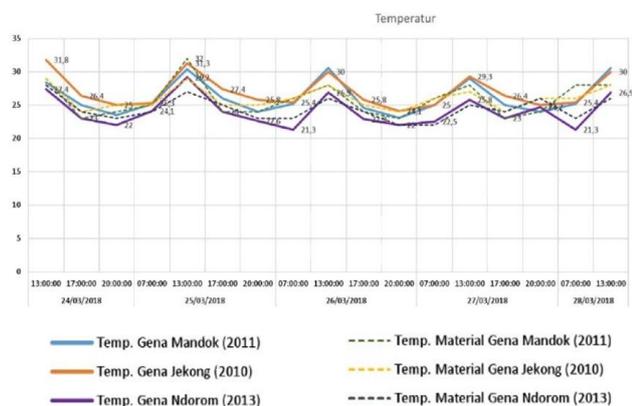
Fig. 11. Chart of Temperature 3 Niang in different ages (°C)

Measurements taken during three maintenance periods of Gena Ndorom (2009), Gena Jekong (2011) and Gena Mandok (2013) manually for four days showed changes in the temperature of the room and the temperature of the reed material which was quite stable inside the house, with the highest temperatures at midday and the lowest temperatures at night as shown at Fig. 9. There was no significant difference in room temperature even though these niangs were of different ages. In the daytime, temperatures of reeds are lower 1-2⁰C than the room temperature, at night the temperatures of reeds are 1-2⁰ higher than the room temperature.

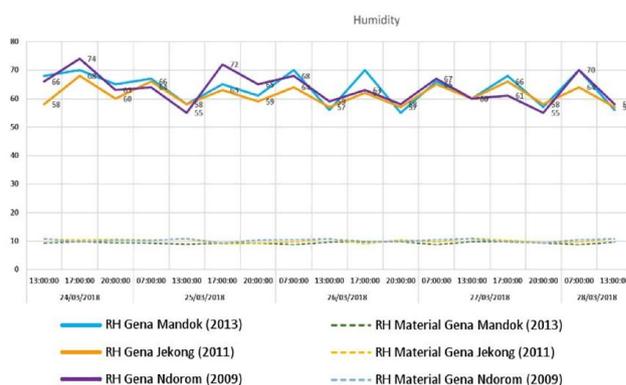
Fig. 12. Humidity chart of 3 Niang in different ages (%)

The difference in humidity level trends between the three different age niangs during the maintenance period still shows the same trend as the extreme day or night, but in the reeds material which was measured by Draminski HMM, humidity shows a stable trend, not too big a difference in day and night.

From the chart at Fig. 10 show that the average humidity trends in both room and materials in different maintenance periods are three years, showing almost the same number. This time determined does not affect the humidity of room or material. It was also observed that the 9-year-old reed (Gena Ndorom) had $23.53 \times 10^4 \text{ N/m}^2$ lower tensile strength than the 7-year-old Gena Jengkong 29.74 N/m^2 and the 5-year-old Gena Mandok $32.38 \times 10^4 \text{ N/m}^2$ which is heated every day and heated. These results do not show the same trend as the Dodsall study [10] which suggests that there is an increase in the value of bending strength and the limits of elasticity of reeds in the $120\text{--}160^\circ\text{C}$ temperature range. From the daily treatment of reeds in Wae Rebo, it is seen that the heating in the traditional house aims to drain the reeds so as not to damp, but if the heating is done at temperatures above 160°C , it can decrease the tensile strength of reeds.

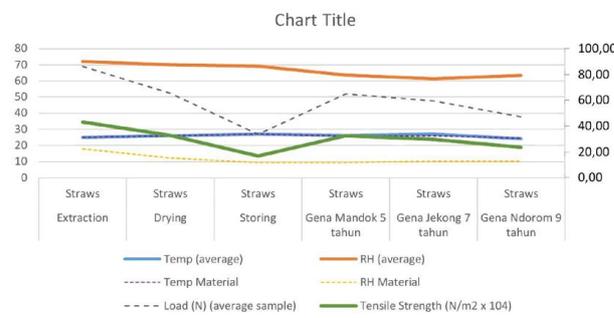
Fig. 13. Tensile Strength grafik related to humidity (x 10⁴ N/m²)

Starting from extraction to storage shows a decrease in humidity with a small different number but followed by a significant drop in tensile strength. From this, it is seen that the process of moisture reduction with natural drying will affect the strength of reeds. The values of tensile strength could be compared with the data obtained by W. Kowalik that the ratio of reed strength to summer and winter conditions notify that the reeds at winter with high humidity have higher tensile strength than in when summer with low humidity [13].

Imperata cylindrica on Mules Island has a tensile strength value of 43.09 x 10⁴ N/m², higher than the *Phragmites australis* grass ever tested by Dabaieh, 2015

of $32.17 \times 10^4 \text{ N/m}^2$ [14]. Despite the humidity down, with wind draining, the tensile strength is still at $32.63 \times 10^4 \text{ N/m}^2$. It can conclude that the reeds of this Mules island have a good quality.

Fig. 11 shows that tensile strength increases from storage to maintenance phase, as treatment changes from drying naturally to drying by heating from the stove. However, measurements of three niangs namely Gena Ndorom (2009), Gena Jengkong (2011) and Gena Mandok (2013) obtained the decreased of tensile strength as the longer the reeds are installed on the roof.
