Assessment of the Ortachala HPP low head dam abutment deformation and seepage regime

Abstract. During Ortachala HPP operation period cracks were formed in the right-bank of foundation, where is located underground fish-way sections. Right bank dam-foundation contact opened only in the horizontal direction, that caused 5.5 cm gap development, while there were no changes in the vertical direction. Visual researches showed that cracks (size is 4–5 cm) developed in fish-way construction. Mathematical models: fish-drainage-foundation, retaining wall-drainage-foundation, with the use of the finite element scheme, allowed us to finalize the suffusion-deformation process developed during the operation, namely: in the cracking zones of fish-way developed high gradients of seepage pressure, causing suffusion; under the influence of the weight of the soil and transport, shrinkage of the soil developed, which for the foundation of the right bank, created bending deformations causing the rotation of the soil in the vertical plane; bending deformation of the foundation at the contact of the concrete structure and the embankment caused a horizontal opening, spread out – at a depth of 4m. In conn

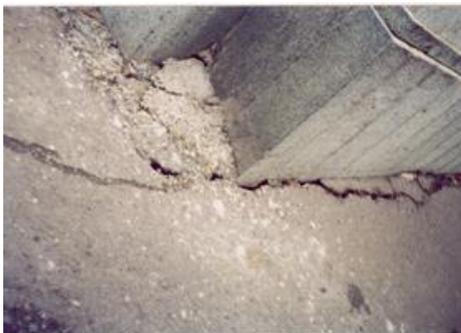
Photo 1. Cracks developed in Ortachala HPP right bank.

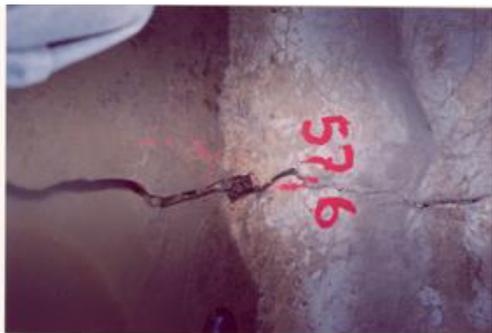
Photo 2. Cracks developed in under ground fish-way.

Fish-way, that is totally located in the embankment, in the process of operation was compacted with soil. In the result, along it's longitudinal axis, cross cracks were developed in the construction (especially in the bottom), that itself caused seepage. Generally, soil seepage strength condition has it's faces:

6. Having established the cause of these processes, the fish way was stopped, and by result of which the fractures were stopped. So fish-way internal surface hydro isolation is necessary as a rehabilitation measure.
