# Restoration of the Martyn brothers house as a bright example of the work of the architect N.M. Socolow

**Abstract.** The paper discusses the history of the Martyn Brothers House, as well as the practice of restoring this object of cultural heritage of federal significance. The author of the mansion is Nikolai Matveevich Sokolov (1859-1906), the city architect of the late XIX - early XX centuries in Rostov-on-Don. To characterize the measures for the protection and modern practice of restoration of one of the brightest examples of N. M. Sokolov's creativity – the Martyn Brothers House in Rostov-on-Don. The main method of research was historical analysis - the study of the origin, formation and development of objects in chronological order, as well as archival and full-scale surveys of the object, photo fixation. The characteristic of practice of restoration of works of "brick style" using Martyn Brothers House as a bright example of the work of the architect N.M. Sokolov was given. The mansion is of scientific and practical interest. During the research, the main techniques and methods used in restoration practice that can be used by modern restorers were identified. After the co

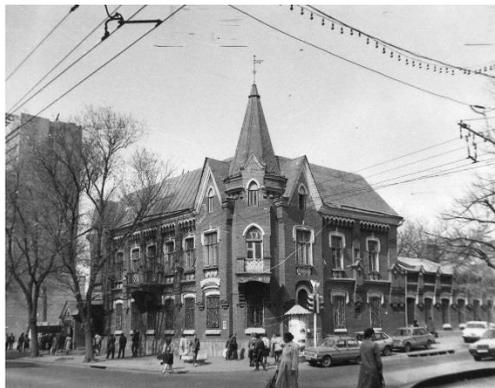
**Fig. 1.** Martyn Brothers House in the postwar years, arch. N. M. Sokolov, Rostov-on-Don (see. [http://hotel7nebo.ru/images/page/45\\_1.jpg](http://hotel7nebo.ru/images/page/45_1.jpg)).

With the establishment of Soviet power in the early 1920s, the Martyn brothers’ household was municipalized. The second floor of the mansion and the one-story wing were used for communal housing; the living rooms and rooms on the first floor were intended for organizations. During its operation, significant losses occurred, the premises were redeveloped, and the details of the decoration were destroyed (Figure 1).

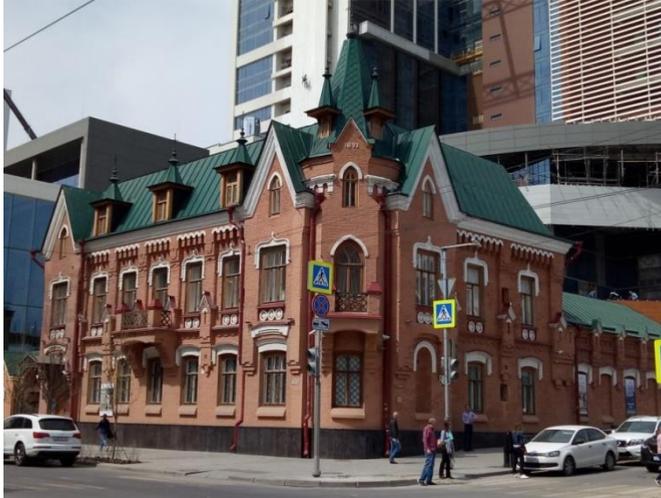
**Fig. 2.** Martyn Brothers House after the restoration, the arch. N. M. Sokolov, Rostov-on-Don. Photo Petrusenko Y. V., 2018.

2014 - restoration of the facade and balconies; restoration of mirrors of stoves; reconstruction of wrought-iron gates, installation of lanterns (see <http://www.sholokhov.ru/>) (Figure 2)
