# Applying Geographic Information Systems (GIS) for surface condition indicators modeling of a flexible pavement

The section under study is part of the Moroccan National Road number 06, from KP 0+080 to KP 0+130.

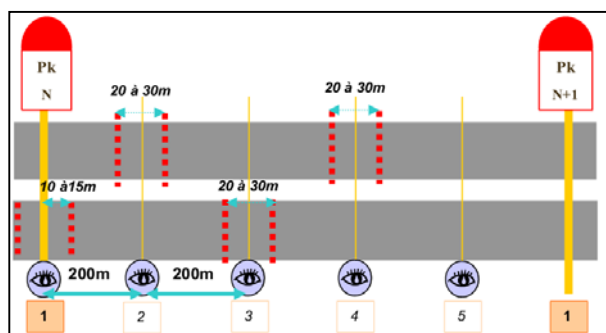
Fig 4. Visual Moroccan inspection method

Every two years based on a visual survey of pavement deteriorations. The visual survey concerns deterioration of the following types: cracks (longitudinal and transverse) [1-3], tears (feathering, peeling, combing, potholes), deformations (rutting, subsidence, etc.), and shoulder slopes. During the same survey, the wearing course nature, the roadway width, shoulders, the traffic class, the nature, and the date of the last intervention are also noted. The principle of the survey is based on the observation at regular intervals of 200 m of the existence or absence of each type of deterioration, indicating its severity (Fig. 4).

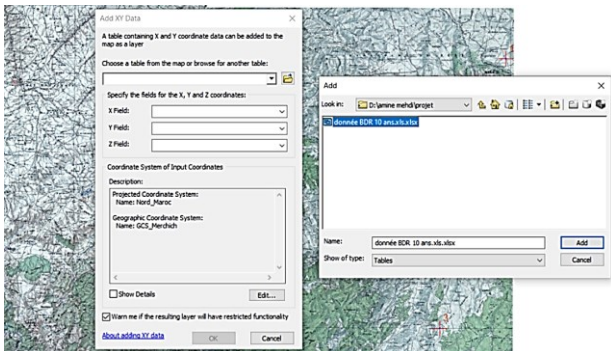
**Fig. 5.** Georeferencing of the map

1. Georeferencing of the map and projection in the Moroccan coordinate system (Fig. 5)
2. Reading of the reduced database (Fig. 6)
3. Projection of the points on the map (Fig. 7)
4. Making the buffer (Fig. 8)
5. Classification by level of surface indicators (Fig. 9)
6. Realization of the thematic map (Fig. 10)

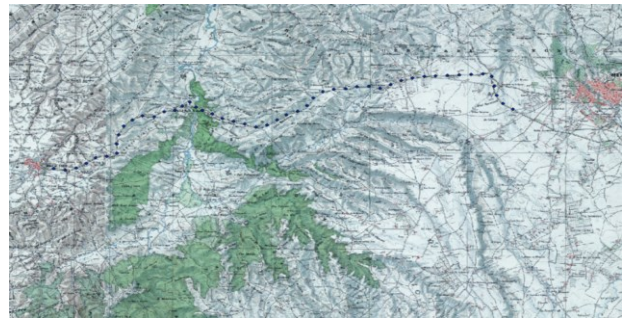
**Fig. 7.** Points projection

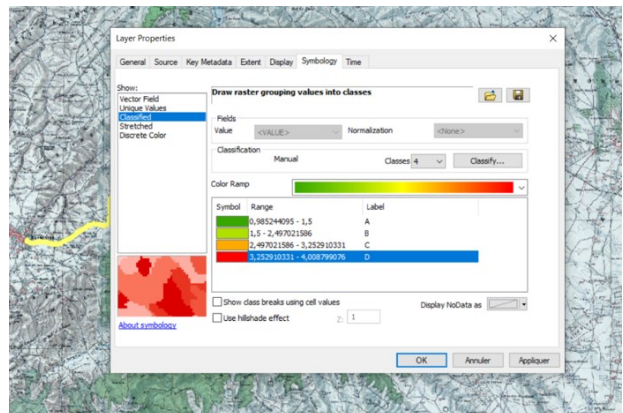
**Fig. 9.** Classification of indicators

These parameters are intended to ensure the viability of this roadway link which is open to two-way traffic on a 24-hour basis. According to the analysis of the results obtained in figure 9, the surface indicators reflect a low

percentage in A+B, which means a substantial increase in the number of deteriorations. Despite the interventions which were recommended for this link, the map (Fig:10) represents a strong discontinuity between the various kilometers points as show an imbalance of surface continuation state on the 50 kilometers, the last kilometers while going towards Meknès are the most degraded (indicators of the state C and D).
