Cause Analysis and Solutions About Abnormal Heating of Equipment Clamp

Abstract: As a kind of link terminal in power grid system, clamp has become one of the key components and widely used for connecting the transmission lines and electrical equipment. However, the joint between the tubular structure and the terminal plate or the drainage plate is always a weak part, which is easy to produce defects and then accelerate the failure of the clamp during service. This is also limited the use space of clamp to a certain extent. In this paper, research status on heating causes of equipment clamps and the corresponding solutions are mainly summarized. And the application of disc shape memory alloy gasket as well as the design of mortise tenon structure clamp will fundamentally solve the problem of abnormal heating of wire clamp.

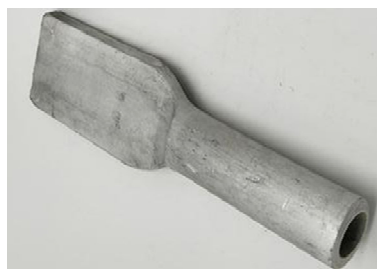
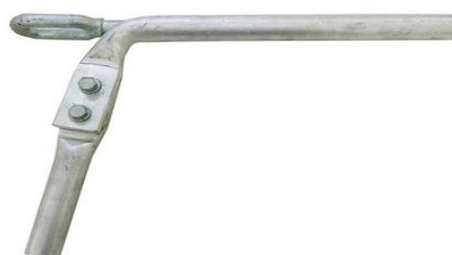
Fig.1 Common types of the equipment clamp

SY type (b)NY type

Equipment clamp is a kind of link terminal in power grid system, which is one of the key components and widely used for connecting the transmission lines and electrical equipment [6-7]. The commonly used equipment clamps are divided into aluminum equipment clamps and copper aluminum transition equipment clamps, which are usually composed of the fastening strand part and the electrical equipment connection part. The former is mostly tubular structure, while the latter is terminal plate. In addition, SY type equipment clamp (Fig.1 (a)) is usually produced by welding aluminum pipe and terminal plate or integral casting, and NY type equipment clamp (Fig.1 (b)) is mainly used in power transmission lines and made of aluminum alloy, producing by welding the strain tube and the drain plate [8].
