# Investigations of damage to the under-rail base on the main routes JSC "Uzbekistan Temir Yullari"

**Abstract.** The article presents the results of field surveys of the condition of reinforced concrete sleepers of the BF70 type with different periods of their operation and different missed tonnage on the main tracks of JSC "Uzbekistan Temir yullari". The main types of defects and the causes of the destruction of the sleepers have been identified. They were distributed according to classification numbers. In order to increase the life cycle of the under-rail foundation and the overhaul period, ways to prevent and eliminate defects are recommended.

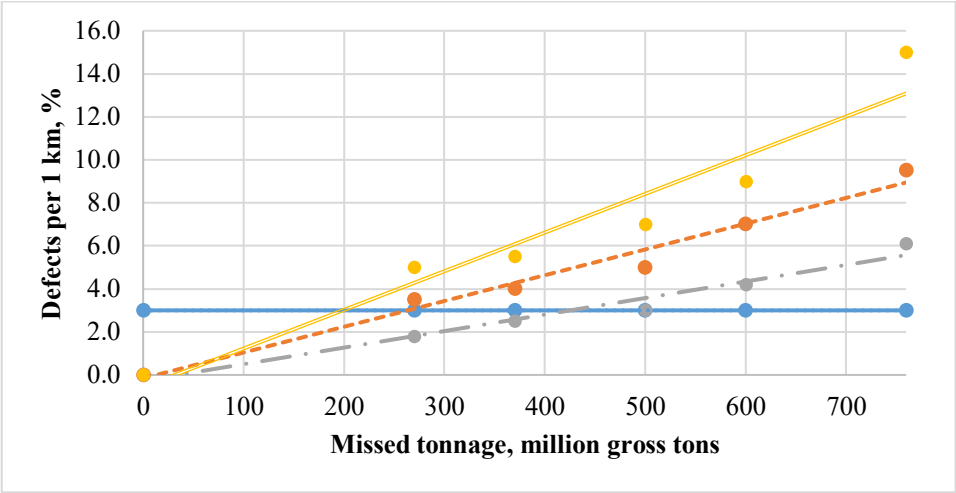
**Fig. 1.** Dependence of the number of defects on the missed tonnage:

A graphical interpretation of the results of the experiment was performed, equations were obtained for the linear dependence of defects on the missed tonnage (Fig. 1) and defects on the period of operation (Fig. 2).

Defect №1 does not depend on the missed tonnage and the number of defects here is 3. The following expressions show a linear dependence for defects № 2, № 3, № 4, respectively:

$$y = 0.012x - 0.1583, R^2 = 0.9756 \quad (1)$$

$$y = 0.012x - 0.1583, R^2 = 0.9756 \quad (2)$$

$$y = 0.018x - 0.5718, R^2 = 0.9326 \quad (3)$$

Expressions 1-3 will allow you to determine the amount of each type of defect for different values of the missed tonnage. Approximation confidence values greater than 0.93 are a confirmation of the high level of reliability of the trend line. The straight trend line reflects the constant rate of increase in the number of defects with increasing tonnage. It should also be noted that the number of sleeper defects increases in proportion to the increase in the missed tonnage (Fig. 1).

—●— №1; —●— №2; —●— №3; —●— №4;  
- - - linear (№ 2); - · - linear (№ 3); — linear (№ 4)

The maximum number of defects of 13% per 1 km of track type No. 4 occurs with a missed tonnage of 750 million gross tons (Fig. 1) for the 18th year of operation of the sleepers (Fig. 2). The minimum amount of 0.5% corresponds to defect No. 3 with a missed tonnage of 100 million gross tons in the third year of operation of the sleepers.

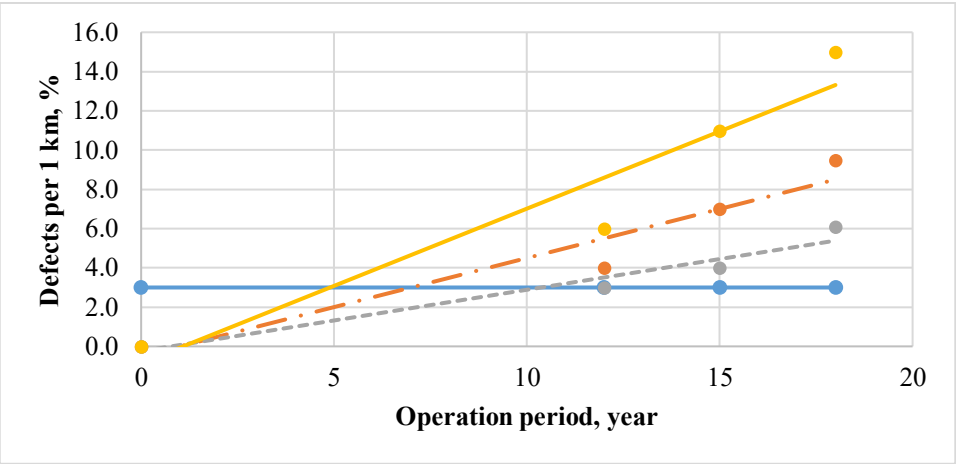
**Fig. 2.** Dependence of the number of defects on the period of operation:

Equations for the dependence of the number of defects on the period of operation, respectively, for defects №2, №3, № 4:

$$y = 0.5x - 0.5, R^2 = 0.9303 \quad (4)$$

$$y = 0.3129x - 0.2446, R^2 = 0.9467 \quad (5)$$

$$y = 0.7871x - 0.8554, R^2 = 0.9183 \quad (6)$$

—●— №1; —●— №2; —●— №3; —●— №4;  
- - - linear (№ 2); - · - linear (№ 3); — linear (№ 4)
