# The influence of the reliability of wheelsets of innovative wagons in operation on the need for new wheels

**Abstract.** The article considers one of the most important wagon units - wheelsets. An analysis was made of the growing number of uncoupled wagons of Russian railways for unplanned repairs and it was revealed that the most common reasons for this are the faulty condition of the wheelsets and axle boxes. It was determined that the factors influencing the nature of the malfunctions are the inappropriate quality of the repair of bogies, the admission to operation of secondary wheels with a rib thickness of less than 26 mm. One of the measures taken is the lubrication of rails and sleepers. The introduction of innovative wagons with wear-resistant wheelsets may also have an impact on reducing the growth in the number of uncoupled wagons requiring repair. The features of newly produced innovative wagons with a higher axle load and an increased turnaround time are considered. To assess the impact of an increase in the share of innovative wagons on the need for wheels, the reliability indicators of wheelsets of innovative gondola and hopper wagons were considered. Reliability w

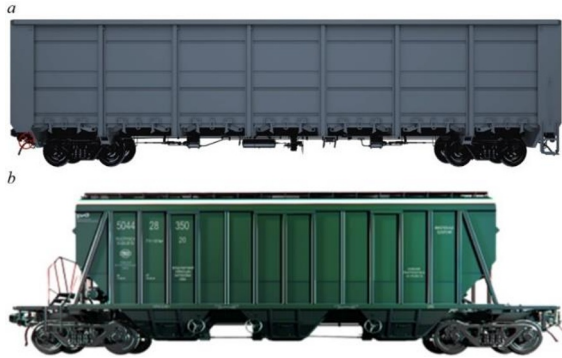
**Fig. 3.** General view of the innovative gondola wagon model 12-9853 (a) and the innovative hopper wagon for grain transportation model 19-9870-01 (b)

Two types of innovative wagons were selected as the object under consideration for the research. These are gondola wagons of model 12-9853 (Figure 3, a), built in 2013, and hopper wagons of model 19-9870-01 (Figure 3, b), built in 2014, manufactured by Tikhvin Wagon Building Plant. These wagons (Table 1) are operated on new bogies of model 18-9855 (25 tf) with RV2SH-957-G wheelsets, the wheels of which are made of steel grade “T” with improved technical characteristics [17]. The number of wagons in supervised operation amounted to 400 units for each type of wagons.
