# Proposed structural and functional evaluation of unpaved roads improved with geosynthetics, reclaimed asphalt pavement and Portland cement

The cargo transport network in Brazil is highly unbalanced, with a marked concentration of road transport in relation to other modes of transport. As if the flagrant imbalance between modes were not enough, serious distortions are also observed in the distribution of road network coverage. Only 13% of the Brazilian network has coating considered definitive, reinforcing the importance of unpaved roads in the transport network. Despite advances, the design methods for unpaved roads were mostly developed for roads treated with gravel in regions with a temperate climate, which are inconsistent with the nature and behavior of Brazilian tropical soils. They also disregard important soil improvement techniques, such as reinforcement with geosynthetics, incorporating civil construction waste, reclaimed asphalt pavement, mining tailings or chemical stabilization with different additives (hydrated lime, Portland cement, latex polymers, organic additives and asphalt emulsion). Faced with this challenging scenario, this research was designed to monitor t

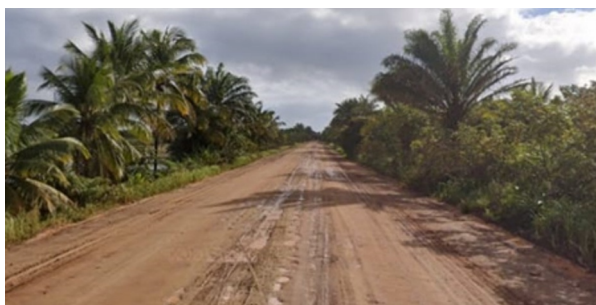
**Figure 3.** Frontal view of the region where the test section will be implemented on the BR-030/BA highway

Another important requirement for defining the region for implementing the test section is topographic and geological uniformity (Figure 3). Compliance with this requirement aims to ensure that the distribution of loads arising from heavy vehicle traffic occurs uniformly in all segments with the incorporation of soil improvement techniques.

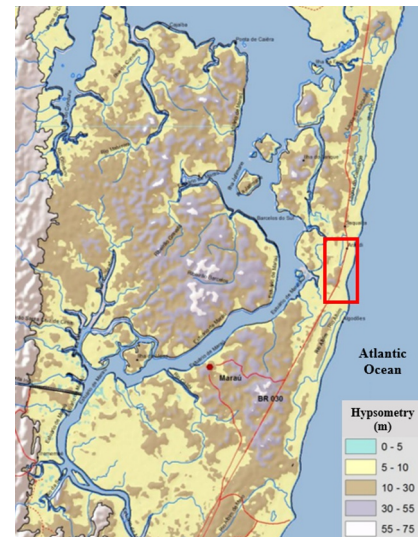
**Figure 4.** Distribution of hypsometry classes in the region of the test section (modified from Waldburger 2014)

The Marau Peninsula has altitudes that vary from sea level to 55 meters, located from the coastal zone to the relief of hills and mountains in the western portion of the area. Figure 4 presents the hypsometry distribution of the area with classification defined according to four altitude intervals. The class between 0 and 10 meters represents the altitudes distributed preferentially in the coastal zone, including coastal sandy deposits and mangroves. The class with altitudes between 10 and 30 meters represents elevations associated with the occurrence of Mesozoic sediments in the Camamu Basin (Waldburger 2014). These are the dominant classes in the area of the future test section of the BR-030/BA highway.

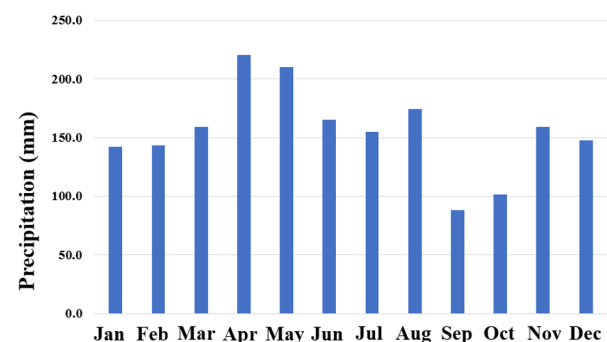
**Figure 5.** Monthly rainfall averages at the Meteorological Station of Marau-BA (INMET 2022)

This region has high rainfall, normally exceeding 2,000.0 mm annually and distributed throughout the year. The greatest rainfall occurs in the months of April and May and the lowest in the months of September and October. Figure 5 presents the consolidated monthly rainfall averages from January 2012 to October 2022, according to results extracted from the Marau Station of the Brazilian National Institute of Meteorology (INMET). The average annual temperature in the region of test sections presents an annual temperature range oscillating between 21 and 25°C.

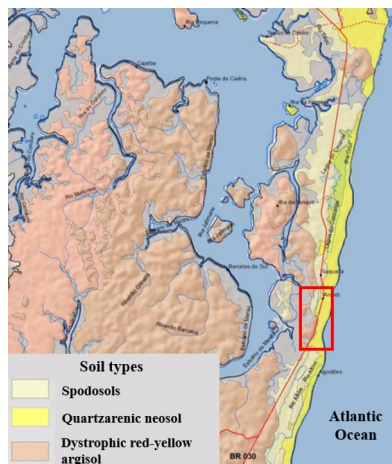
**Figure 6.** Soil types distribution in the region of the first test section (modified from Waldburger 2014)

Figure 6 shows an extract from the soil distribution map of the Marau Peninsula (Waldburger 2014).

Due to the spatial distribution of rocky substrates and pedological processes specific to the region, the region of the future experimental section is characterized by the occurrence of the following soil classes:

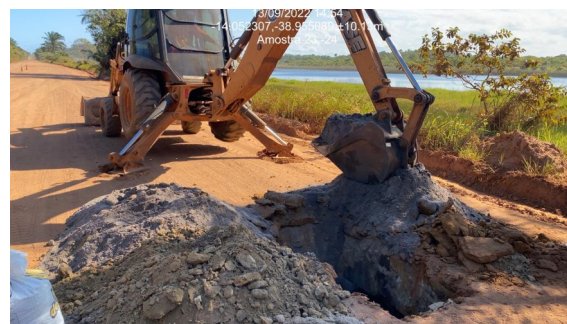
**Figure 8.** Collection of soil samples in the test section

Soil samples from the primary coating and subgrade (1.5 meters deep) were collected at the midpoint of each improved segment and control section, as shown in Figure 8. The samples were used for granulometric characterization and determination of consistency limits and resistance parameters (compaction and CBR tests).

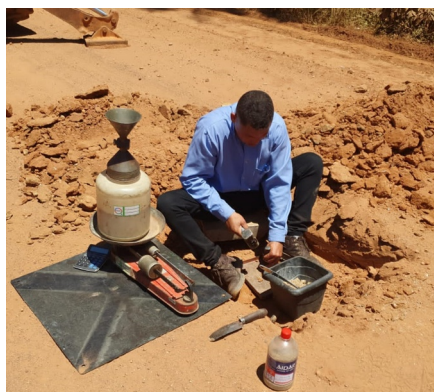
**Figure 9.** The sand cone method was performed on the primary coating in the test section

The collection was carried out alternately on the axis and on the left and right edges of the road in order to expand the investigation of the area of application of the stresses. At these points, in addition to collecting soil samples, tests were carried out on the surface and in-depth to determine the relative density in situ using the sand cone method, as shown in Figure 9.

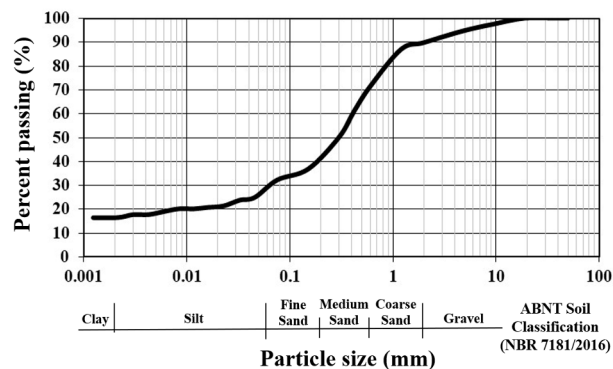
**Figure 10.** Particle size distribution curve of the subgrade sample (1.5 meters deep) in Improved Segment 1 (spot 903.8)

Figure 10 shows the granulometric distribution curve of the subgrade soil in the region where the future test section will be implemented. According to the textural classification proposed by the Brazilian Association of Technical Standards (ABNT), the soil is made up of 10% gravel, 61% sand, 12% silt, and 17% clay.

Tests indicated a liquid limit of 25%, a plasticity limit of 19% and a plasticity index of 6% for the soil subgrade. According to Unified Soil Classification System (USCS), the subgrade soil is classified as SM. According to the Transportation Research Board (TRB) classification, the sampled soil is classified as A-2-4, which predicts satisfactory behavior as a subgrade.

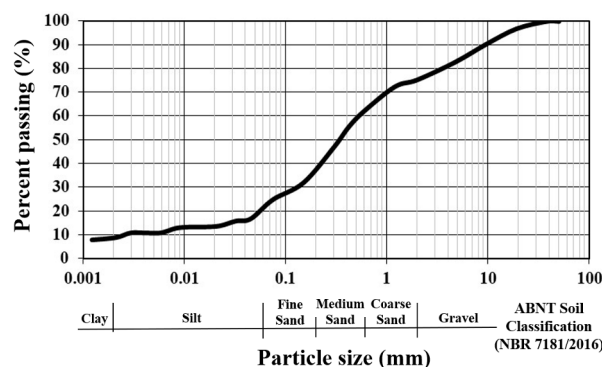
**Figure 11.** Particle size distribution curve of the primary coating sample in Improved Segment 1 (spot 903.8).

Figure 11 shows the granulometric distribution curve of the primary coating soil (lateritic gravel) in the region of the future test section. According to the textural classification proposed by ABNT (2016), the soil is made up of 25% gravel, 53% sand, 13% silt, and 9% clay.

Tests indicated the non-plastic behavior of the materials used in the primary road surfacing. Despite greater participation of gravel in the matrix, primary coating has the same classification according to the USCS and TRB methodologies. However, in-depth, the subgrade presents some compressibility.

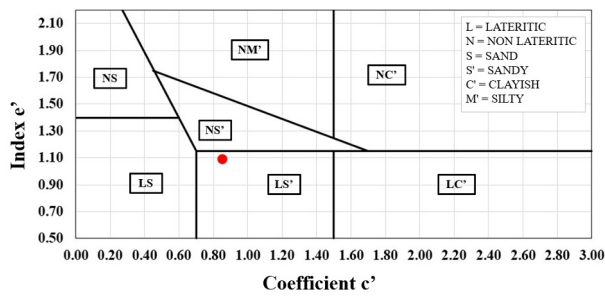
**Figure 12.** Brazilian MCT classification of the primary coating sample in Improved Segment 1 (spot 903.8)

Figure 12 shows MCT (Miniature, Compacted, Tropical) methodology's result for classifying tropical soils to the primary coating material. This systematic divided tropical soils into seven groups and two main classes: soils with non-lateritic behavior and soils with lateritic behavior (Nogami & Villibor, 1981).

According to the MCT classification, the primary coating soil of the test section is classified as lateritic sandy (LS'), but at the limit of the line that defines the lateritic behavior of the soils. This observation requires the enlargement of the tests to better characterize the material that makes up the base and the wear layer, over and with which all soil reinforcement and stabilization techniques will be performed in the test sections of the unpaved road under investigation.
